## **Fearna Pumped Storage Hydro Scheme EIA Report**

### **Appendix 12.4 – Schedule of Water Crossings**

**February 2025**

## Fearna Pumped Storage Hydro Project

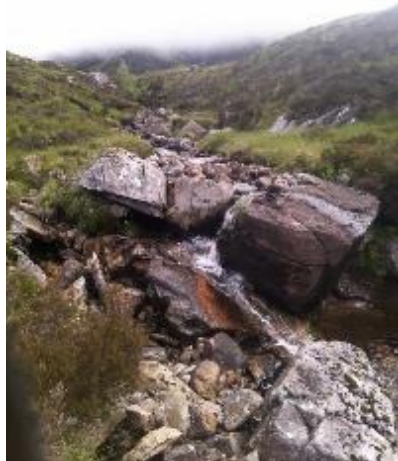
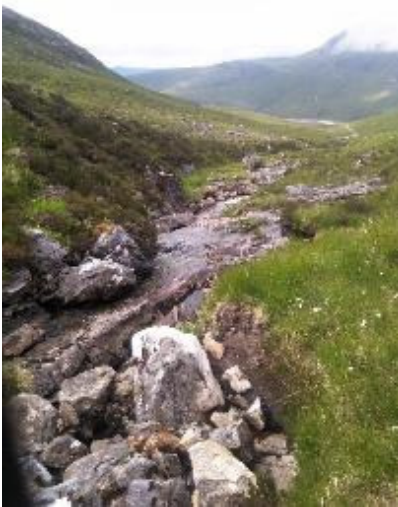
| Watercourse Crossing ID | WX01 |

| Watercourse Crossing ID | WX01 |
|---|---|
| Watercourse Crossing Details | <b>Grid Reference:</b> E 204989 / N 803798<br><b>Status:</b> New<br><b>Watercourse Width:</b> 3 to 4 m<br><b>Watercourse Depth:</b> 0.3 m<br><b>Notes:</b> Incised in bedrock. |
| Photograph Looking Upstream | |
| Photograph Looking Downstream | |

| Watercourse Crossing ID | WX01 |
|---|---|
| Potential Crossing Type<br>Likely Required CAR Authorisation | Open span bridge or bottomless arch culvert<br>Licence |

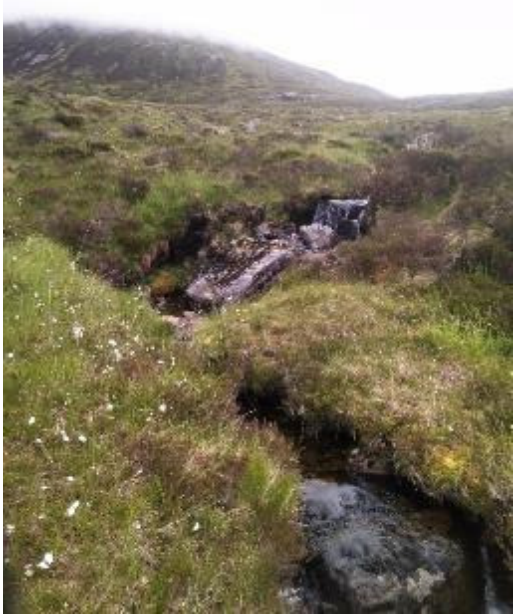
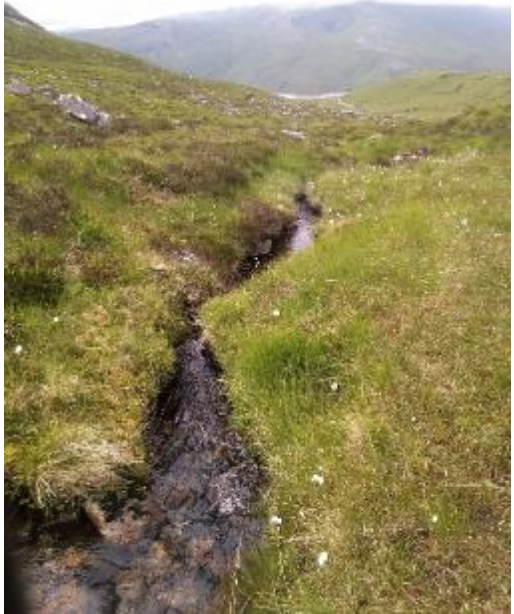
| Watercourse Crossing ID | WX02 |
|---|---|
| Watercourse Crossing Details | <p><b>Grid Reference:</b> E 205033 / N 803756</p> <p><b>Status:</b> New</p> <p><b>Watercourse Width:</b> 2 m</p> <p><b>Watercourse Depth:</b> 0.3 to 0.5 m</p> <p><b>Notes:</b> Incised in bedrock. Watercourse slightly narrower immediately downstream of crossing point.</p> |
| Photograph Looking Upstream | <p>A photograph showing a watercourse flowing through a grassy, hilly landscape. The water is dark and appears to be flowing over a rocky bed. The surrounding vegetation is green and brown, typical of a moorland or upland area.</p> |
| Photograph Looking Downstream | <p>A photograph showing a watercourse flowing through a grassy, hilly landscape. The water is dark and appears to be flowing over a rocky bed. The surrounding vegetation is green and brown, typical of a moorland or upland area.</p> |

| Watercourse Crossing ID | WX02 |
|---|---|
| Potential Crossing Type<br>Likely Required CAR Authorisation | Open span bridge or bottomless arch culvert<br>Licence |

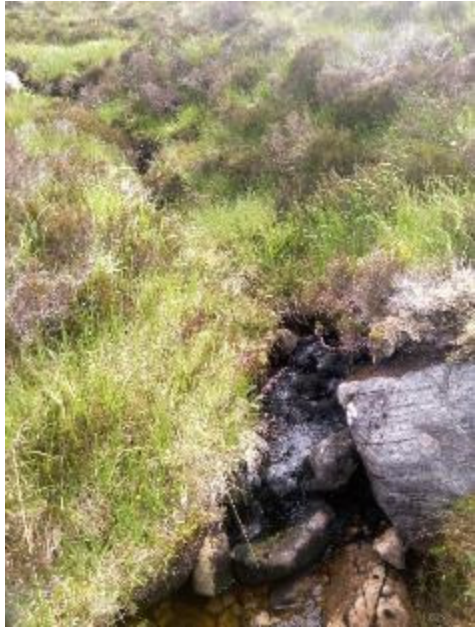
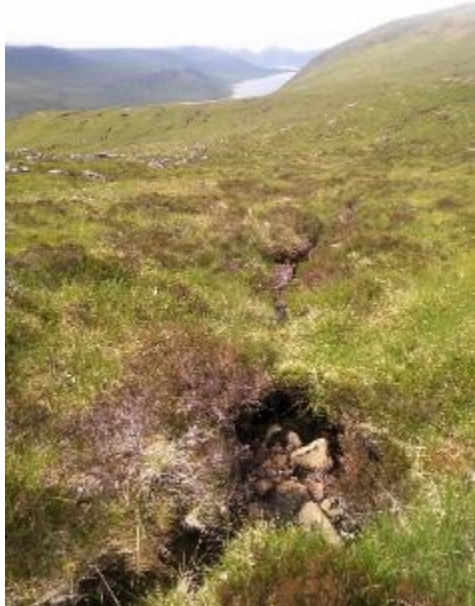
| Watercourse Crossing ID | WX03 |
|---|---|
| Watercourse Crossing Details | <b>Grid Reference:</b> E 205065 / N 803727<br><b>Status:</b> New<br><b>Watercourse Width:</b> 0.5 to 1 m<br><b>Watercourse Depth:</b> 0.3 m<br><b>Notes:</b> Cobbles to boulders noted within the channel. |

| Watercourse Crossing ID | WX03 |
|---|---|
| Potential Crossing Type<br>Likely Required CAR Authorisation | Culvert<br>Registration |

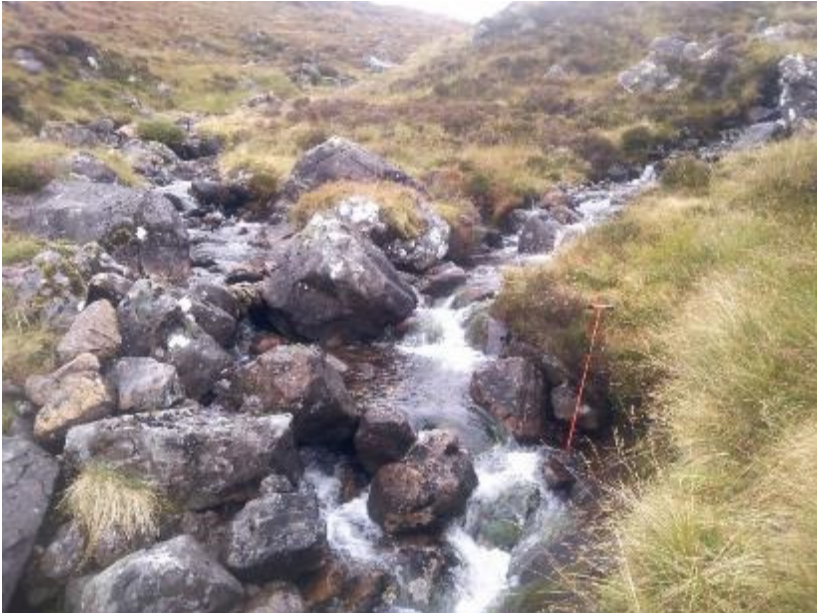
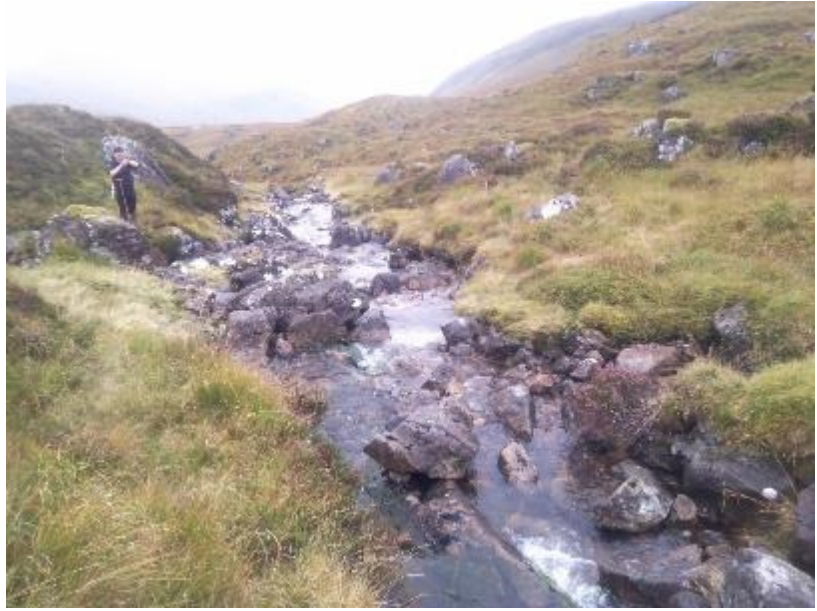
| Watercourse Crossing ID | WX04 |
|---|---|
| Watercourse Crossing Details | <p><b>Grid Reference:</b> E 204956 / N 803681</p> <p><b>Status:</b> New</p> <p><b>Watercourse Width:</b> 2.5 m</p> <p><b>Watercourse Depth:</b> 0.2 m</p> <p><b>Notes:</b> Watercourse located within a smaller channel which is up to 0.8 m deep. Boulders noted within channel. Crossing noted immediately downstream of confluence of two watercourses.</p> |

| Watercourse Crossing ID | WX04 |
|---|---|
| Potential Crossing Type<br>Likely Required CAR<br>Authorisation | <p>Open span bridge or bottomless arch culvert<br/>Licence</p> |

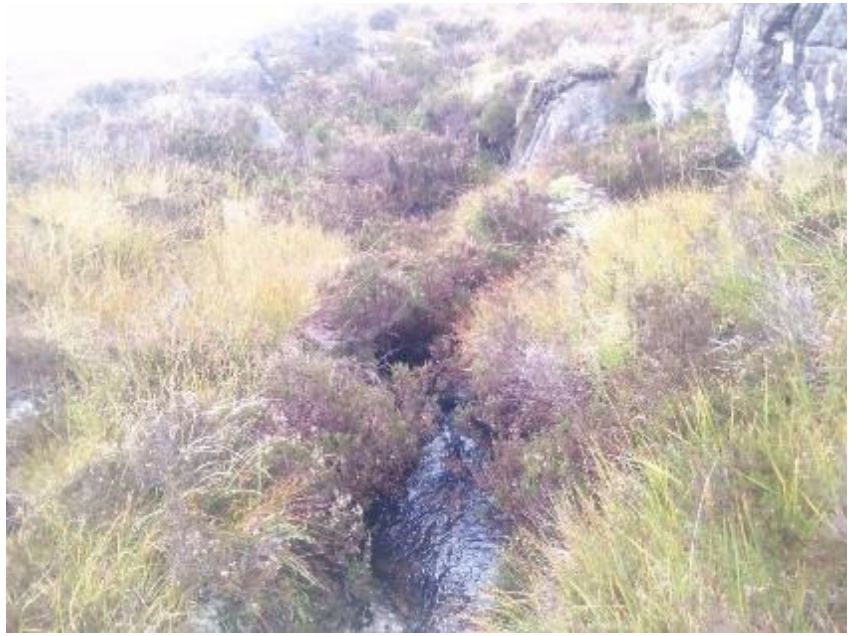
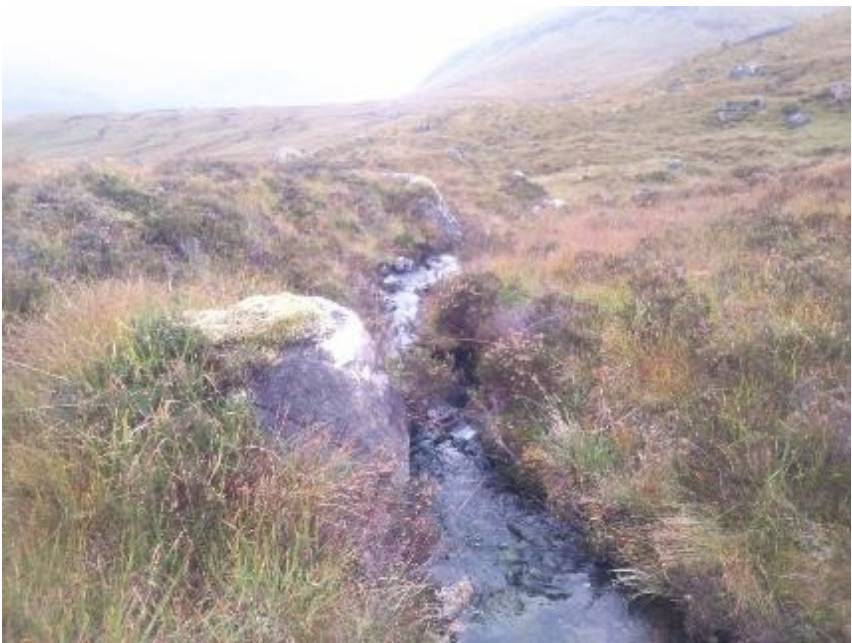
| Watercourse Crossing ID | WX05 |
|---|---|
| Watercourse Crossing Details | <b>Grid Reference:</b> E 204970 / N 803670<br><b>Status:</b> New<br><b>Watercourse Width:</b> 1.3 m<br><b>Watercourse Depth:</b> 0.5 m<br><b>Notes:</b> None. |

| Watercourse Crossing ID | WX05 |
|---|---|
| Potential Crossing Type<br>Likely Required CAR<br>Authorisation | Culvert<br>Registration |

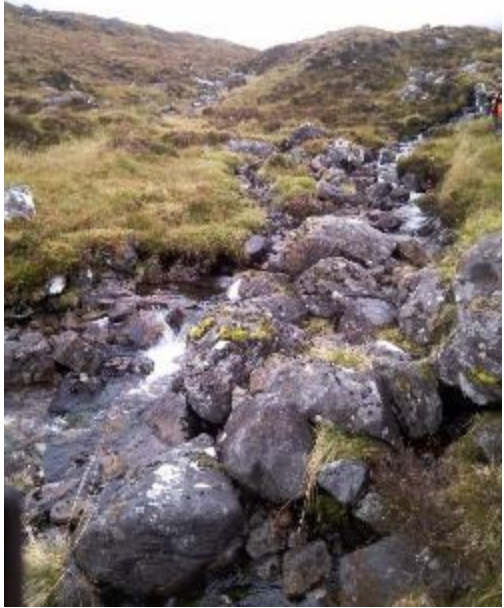
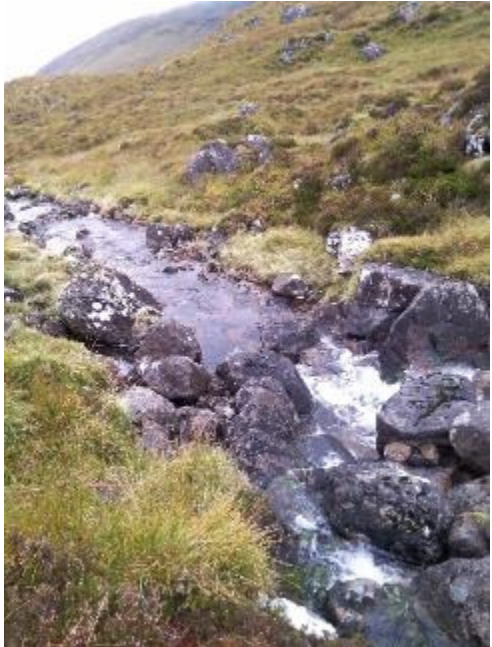
| Watercourse Crossing ID | WX06 |
|---|---|
| Watercourse Crossing Details | <p><b>Grid Reference:</b> E 204941 / N 803671</p> <p><b>Status:</b> New</p> <p><b>Watercourse Width:</b> 4 to 5 m</p> <p><b>Watercourse Depth:</b> 0.2 m</p> <p><b>Notes:</b> Incised in bedrock with large boulders in the channel and several small waterfalls.</p> |
| Photograph Looking Upstream | |
| Photograph Looking Downstream | |

| Watercourse Crossing ID | WX06 |
|---|---|
| Potential Crossing Type<br>Likely Required CAR Authorisation | Open span bridge or bottomless arch culvert<br>Licence |

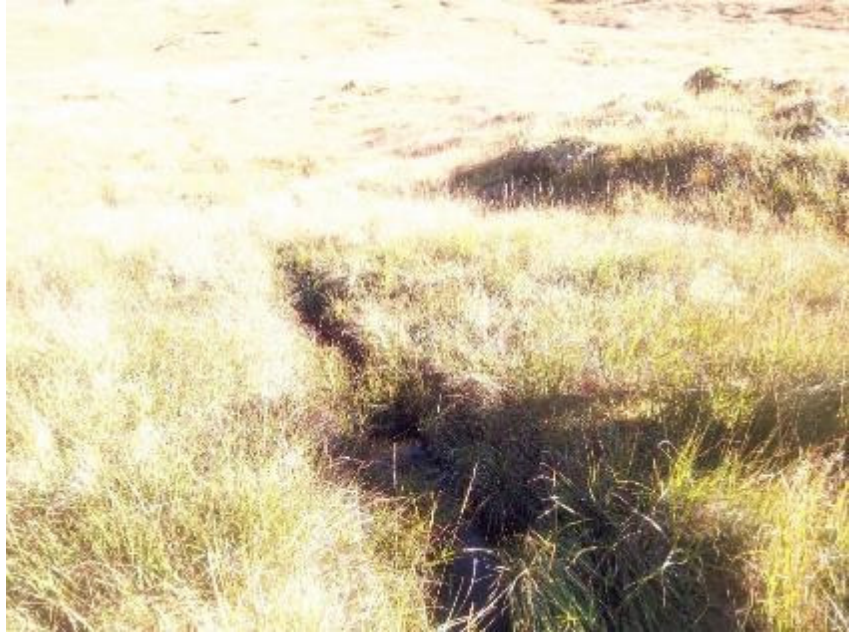
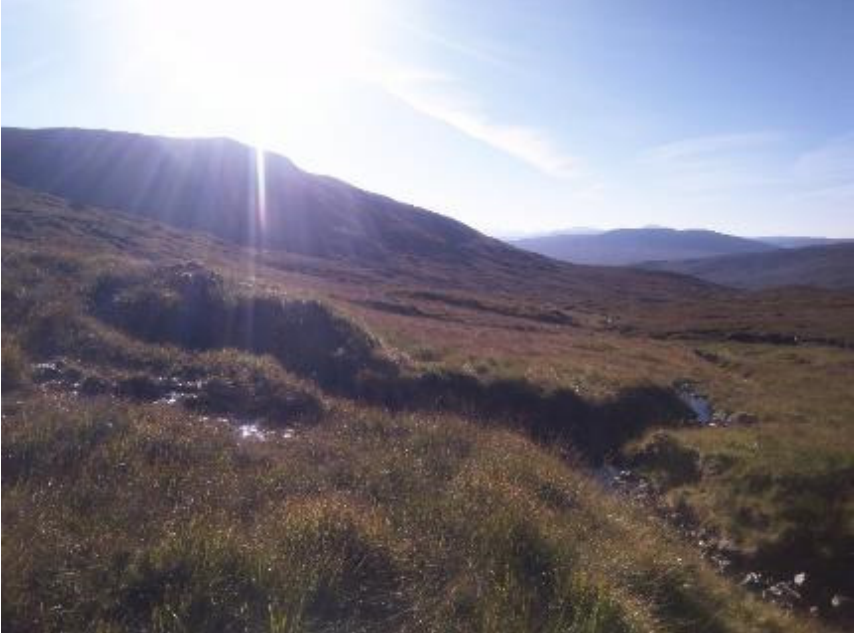
| Watercourse Crossing ID | WX07 |
|---|---|
| Watercourse Crossing Details | <p><b>Grid Reference:</b> E 204322 / N 803858</p> <p><b>Status:</b> New</p> <p><b>Watercourse Width:</b> 0.5 m</p> <p><b>Watercourse Depth:</b> 0.5 m</p> <p><b>Notes:</b> Located within an incised channel up to 1.3m deep which is incised in peat.</p> |

| Watercourse Crossing ID | WX07 |
|---|---|
| Potential Crossing Type<br>Likely Required CAR<br>Authorisation | <p>Culvert<br/>Registration</p> |

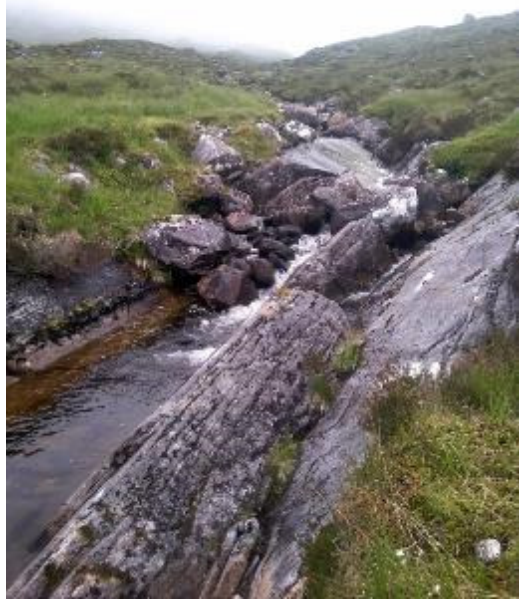
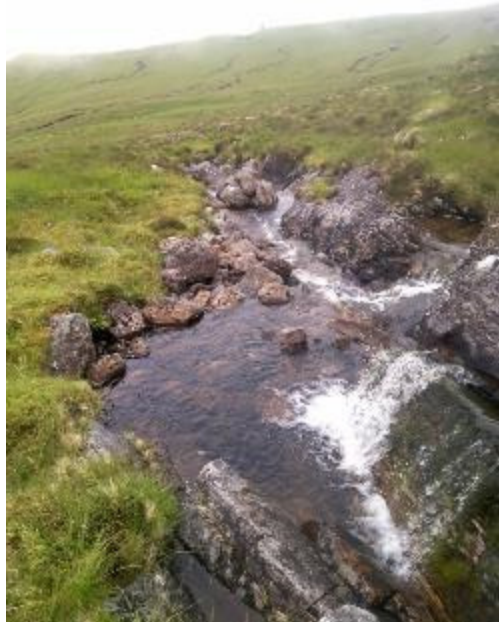
| Watercourse Crossing ID | WX08 |
|---|---|
| Watercourse Crossing Details | <p><b>Grid Reference:</b> E 204743 / N 803372</p> <p><b>Status:</b> New</p> <p><b>Watercourse Width:</b> 3 m</p> <p><b>Watercourse Depth:</b> 0.8 m</p> <p><b>Notes:</b> Incised in bedrock with large boulders in the channel and several small waterfalls.</p> |
| Photograph Looking Upstream | |
| Photograph Looking Downstream | |

| Watercourse Crossing ID | WX08 |
|---|---|
| Potential Crossing Type<br>Likely Required CAR Authorisation | Open span bridge or bottomless arch culvert<br>Licence |

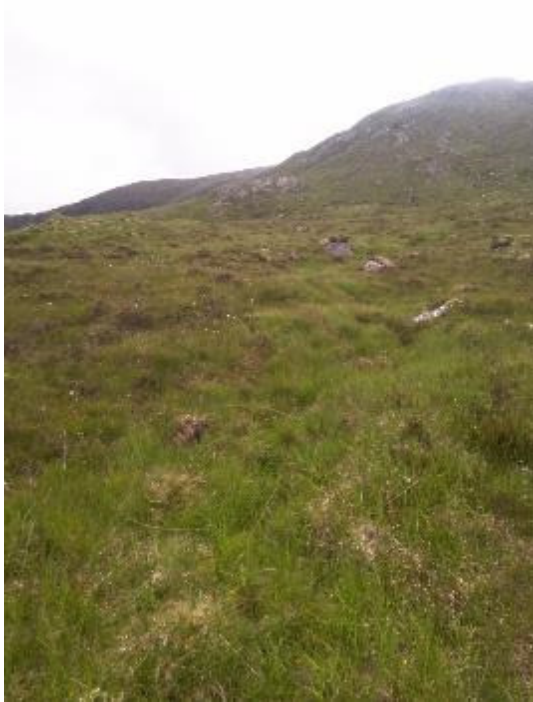
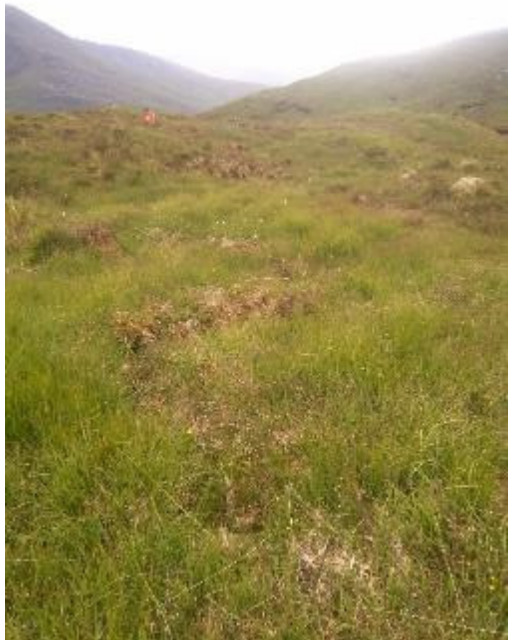
| Watercourse Crossing ID | WX09 |

| Watercourse Crossing ID | WX09 |
|---|---|
| Watercourse Crossing Details | <b>Grid Reference:</b> E 204722 / N 803096<br><b>Status:</b> New<br><b>Watercourse Width:</b> 0.4 m<br><b>Watercourse Depth:</b> 0.3 m<br><b>Notes:</b> Small watercourse with grasses. |
| Photograph Looking Upstream | |
| Photograph Looking Downstream | |

| Watercourse Crossing ID | WX09 |
|---|---|
| Potential Crossing Type<br>Likely Required CAR Authorisation | Culvert<br>Registration |

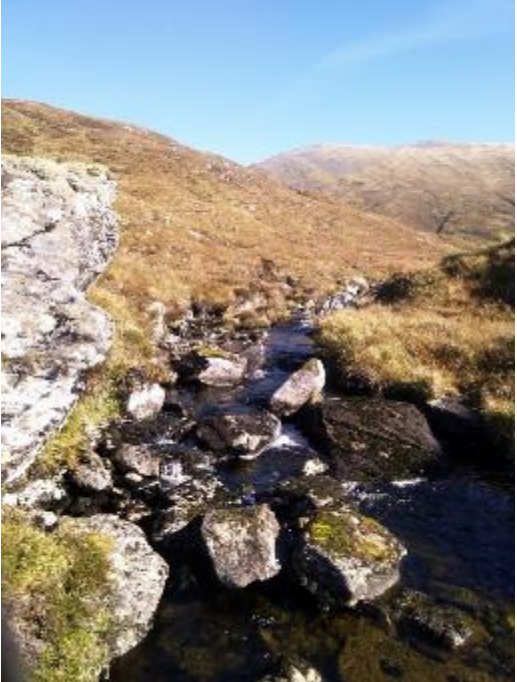
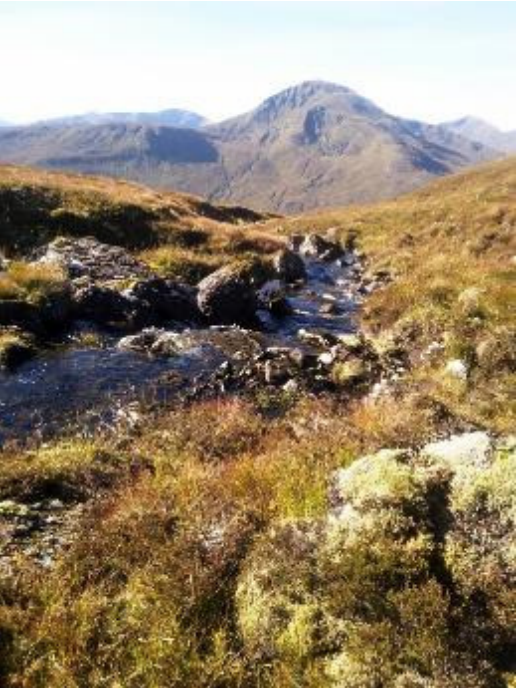
| Watercourse Crossing ID | WX10 |
|---|---|
| Watercourse Crossing Details | <p><b>Grid Reference:</b> E 205266 / N 802901</p> <p><b>Status:</b> New</p> <p><b>Watercourse Width:</b> 2 m</p> <p><b>Watercourse Depth:</b> 0.2 m</p> <p><b>Notes:</b> Incised in bedrock and large boulders noted in channel.</p> |

| Watercourse Crossing ID | WX10 |
|---|---|
| <p>Potential Crossing Type</p> <p>Likely Required CAR Authorisation</p> | <p>Open span bridge or bottomless arch culvert</p> <p>Licence</p> |

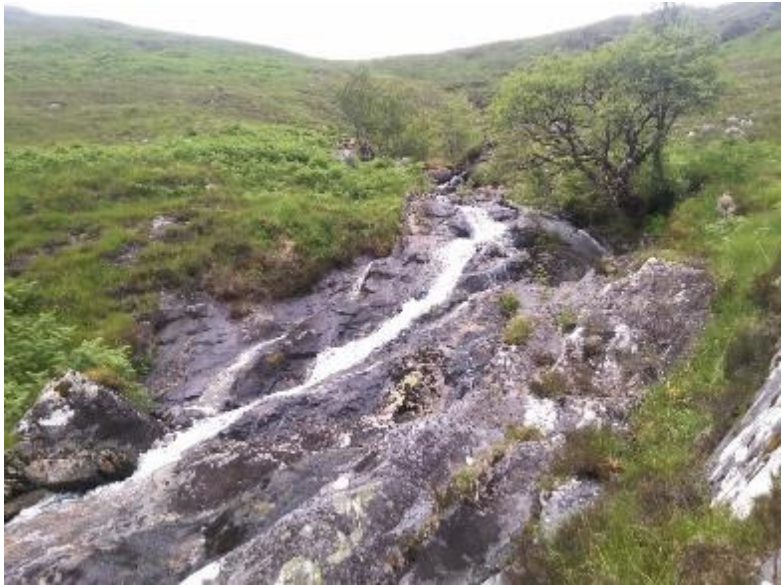
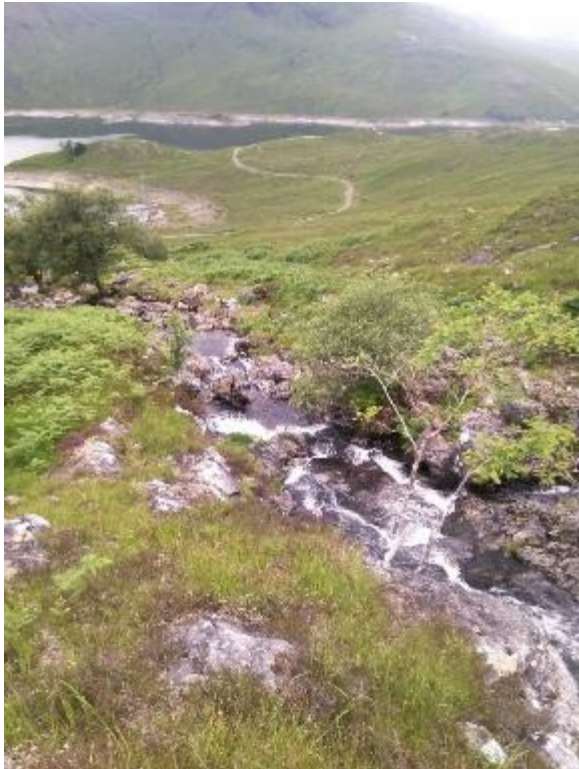
| Watercourse Crossing ID | WX11 |
|---|---|
| Watercourse Crossing Details | <p><b>Grid Reference:</b> E 204942 / N 802437</p> <p><b>Status:</b> New</p> <p><b>Watercourse Width:</b> 3 to 5 m</p> <p><b>Watercourse Depth:</b> 0.5 m</p> <p><b>Notes:</b> Incised in bedrock.</p> |

| Watercourse Crossing ID | WX11 |
|---|---|
| Potential Crossing Type<br>Likely Required CAR<br>Authorisation | Open span bridge or bottomless arch culvert<br>Licence |

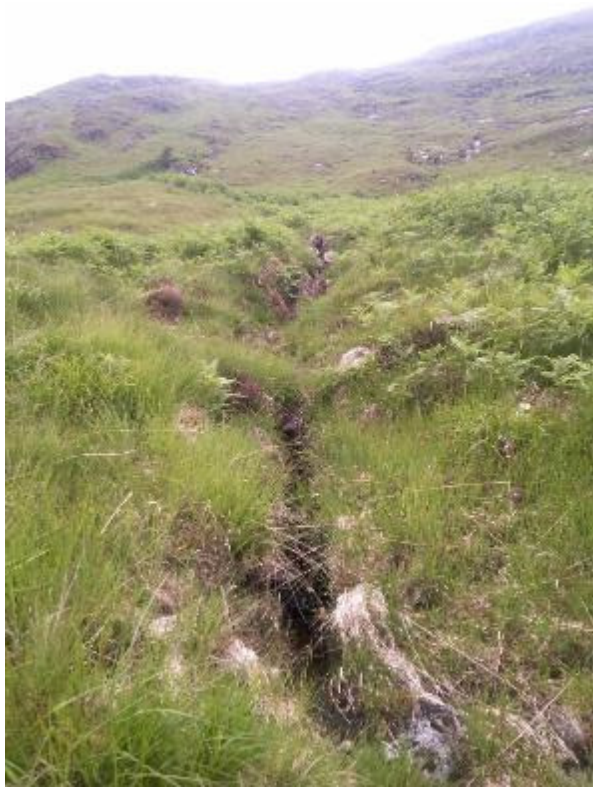
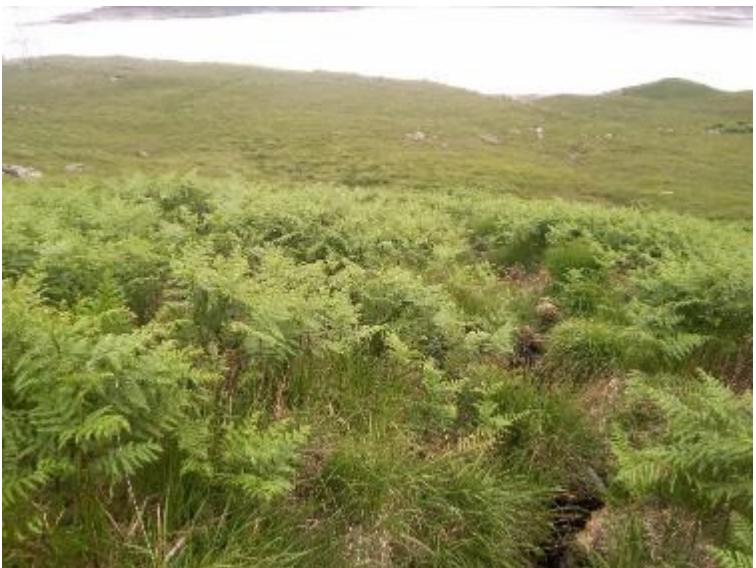
| Watercourse Crossing ID | WX12 |
|---|---|
| Watercourse Crossing Details | <b>Grid Reference:</b> E 205226 / N 802248<br><b>Status:</b> New<br><b>Watercourse Width:</b> 0.5 m<br><b>Watercourse Depth:</b> 0.2 m<br><b>Notes:</b> None. |

| Watercourse Crossing ID | WX12 |
|---|---|
| Potential Crossing Type<br>Likely Required CAR Authorisation | Culvert<br>Registration |

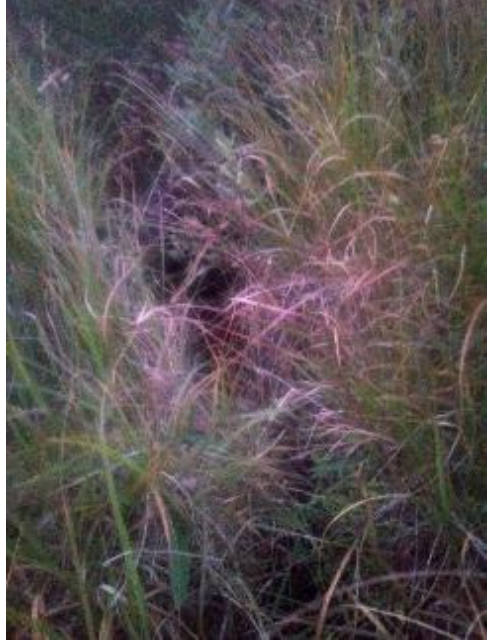
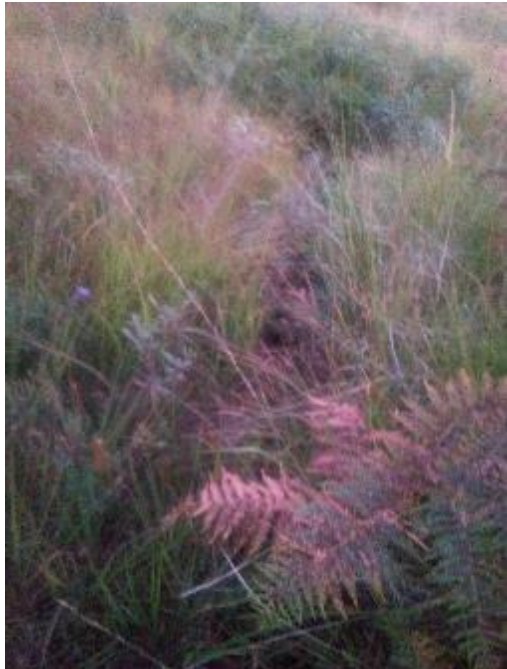
| Watercourse Crossing ID | WX13 |

| Watercourse Crossing ID | WX13 |
|---|---|
| Watercourse Crossing Details | <b>Grid Reference:</b> E 205449 / N 802079<br><b>Status:</b> New<br><b>Watercourse Width:</b> 0.2 m<br><b>Watercourse Depth:</b> 0.1 m<br><b>Notes:</b> Small watercourse which was heavily vegetated during the survey. |
| Photograph Looking Upstream | |
| Photograph Looking Downstream | |

| Watercourse Crossing ID | WX13 |
|---|---|
| Potential Crossing Type<br>Likely Required CAR Authorisation | Culvert<br>Registration |

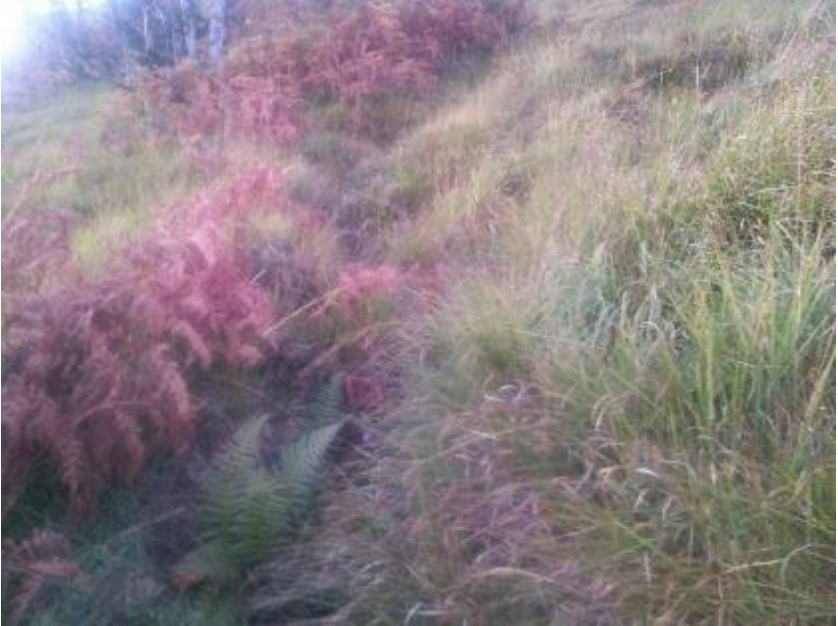
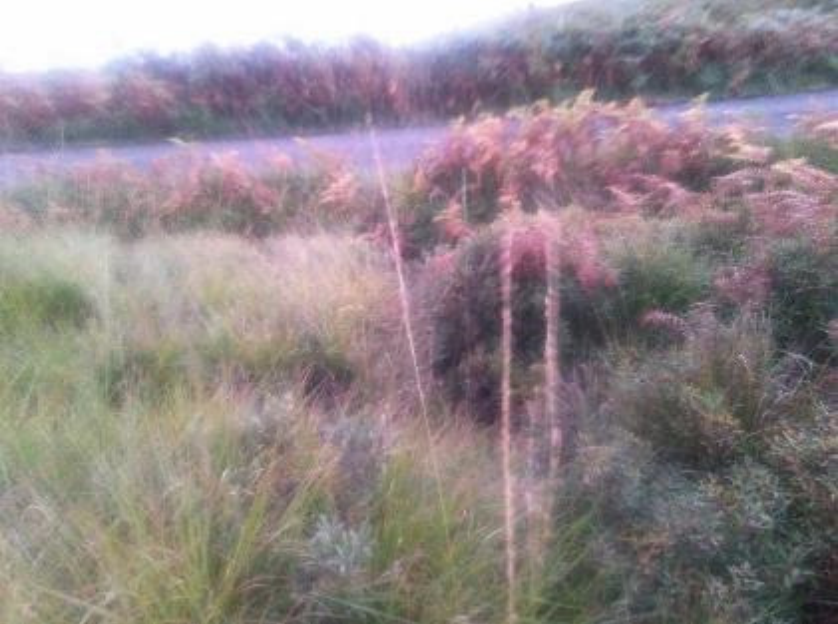
| Watercourse Crossing ID | WX14 |
|---|---|
| Watercourse Crossing Details | <p><b>Grid Reference:</b> E 205576 / N 802000</p> <p><b>Status:</b> New</p> <p><b>Watercourse Width:</b> 0.4 m</p> <p><b>Watercourse Depth:</b> 0.1 m</p> <p><b>Notes:</b> Small watercourse which was heavily vegetated during the survey.</p> |

| Watercourse Crossing ID | WX14 |
|---|---|
| Potential Crossing Type Likely Required CAR Authorisation | Culvert<br>Registration |

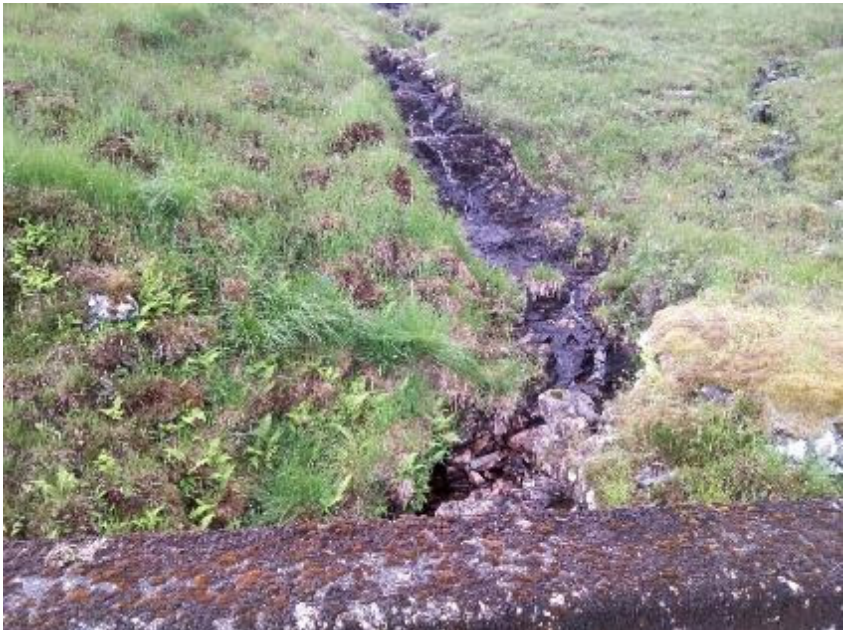
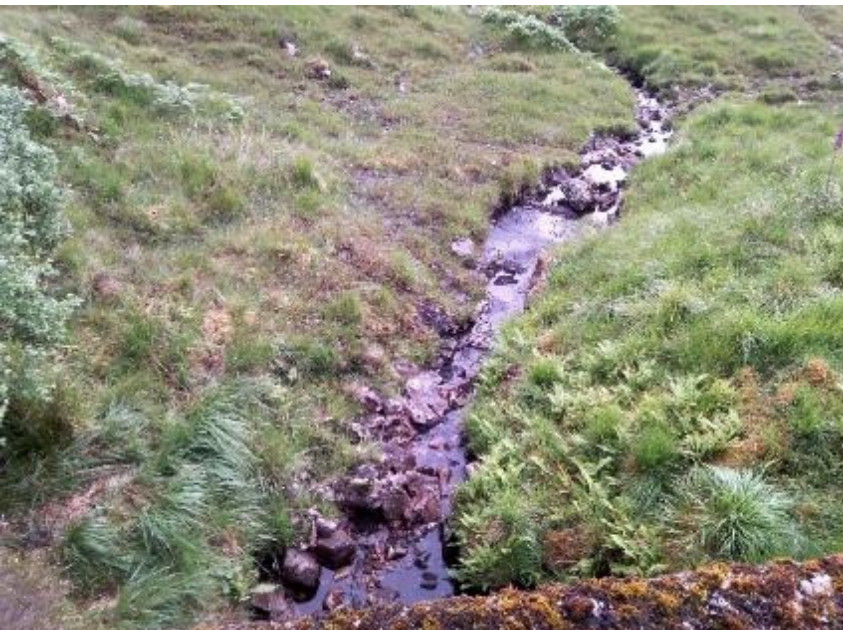
| Watercourse Crossing ID | WX15 |
|---|---|
| Watercourse Crossing Details | <p><b>Grid Reference:</b> E 206247/ N 802145</p> <p><b>Status:</b> Existing</p> <p><b>Crossing Type:</b> Stone bridge</p> <p><b>Crossing Size:</b> up to 3 m wide</p> <p><b>Watercourse Width:</b> 1.2 m</p> <p><b>Watercourse Depth:</b> 0.1 m</p> <p><b>Notes:</b> None.</p> |

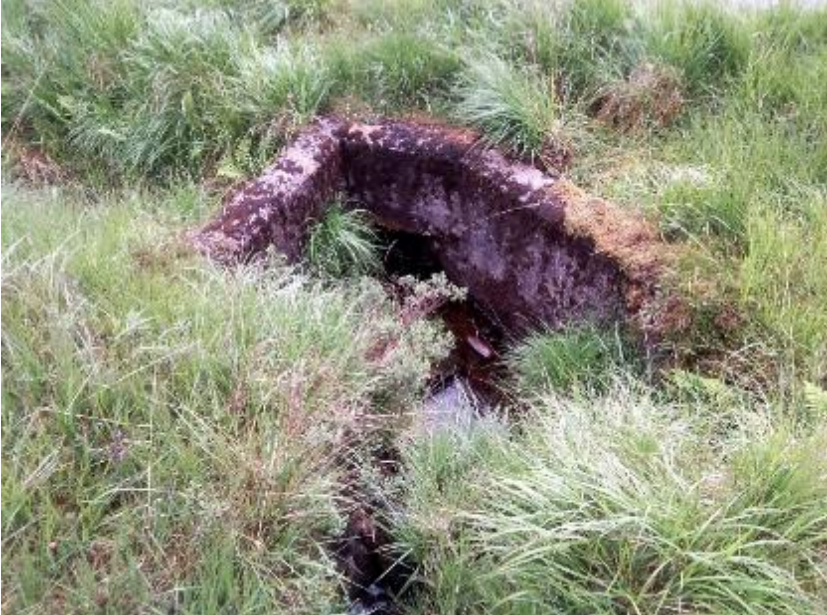
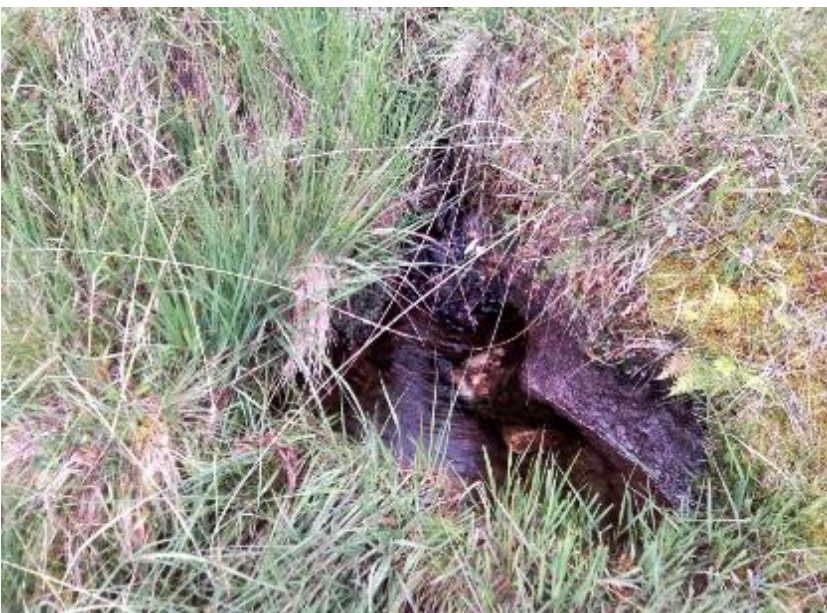
| Watercourse Crossing ID | WX16 |
|---|---|
| Watercourse Crossing Details | <p><b>Grid Reference:</b> E 206283 / N 802201</p> <p><b>Status:</b> Existing</p> <p><b>Crossing Type:</b> Circular culvert</p> <p><b>Crossing Size:</b> 0.3 m diameter</p> <p><b>Watercourse Width:</b> 0.3 m</p> <p><b>Watercourse Depth:</b> 0.3 m</p> <p><b>Notes:</b> Culvert entrance reinforced with concrete headwall. Small watercourse which was heavily vegetated during survey.</p> |

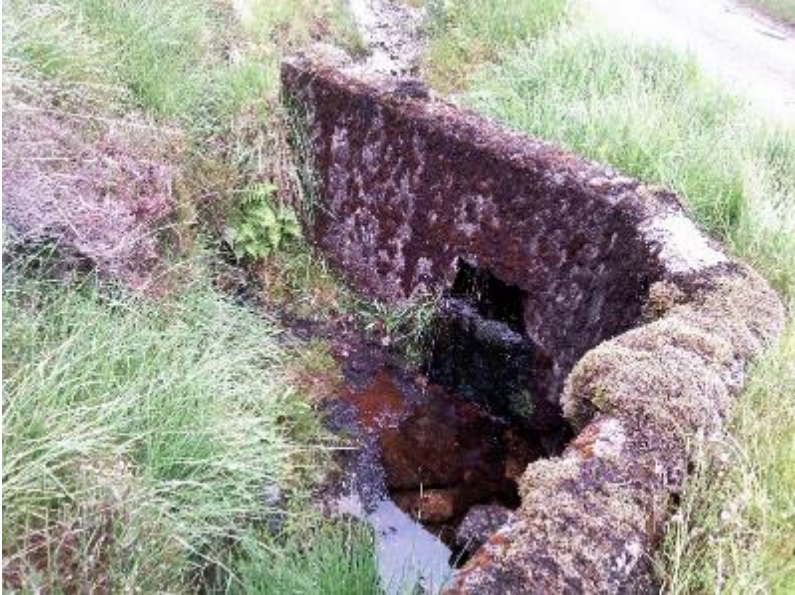
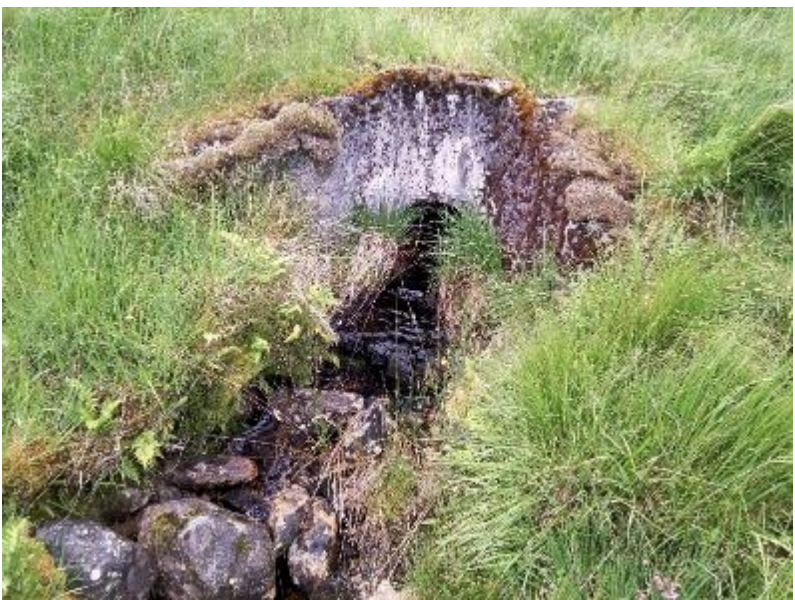
| Watercourse Crossing ID | WX17 |
|---|---|
| Watercourse Crossing Details | <p><b>Grid Reference:</b> E 206316 / N 802219</p> <p><b>Status:</b> Existing</p> <p><b>Crossing Type:</b> Circular culvert</p> <p><b>Crossing Size:</b> 0.3 m diameter</p> <p><b>Watercourse Width:</b> 0.4 m</p> <p><b>Watercourse Depth:</b> 0.1 m</p> <p><b>Notes:</b> Culvert entrance and exit reinforced with concrete headwall.</p> |

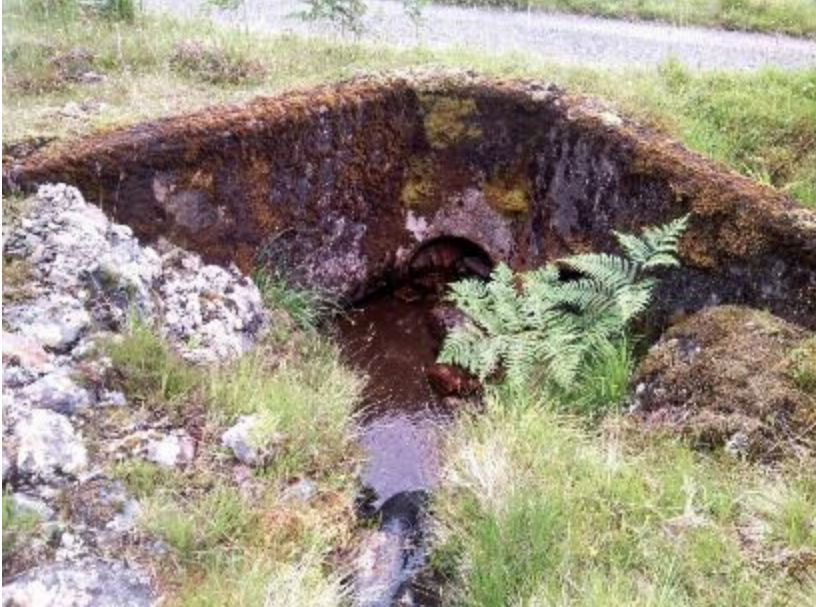
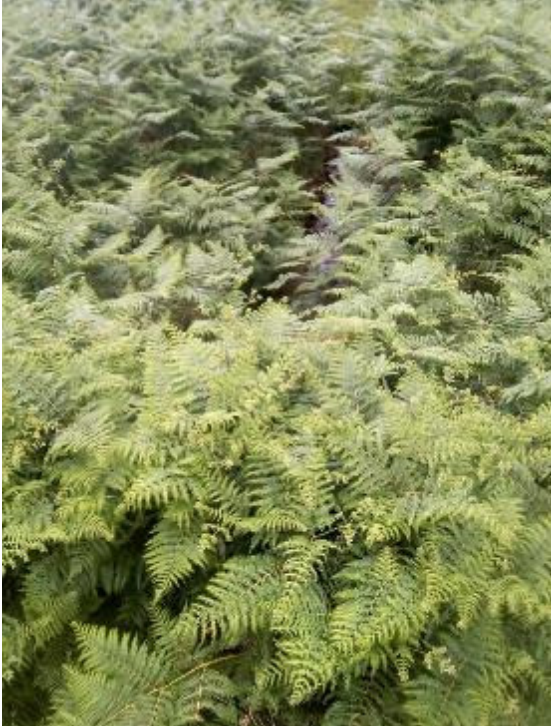
| Watercourse Crossing ID | WX18 |
|---|---|
| Watercourse Crossing Details | <p><b>Grid Reference:</b> E 206422 / N 802269</p> <p><b>Status:</b> Existing</p> <p><b>Crossing Type:</b> Circular culvert</p> <p><b>Crossing Size:</b> 0.3 m diameter</p> <p><b>Watercourse Width:</b> 0.1 m</p> <p><b>Watercourse Depth:</b> 0.3 m</p> <p><b>Notes:</b> Culvert exit and watercourse downstream of road heavily vegetated with bracken. Culvert entrance reinforced with concrete headwall.</p> |

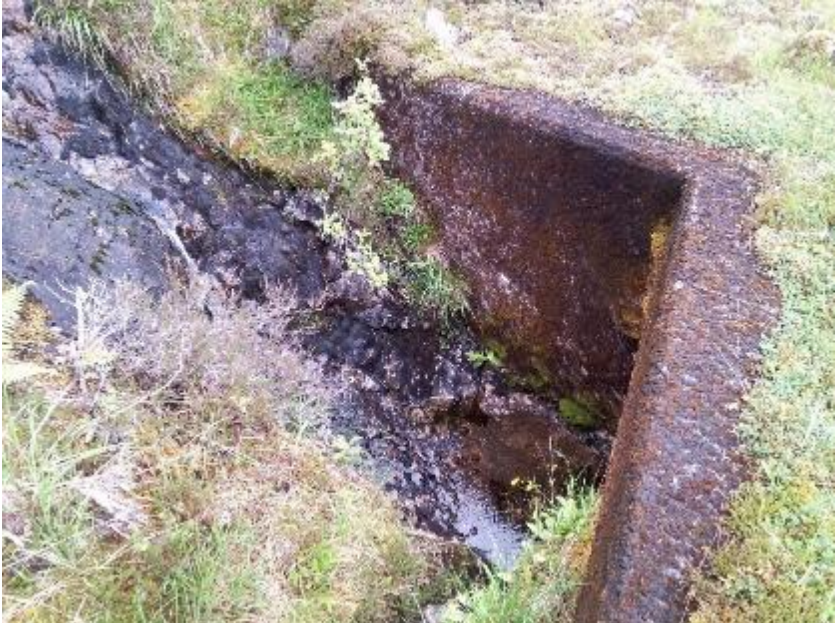
| Watercourse Crossing ID | WX19 |
|---|---|
| Watercourse Crossing Details | <p><b>Grid Reference:</b> E 206573 / N 802362</p> <p><b>Status:</b> Existing</p> <p><b>Crossing Type:</b> Unknown</p> <p><b>Crossing Size:</b> Unknown</p> <p><b>Watercourse Width:</b> 0.3 m</p> <p><b>Watercourse Depth:</b> 0.1 m</p> <p><b>Notes:</b> Watercourse heavily vegetated so unable to access.</p> |

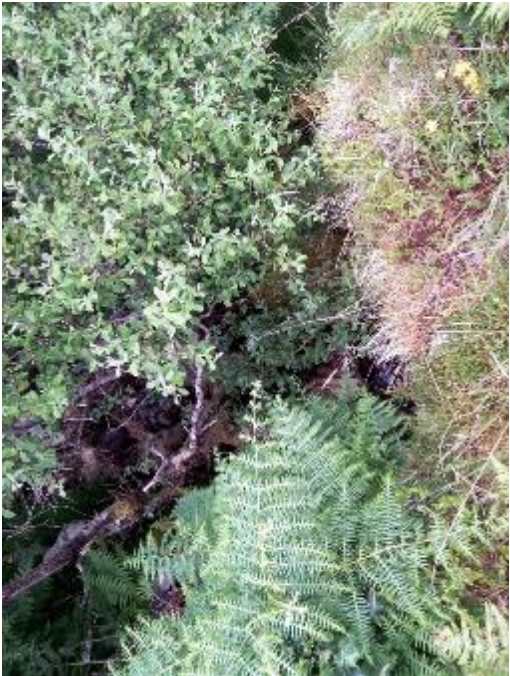
| Watercourse Crossing ID | WX19 |
|---|---|
| Photograph of Culvert Exit from Downstream | <p>A photograph showing the exit of a culvert from a downstream perspective. The culvert is a dark, rectangular opening in a grassy bank. The surrounding area is covered in dense, low-lying vegetation and grass. The water level is visible just inside the entrance.</p> |

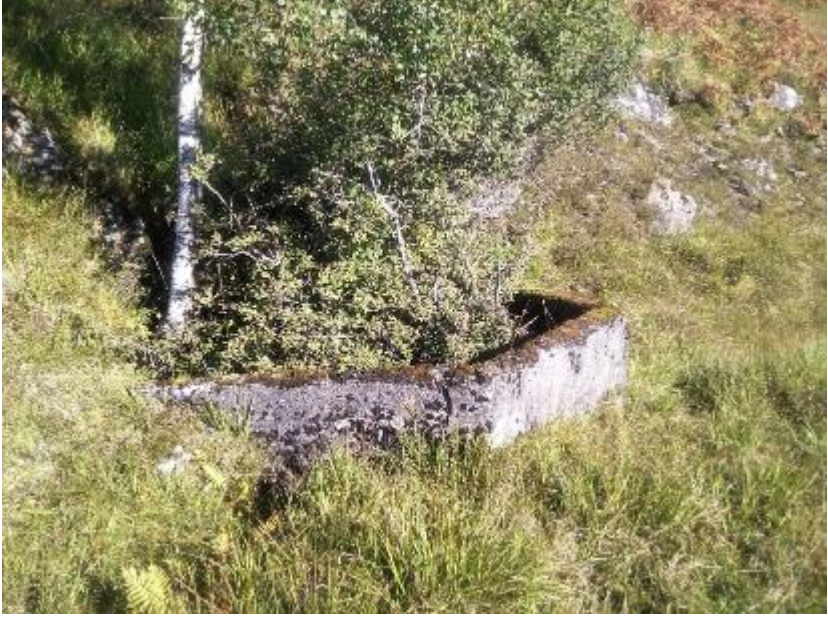
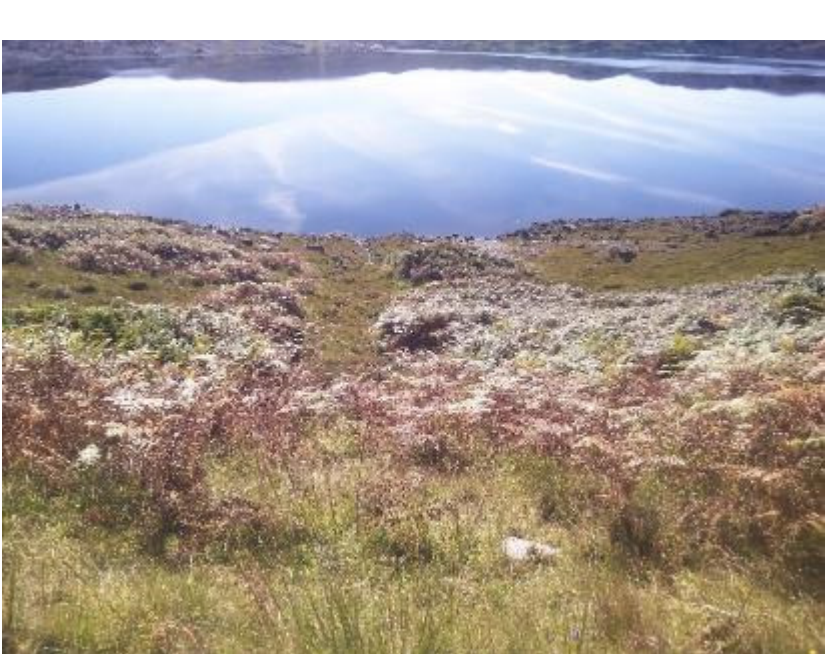
| Watercourse Crossing ID | WX20 |
|---|---|
| Watercourse Crossing Details | <p><b>Grid Reference:</b> E 206651 / N 802403</p> <p><b>Status:</b> Existing</p> <p><b>Crossing Type:</b> Unknown</p> <p><b>Crossing Size:</b> Unknown</p> <p><b>Watercourse Width:</b> 0.5 m</p> <p><b>Watercourse Depth:</b> 0.1 m</p> <p><b>Notes:</b> Watercourse heavily vegetated so unable to survey existing crossing in detail.</p> |

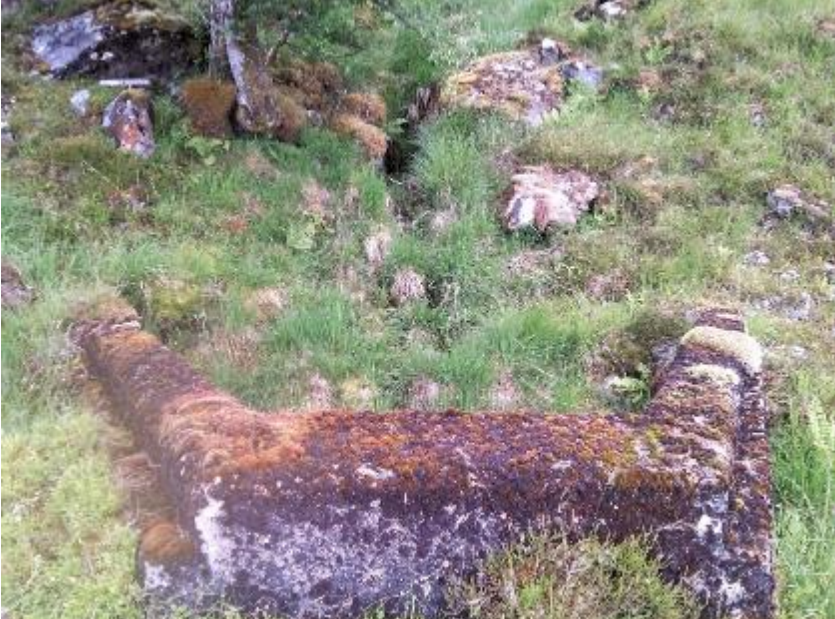
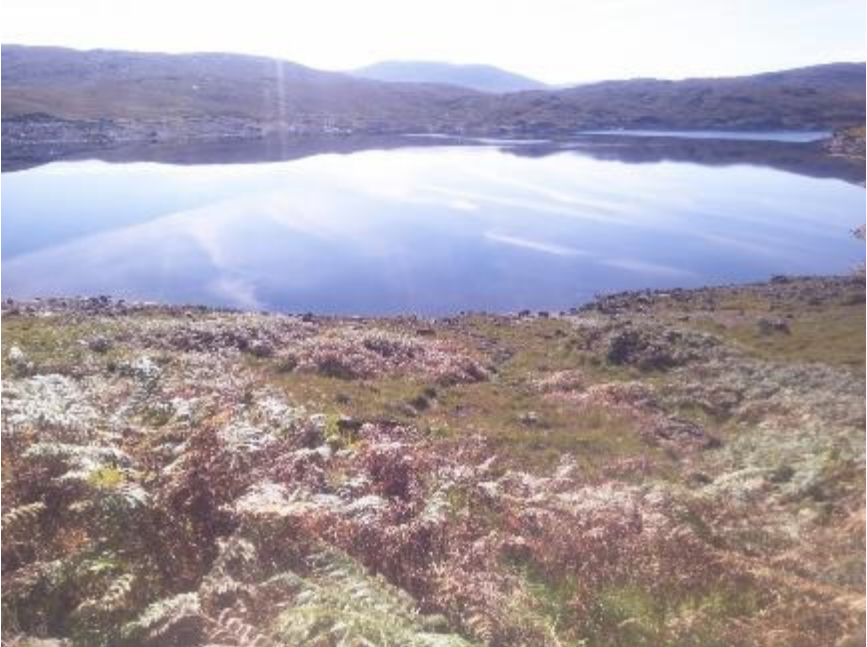
| Watercourse Crossing ID | WX21 |
|---|---|
| Watercourse Crossing Details | <p><b>Grid Reference:</b> E 206675 / N 802403</p> <p><b>Status:</b> Existing</p> <p><b>Crossing Type:</b> Circular culvert</p> <p><b>Crossing Size:</b> 0.5 m</p> <p><b>Watercourse Width:</b> 0.5 m</p> <p><b>Watercourse Depth:</b> 0.1 m</p> <p><b>Notes:</b> Culvert exit heavily vegetated.</p> |

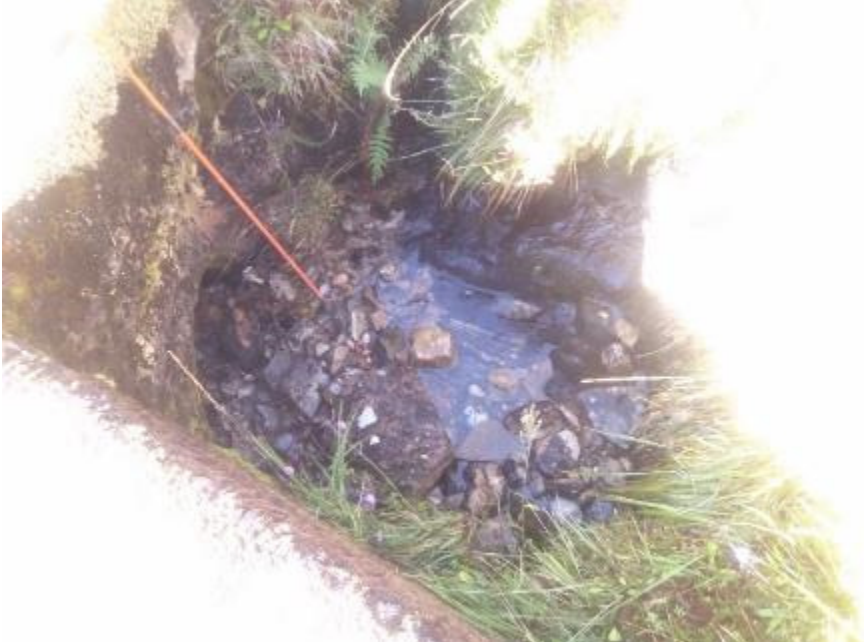
| Watercourse Crossing ID | WX22 |
|---|---|
| Watercourse Crossing Details | <p><b>Grid Reference:</b> E 206761 / N 802403</p> <p><b>Status:</b> Existing</p> <p><b>Crossing Type:</b> Circular culvert</p> <p><b>Crossing Size:</b> 0.4 m</p> <p><b>Watercourse Width:</b> 0.2 m</p> <p><b>Watercourse Depth:</b> 0.1 m</p> <p><b>Notes:</b> Culvert exit heavily vegetated. Culvert entrance partially blocked.</p> |

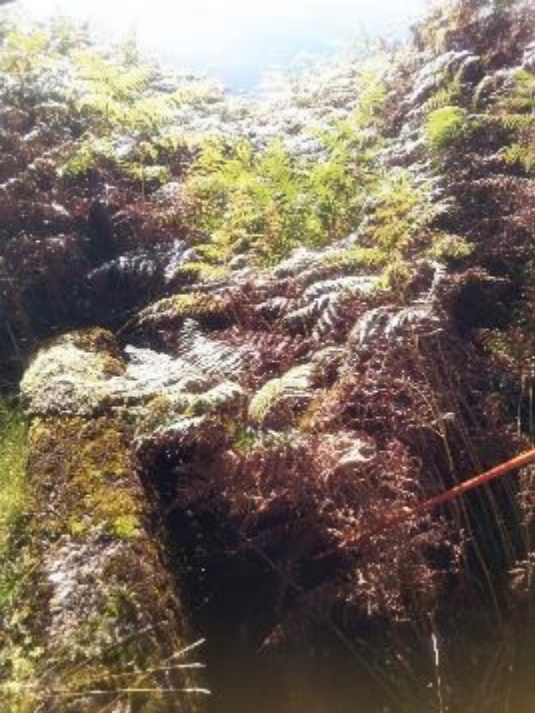
| Watercourse Crossing ID | WX22 |
|---|---|
| Photograph Looking Downstream | <p>A photograph looking downstream from the culvert exit. The view is dominated by dense, lush green vegetation, including ferns and moss, which appears to be growing over and around the culvert structure. A red surveying pole is visible on the right side of the frame.</p> |
