## **Fearna Pumped Storage Hydro Scheme EIA Report**

### **Appendix 12.4 – Schedule of Water Crossings**

**February 2025**

## Fearna Pumped Storage Hydro Project

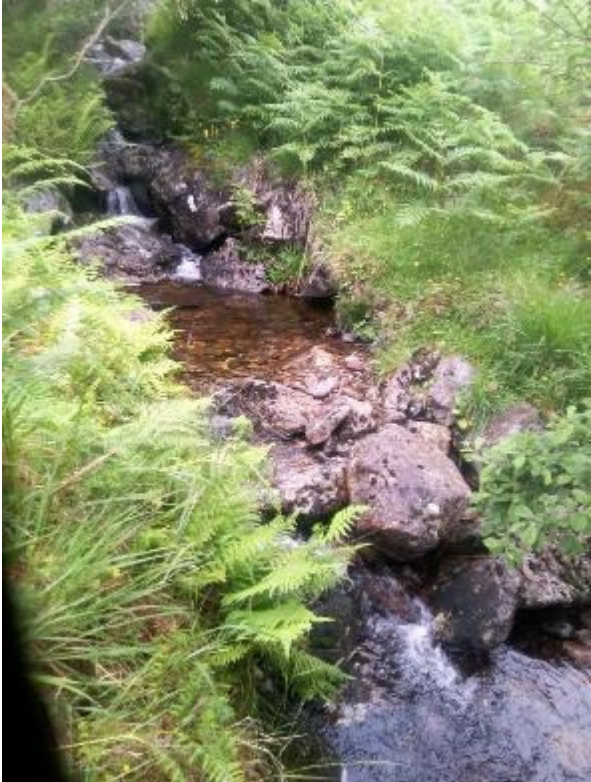
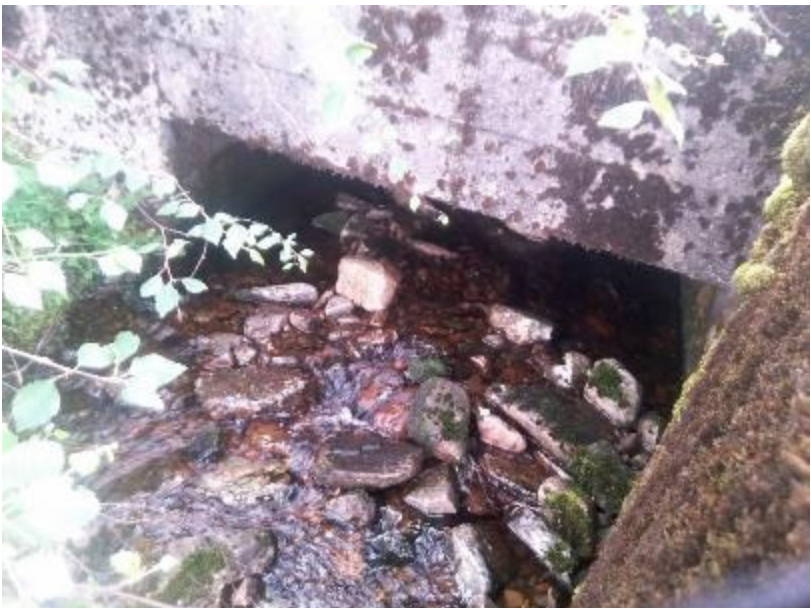
| Watercourse Crossing ID | WX23 |
|---|---|
| Watercourse Crossing Details | <p><b>Grid Reference:</b> E 206793 / N 802400</p> <p><b>Status:</b> Existing</p> <p><b>Crossing Type:</b> Open span rectangular culvert</p> <p><b>Crossing Size:</b> 0.5 m width</p> <p><b>Watercourse Width:</b> 0.5 to 2 m</p> <p><b>Watercourse Depth:</b> 0.5 m</p> <p><b>Notes:</b> Culvert entrance partially blocked.</p> |

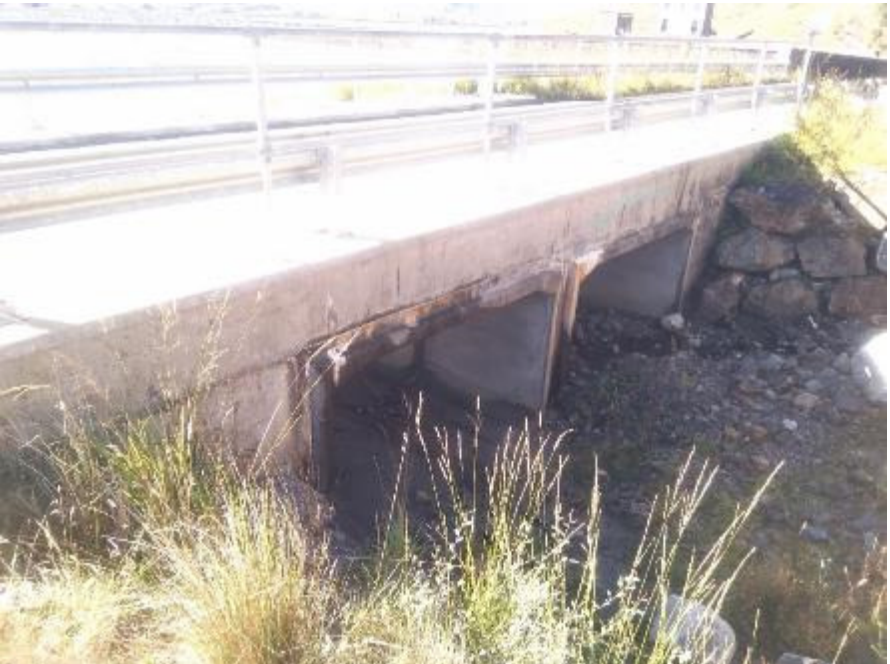
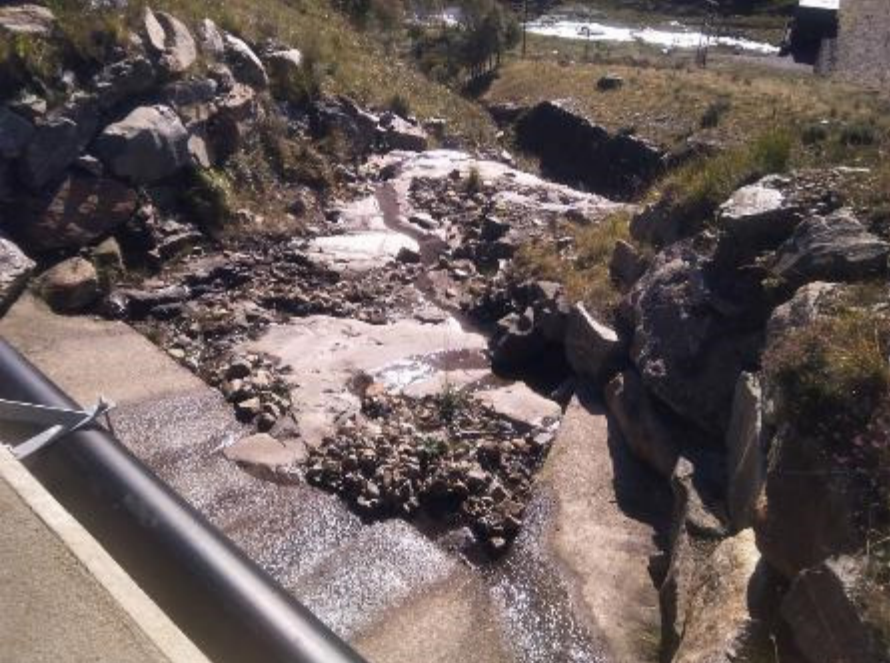
| Watercourse Crossing ID | WX24 |
|---|---|
| Watercourse Crossing Details | <p><b>Grid Reference:</b> E 207058 / N 802481</p> <p><b>Status:</b> Existing</p> <p><b>Crossing Type:</b> Twin open box culverts</p> <p><b>Crossing Size:</b> 3 m wide each</p> <p><b>Watercourse Width:</b> 1 m</p> <p><b>Watercourse Depth:</b> 0.1 m</p> <p><b>Notes:</b> Watercourse incised in bedrock and is located within a wider channel which is approximately 7 m wide. Channel affected by historic rockfall.</p> |

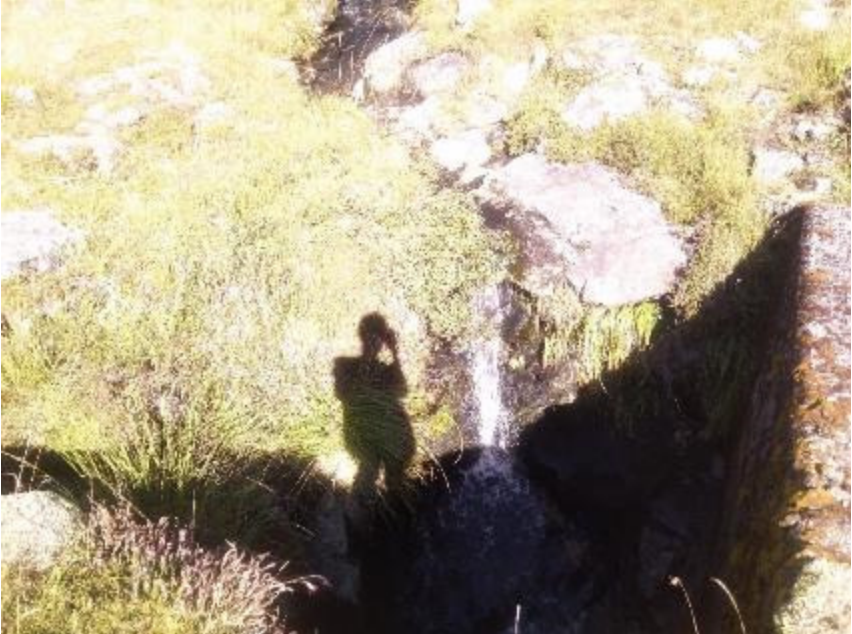
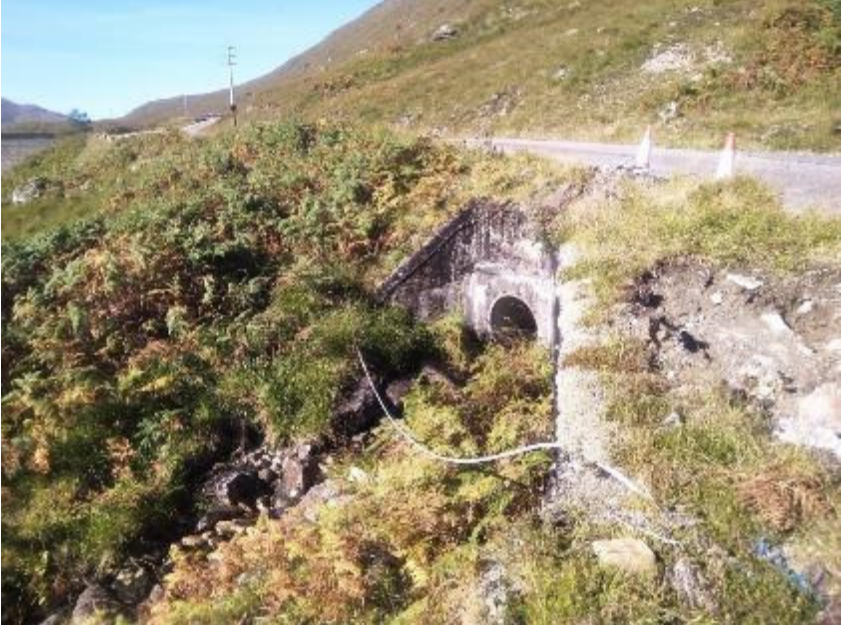
| Watercourse Crossing ID | WX25 |
|---|---|
| Watercourse Crossing Details | <p><b>Grid Reference:</b> E 207216 / N 802508</p> <p><b>Status:</b> Existing</p> <p><b>Crossing Type:</b> Circular culvert</p> <p><b>Crossing Size:</b> 0.5 m diameter</p> <p><b>Watercourse Width:</b> 1.5 m</p> <p><b>Watercourse Depth:</b> 0.2 m</p> <p><b>Notes:</b> Watercourse slightly narrower upstream of crossing compared to downstream. Culvert exit reinforced with concrete headwall.</p> |

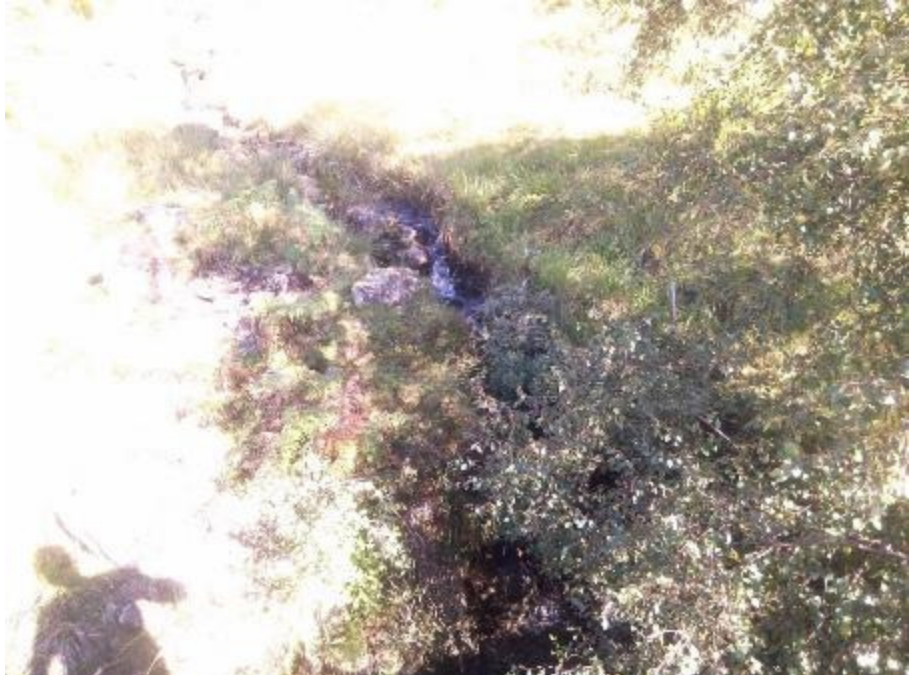
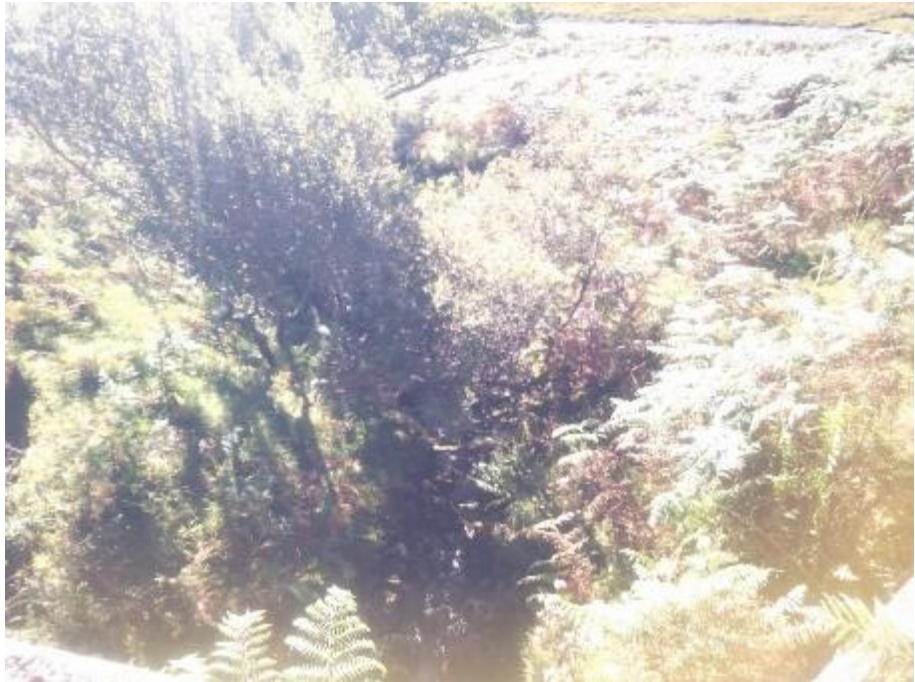
| Watercourse Crossing ID | WX26 |
|---|---|
| Watercourse Crossing Details | <p><b>Grid Reference:</b> E 207342 / N 802495</p> <p><b>Status:</b> Existing</p> <p><b>Crossing Type:</b> Unknown</p> <p><b>Crossing Size:</b> Unknown</p> <p><b>Watercourse Width:</b> 0.5 m</p> <p><b>Watercourse Depth:</b> 0.5 m</p> <p><b>Notes:</b> Culvert heavily vegetated so unable to access.</p> |

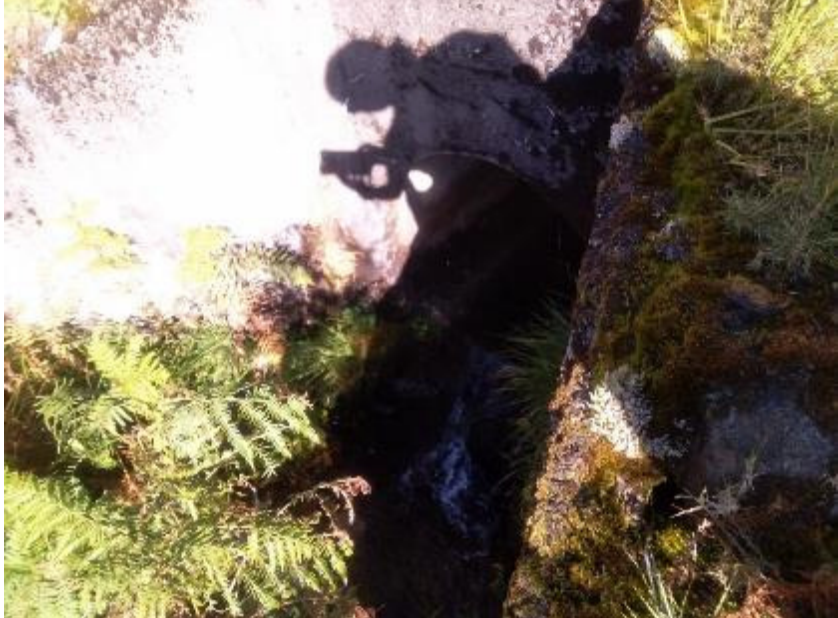
| Watercourse Crossing ID | WX27 |
|---|---|
| Watercourse Crossing Details | <p><b>Grid Reference:</b> E 207414 / N 802473</p> <p><b>Status:</b> Existing</p> <p><b>Crossing Type:</b> Circular culvert</p> <p><b>Crossing Size:</b> 0.7 m diameter</p> <p><b>Watercourse Width:</b> 1.3 m</p> <p><b>Watercourse Depth:</b> 0.2 m</p> <p><b>Notes:</b> None.</p> |

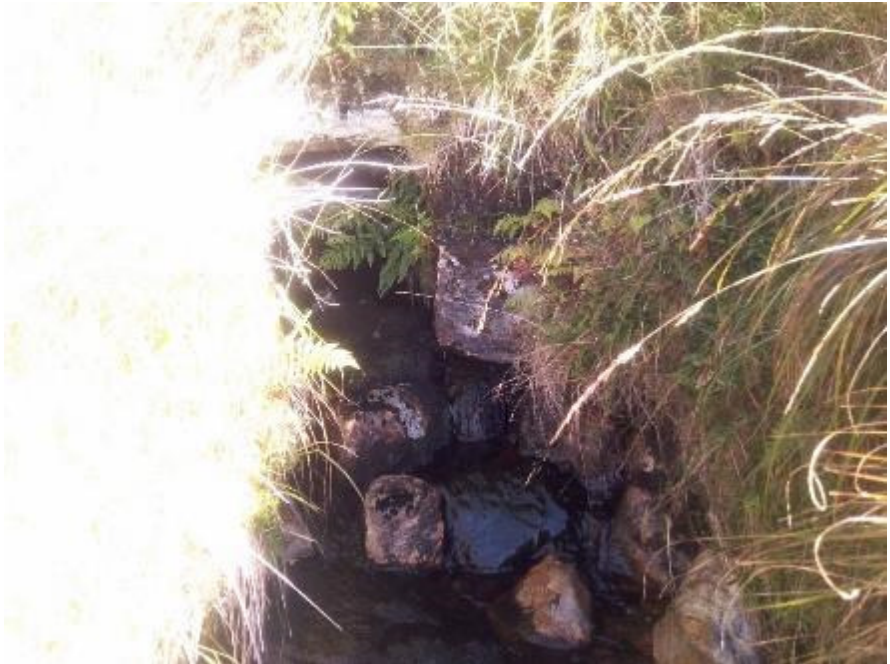
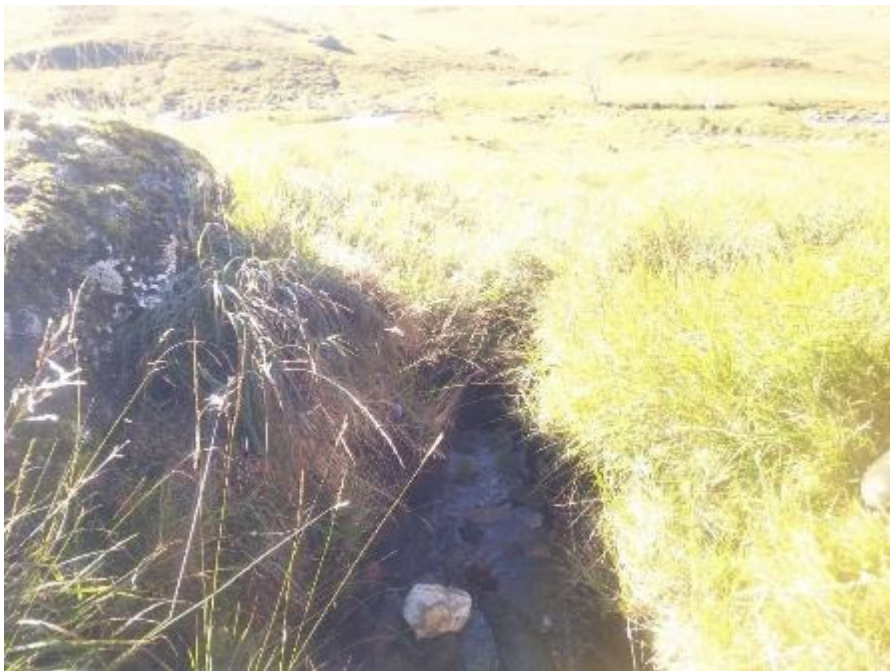
| Watercourse Crossing ID | WX28 |
|---|---|
| Watercourse Crossing Details | <p><b>Grid Reference:</b> E 207625 / N 802347</p> <p><b>Status:</b> Existing</p> <p><b>Crossing Type:</b> Open span box culvert</p> <p><b>Crossing Size:</b> 0.5 m wide</p> <p><b>Watercourse Width:</b> 1.1 m</p> <p><b>Watercourse Depth:</b> 0.2 m</p> <p><b>Notes:</b> None.</p> |

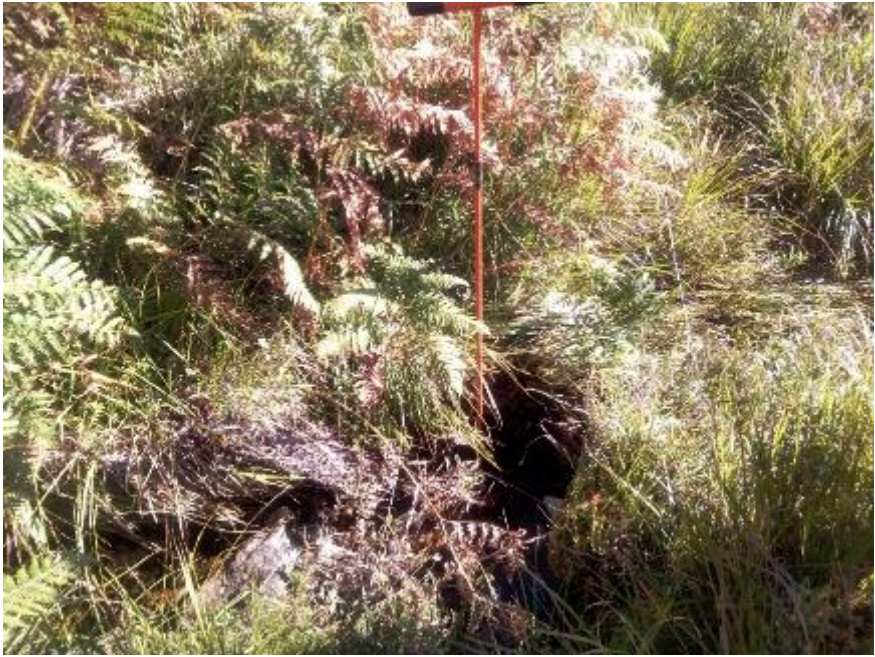
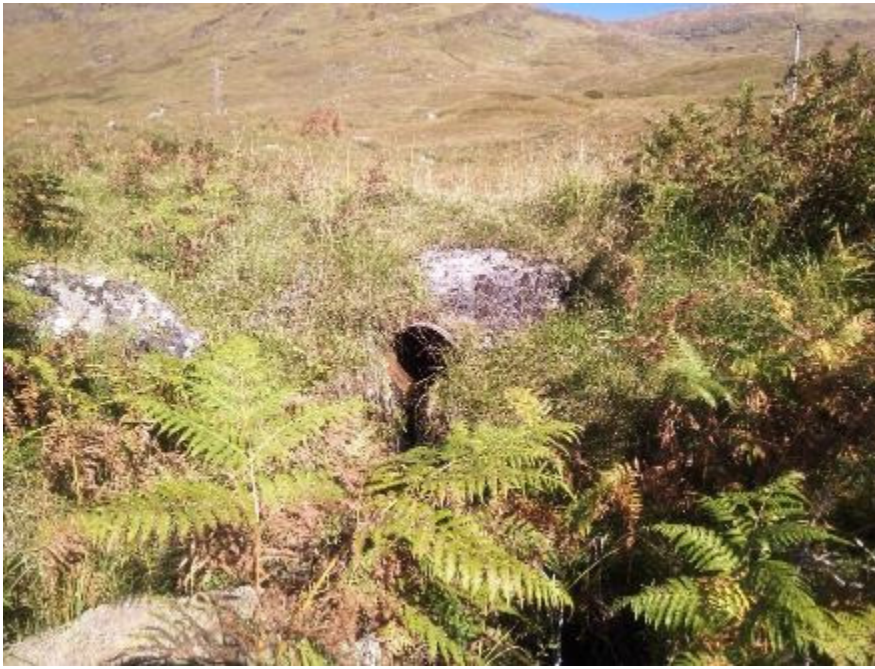
| Watercourse Crossing ID | WX29 |
|---|---|
| Watercourse Crossing Details | <p><b>Grid Reference:</b> E 207738 / N 802285</p> <p><b>Status:</b> Existing</p> <p><b>Crossing Type:</b> Circular culvert</p> <p><b>Crossing Size:</b> 0.4 m diameter</p> <p><b>Watercourse Width:</b> 0.6 m</p> <p><b>Watercourse Depth:</b> 0.1 m</p> <p><b>Notes:</b> Culvert entrance heavily vegetated.</p> |

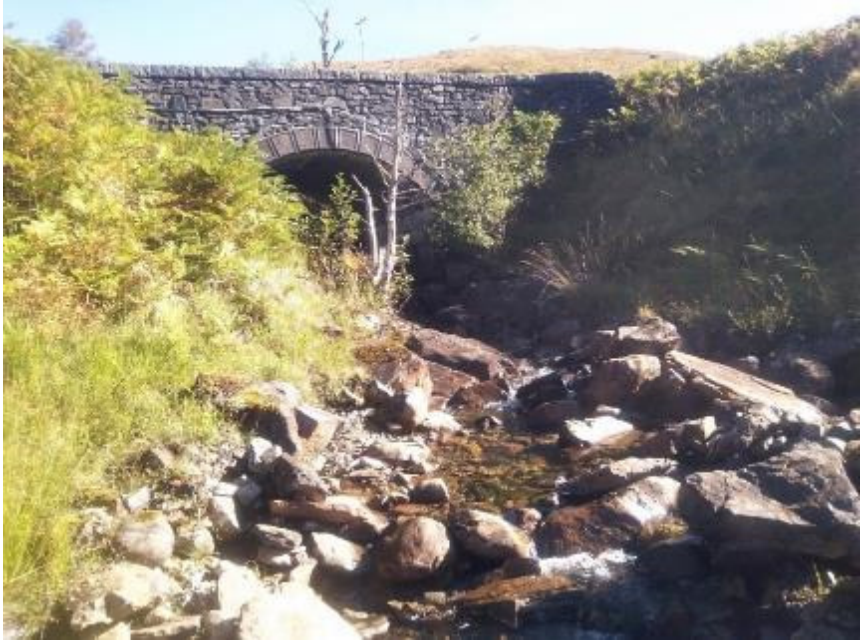
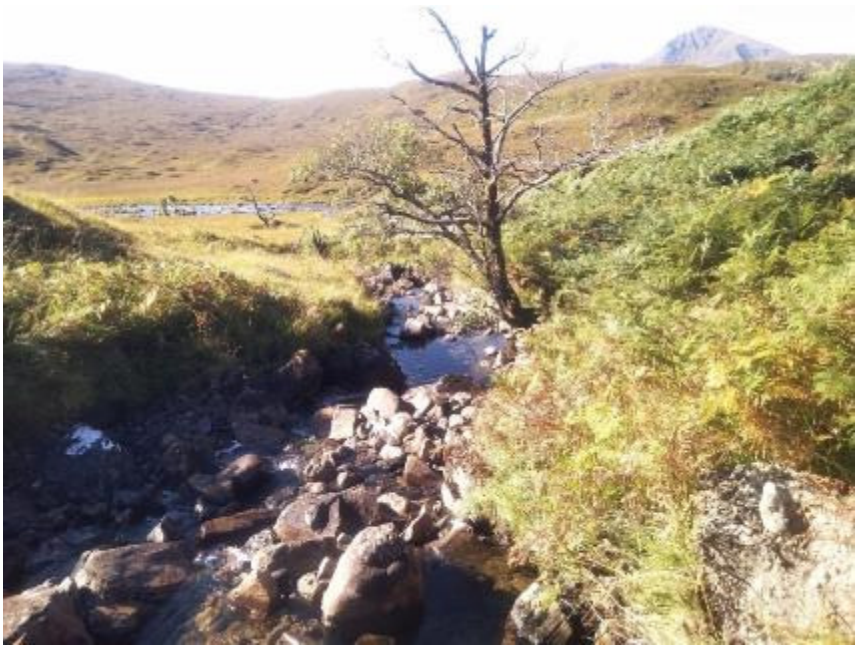
| Watercourse Crossing ID | WX30 |
|---|---|
| Watercourse Crossing Details | <p><b>Grid Reference:</b> E 207853 / N 802235</p> <p><b>Status:</b> New</p> <p><b>Watercourse Width:</b> 5 m</p> <p><b>Watercourse Depth:</b> 0.6 m</p> <p><b>Notes:</b> Watercourse incised in bedrock and is located within a wider channel which is approximately 2 m deep. Upstream crossing on existing road is an open span bridge approximately 20 m upstream.</p> |

| Watercourse Crossing ID | WX30 |
|---|---|
| Potential Crossing Type<br>Likely Required CAR<br>Authorisation | Open span bridge or culvert<br>Licence |

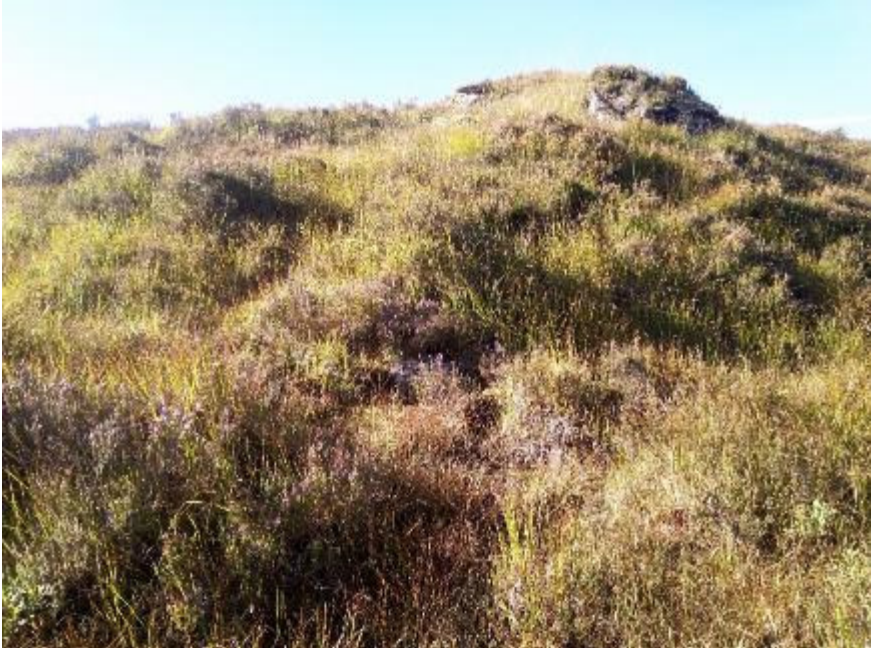
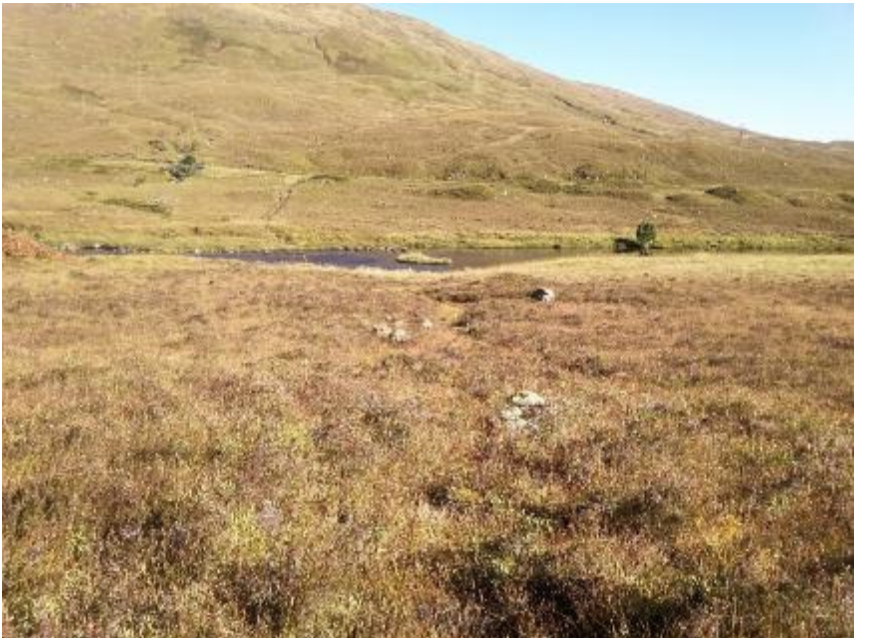
| Watercourse Crossing ID | WX32 |
|---|---|
| Watercourse Crossing Details | <p><b>Grid Reference:</b> E 208105 / N 801877</p> <p><b>Status:</b> New</p> <p><b>Watercourse Width:</b> 0.6 m</p> <p><b>Watercourse Depth:</b> 0.1 m</p> <p><b>Notes:</b> Small watercourse in grasses.</p> |

| Watercourse Crossing ID | WX32 |
|---|---|
| Potential Crossing Type Likely Required CAR Authorisation | <p>Culvert<br/>Registration</p> |

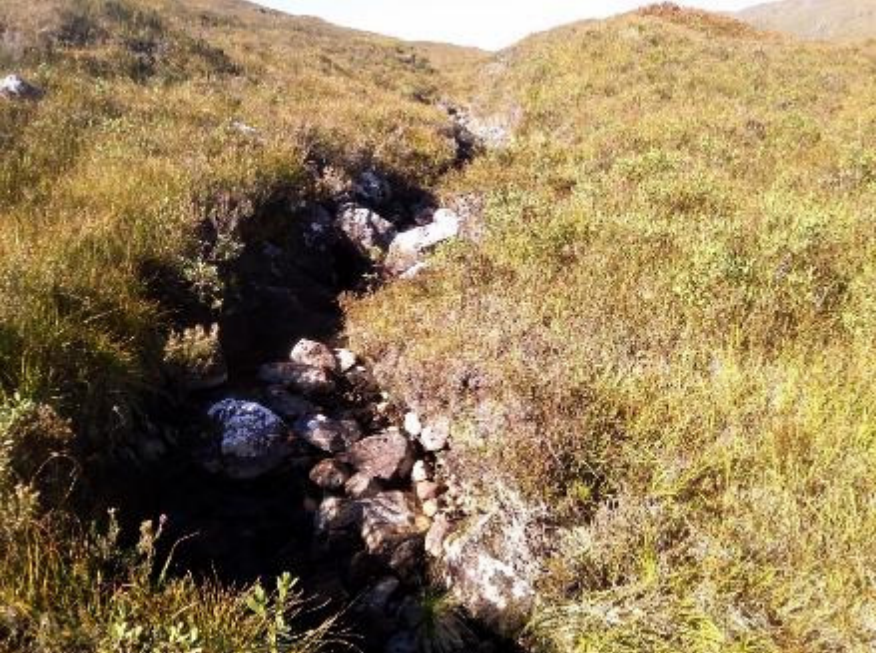
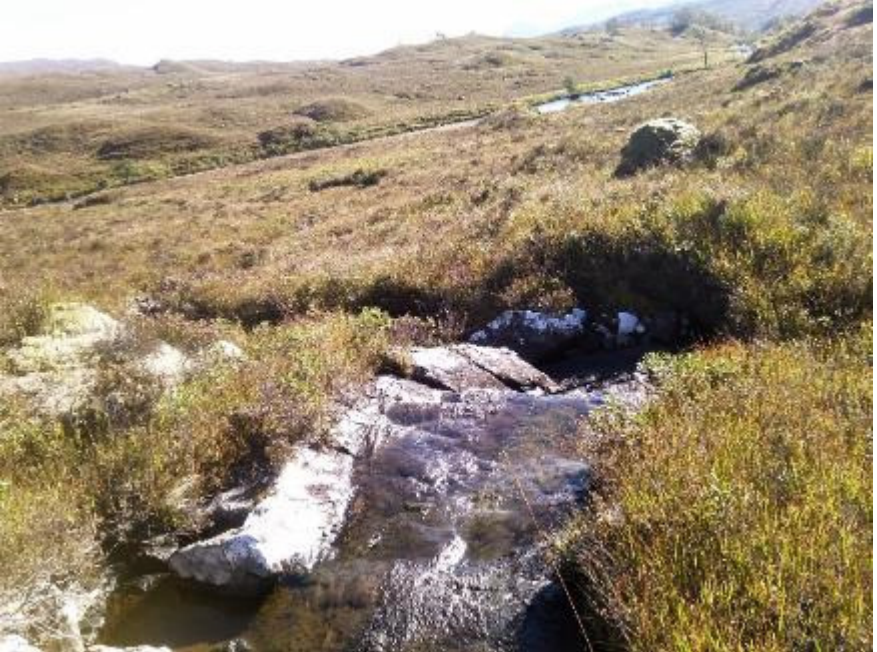
| Watercourse Crossing ID | WX33 |
|---|---|
| Watercourse Crossing Details | <p><b>Grid Reference:</b> E 208463 / N 801723</p> <p><b>Status:</b> New</p> <p><b>Watercourse Width:</b> 1.1 m</p> <p><b>Watercourse Depth:</b> 0.1 m</p> <p><b>Notes:</b> Watercourse incised in bedrock.</p> |

| Watercourse Crossing ID | WX33 |
|---|---|
| Potential Crossing Type<br>Likely Required CAR<br>Authorisation | <p>Open span bottomless arch culvert</p> <p>Registration</p> |

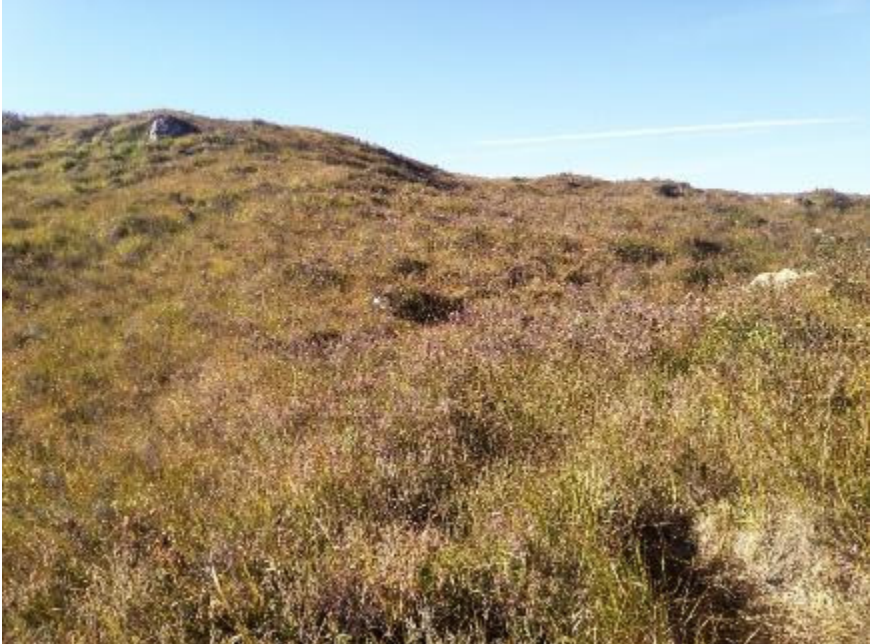
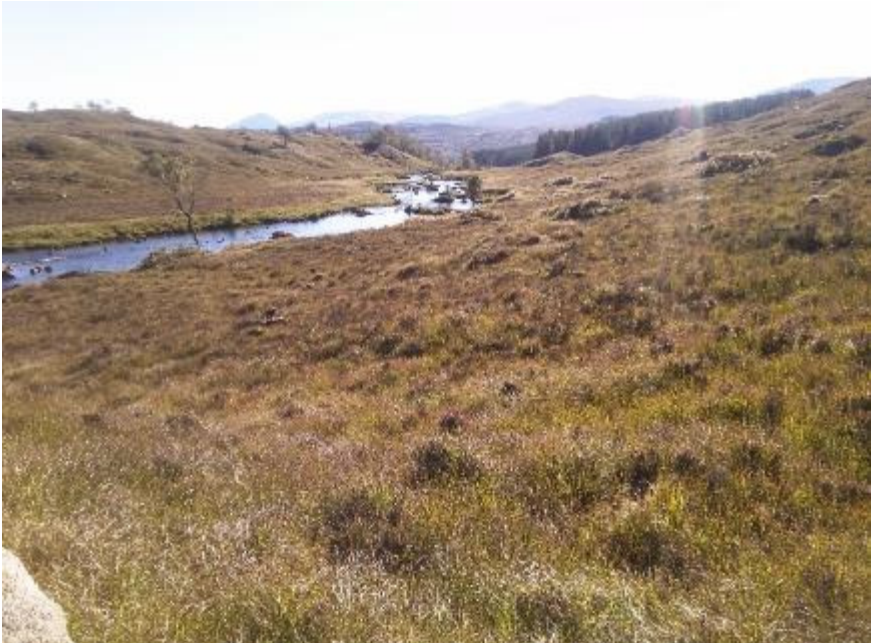
| Watercourse Crossing ID | WX34 |
|---|---|
| Watercourse Crossing Details | <p><b>Grid Reference:</b> E 208538 / N 801652</p> <p><b>Status:</b> New</p> <p><b>Watercourse Width:</b> N/A</p> <p><b>Watercourse Depth:</b> N/A</p> <p><b>Notes:</b> No active channel evident during site visit.</p> |

| Watercourse Crossing ID | WX34 |
|---|---|
| Potential Crossing Type<br>Likely Required CAR<br>Authorisation | <p>Culvert<br/>Registration</p> |

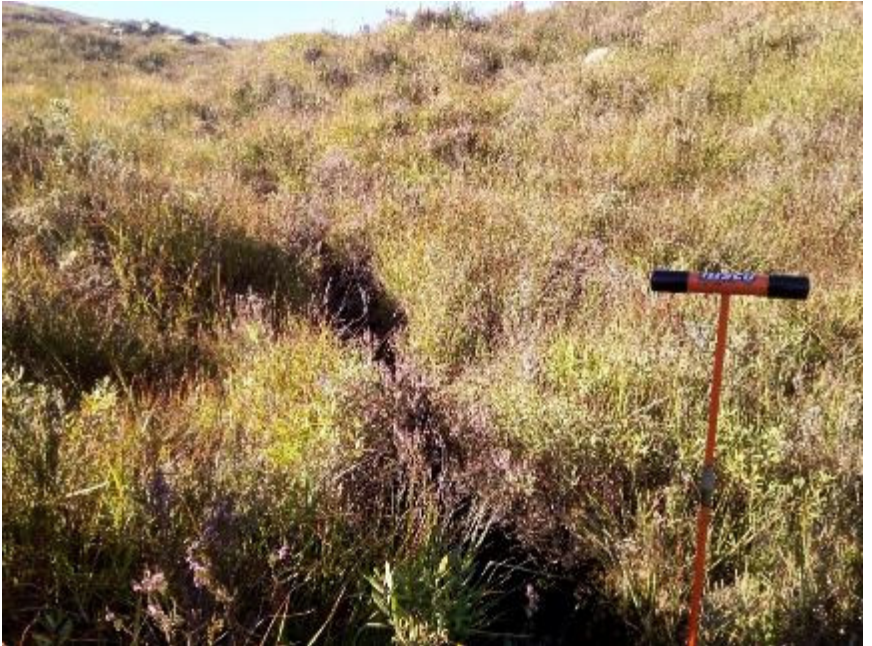
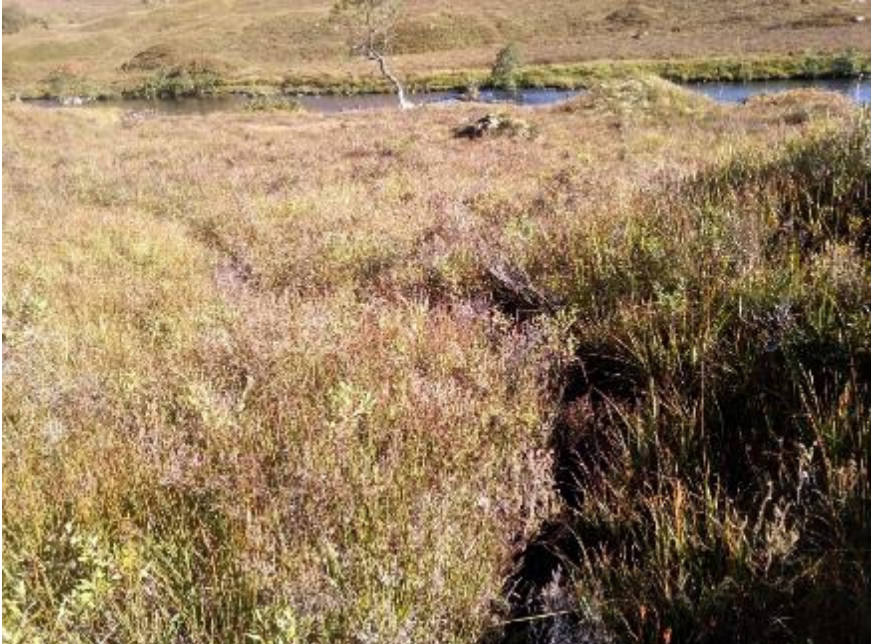
| Watercourse Crossing ID | WX35 |
|---|---|
| Watercourse Crossing Details | <p><b>Grid Reference:</b> E 208577 / N 801594</p> <p><b>Status:</b> New</p> <p><b>Watercourse Width:</b> 0.4 m</p> <p><b>Watercourse Depth:</b> 0.1 m</p> <p><b>Notes:</b> Watercourse located in a channel which is 0.3 m deep.</p> |

| Watercourse Crossing ID | WX35 |
|---|---|
| Potential Crossing Type Likely Required CAR Authorisation | <p>Culvert<br/>Registration</p> |

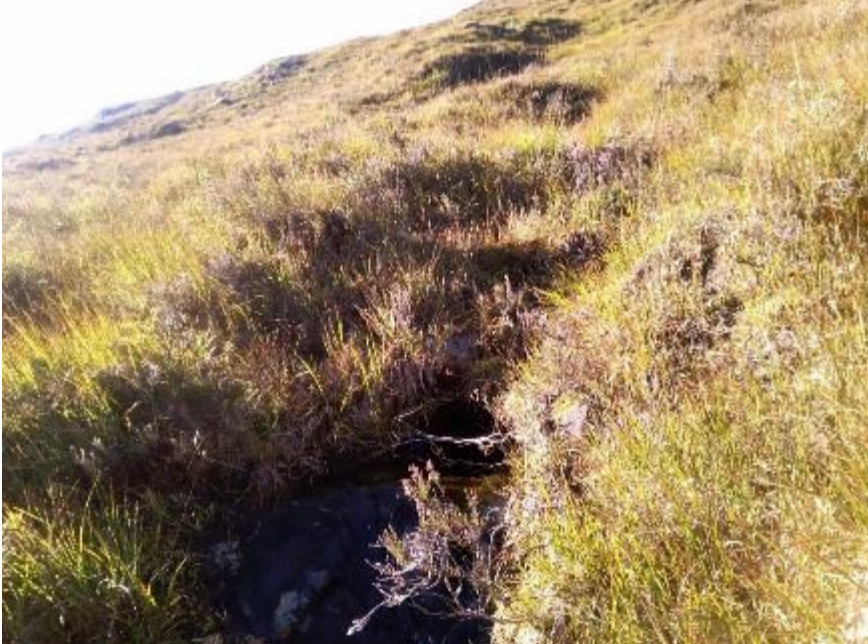
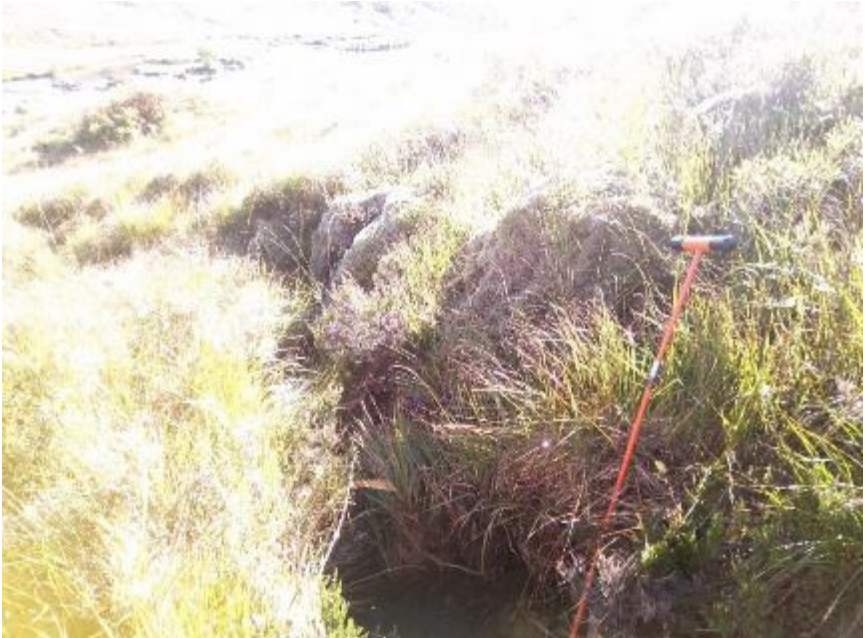
| Watercourse Crossing ID | WX36 |
|---|---|
| Watercourse Crossing Details | <p><b>Grid Reference:</b> E 208632 / N 801550</p> <p><b>Status:</b> New</p> <p><b>Watercourse Width:</b> 0.6 m</p> <p><b>Watercourse Depth:</b> 0.1 m</p> <p><b>Notes:</b> Low flow / stagnant water present at crossing point during survey.</p> |

| Watercourse Crossing ID | WX36 |
|---|---|
| Potential Crossing Type Likely Required CAR Authorisation | <p>Culvert<br/>Registration</p> |

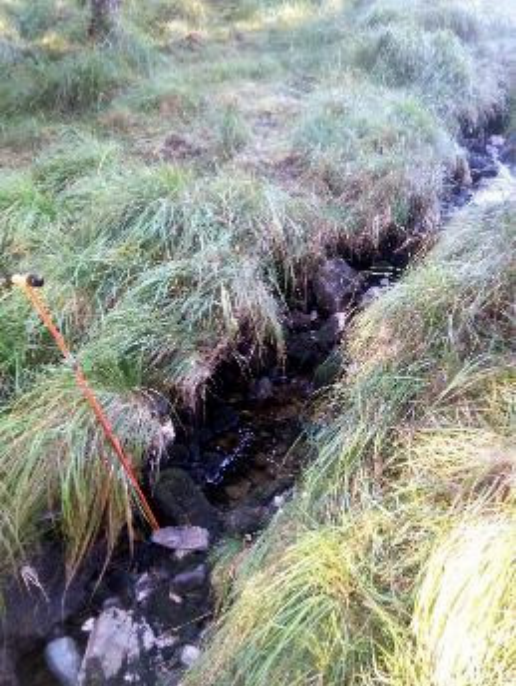
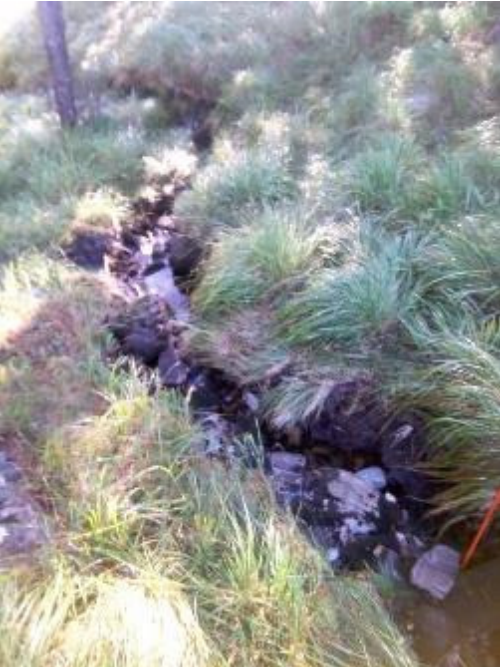
| Watercourse Crossing ID | WX37 |

| Watercourse Crossing ID | WX37 |
|---|---|
| Watercourse Crossing Details | <p><b>Grid Reference:</b> E 208856 / N 801345</p> <p><b>Status:</b> New</p> <p><b>Watercourse Width:</b> 0.7 m</p> <p><b>Watercourse Depth:</b> 0.1 m</p> <p><b>Notes:</b> Watercourse located in a channel which is 0.6 m deep.</p> |
| Photograph Looking Upstream | |
| Photograph Looking Downstream | |

| Watercourse Crossing ID | WX37 |
|---|---|
| Potential Crossing Type<br>Likely Required CAR Authorisation | Culvert<br>Registration |

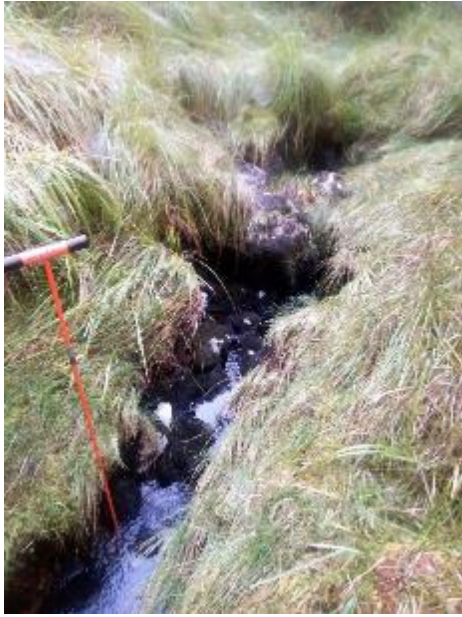
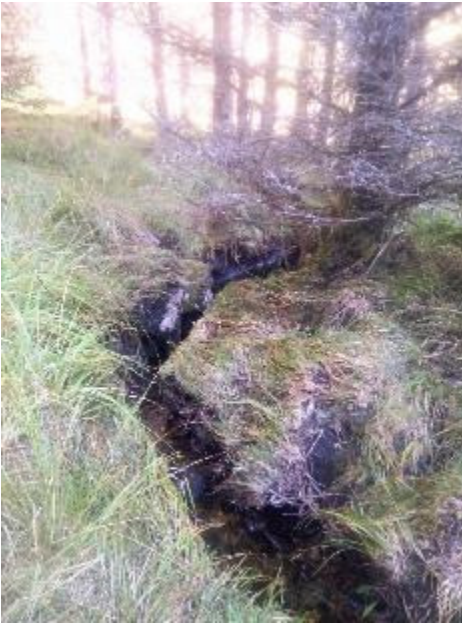
| Watercourse Crossing ID | WX38 |
|---|---|
| Watercourse Crossing Details | <p><b>Grid Reference:</b> E 209162 / N 800987</p> <p><b>Status:</b> New</p> <p><b>Watercourse Width:</b> 0.3 to 0.7 m</p> <p><b>Watercourse Depth:</b> 0.1 m</p> <p><b>Notes:</b> Watercourse located in a channel which is 0.5 m deep.</p> |
| Photograph Looking Upstream | |
| Photograph Looking Downstream | |

| Watercourse Crossing ID | WX38 |
|---|---|
| Potential Crossing Type<br>Likely Required CAR Authorisation | Culvert<br>Registration |

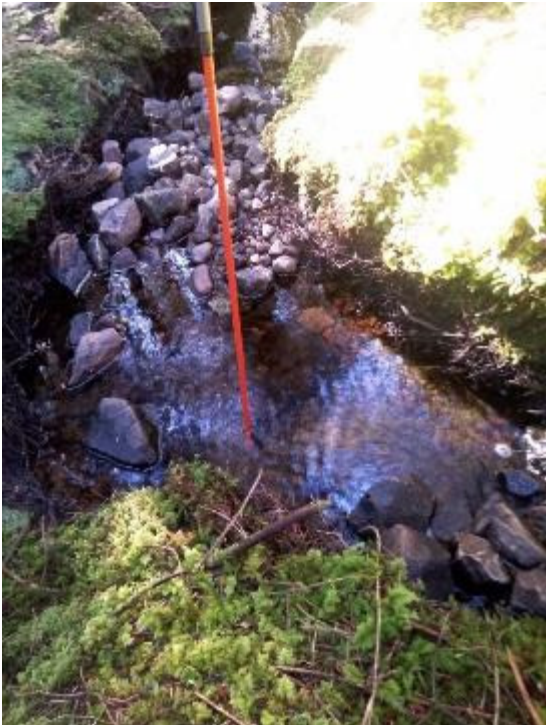
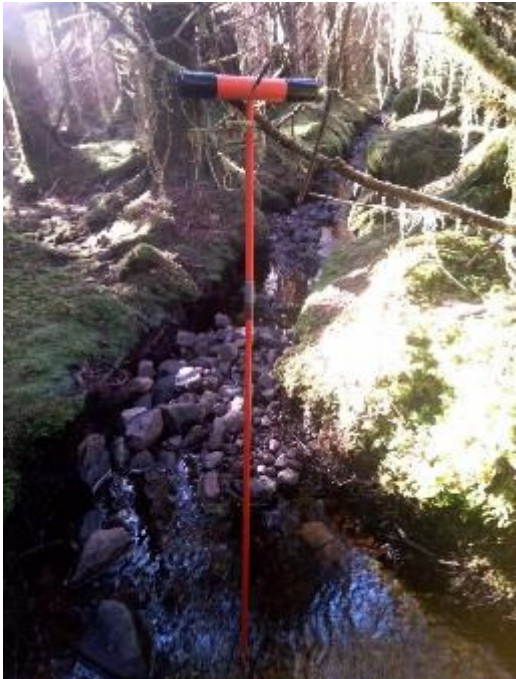
| Watercourse Crossing ID | WX39 |

| Watercourse Crossing ID | WX39 |
|---|---|
| Watercourse Crossing Details | <p><b>Grid Reference:</b> E 209030 / N 800152</p> <p><b>Status:</b> New</p> <p><b>Watercourse Width:</b> 0.7 m</p> <p><b>Watercourse Depth:</b> 0.2 m</p> <p><b>Notes:</b> None.</p> |
| Photograph Looking Upstream | |
| Photograph Looking Downstream | |

| Watercourse Crossing ID | WX39 |
|---|---|
| Potential Crossing Type<br>Likely Required CAR<br>Authorisation | Culvert<br>Registration |

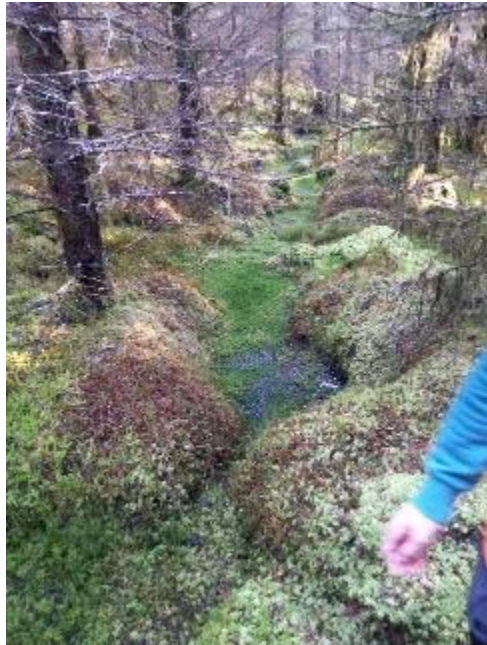
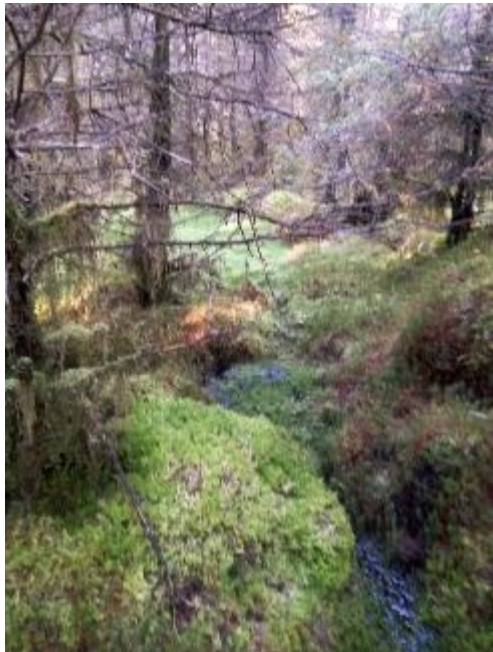
| Watercourse Crossing ID | WX40 |
|---|---|
| Watercourse Crossing Details | <p><b>Grid Reference:</b> E 209017 / N 800100</p> <p><b>Status:</b> New</p> <p><b>Watercourse Width:</b> N/A</p> <p><b>Watercourse Depth:</b> N/A</p> <p><b>Notes:</b> No obvious watercourse channel or flowing water. Area has been altered by drainage for the forestry. Stagnant water noted up to 0.5 m wide.</p> |

| Watercourse Crossing ID | WX40 |
|---|---|
| Potential Crossing Type<br>Likely Required CAR Authorisation | <p>Culvert<br/>Registration</p> |

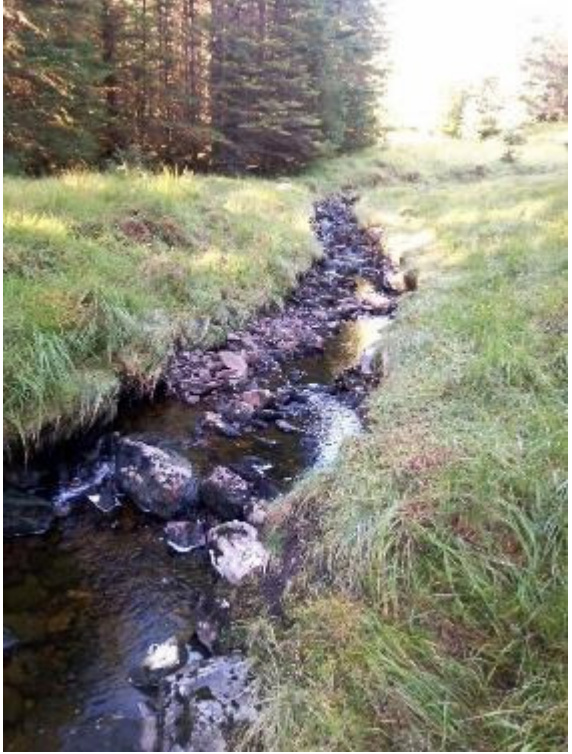
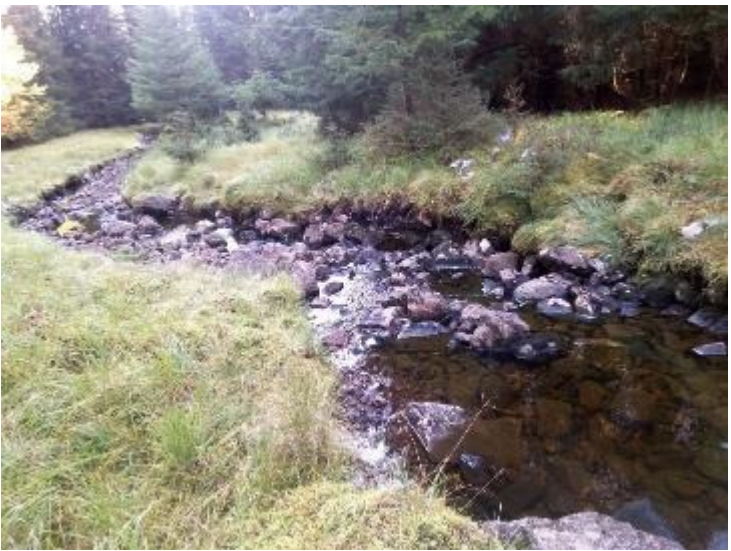
| Watercourse Crossing ID | WX41 |
|---|---|
| Watercourse Crossing Details | <p><b>Grid Reference:</b> E 209024 / N 800071</p> <p><b>Status:</b> New</p> <p><b>Watercourse Width:</b> 1.2 m</p> <p><b>Watercourse Depth:</b> 0.2 m</p> <p><b>Notes:</b> Watercourse is located within a wider meandering channel which is approximately 0.7 m deep and 1.7 m wide.</p> |

| Watercourse Crossing ID | WX41 |
|---|---|
| Potential Crossing Type<br>Likely Required CAR Authorisation | Open span bottomless arch culvert<br>Registration |

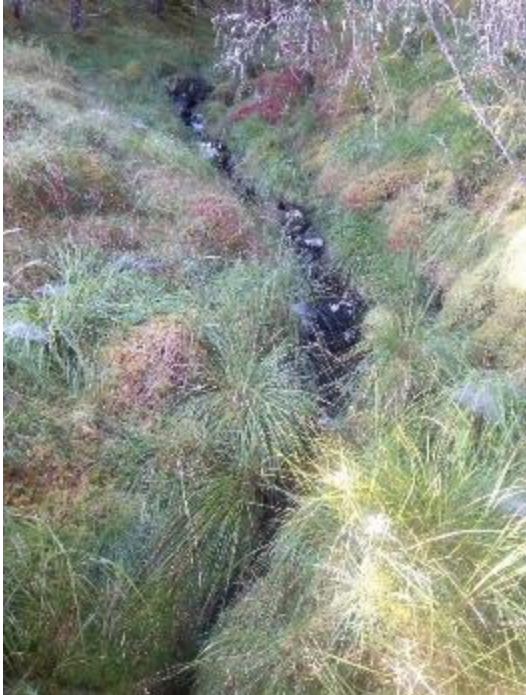
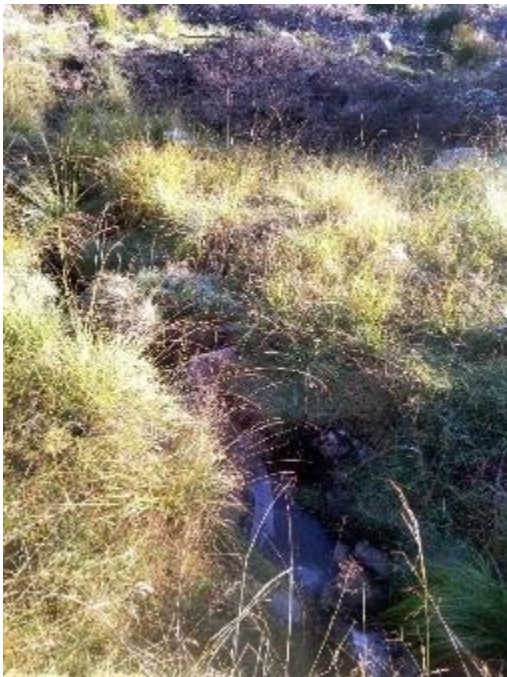
| Watercourse Crossing ID | WX43 |
|---|---|
| Watercourse Crossing Details | <p><b>Grid Reference:</b> E 209679 / N 800013</p> <p><b>Status:</b> Existing</p> <p><b>Crossing Type:</b> Culvert</p> <p><b>Crossing Size:</b> Unknown but small</p> <p><b>Watercourse Width:</b> 0.3 m</p> <p><b>Watercourse Depth:</b> 0.2 m</p> <p><b>Notes:</b> Minor culvert difficult to access during survey.</p> |
| Photograph Looking Upstream | |
| Photograph Looking Downstream | |

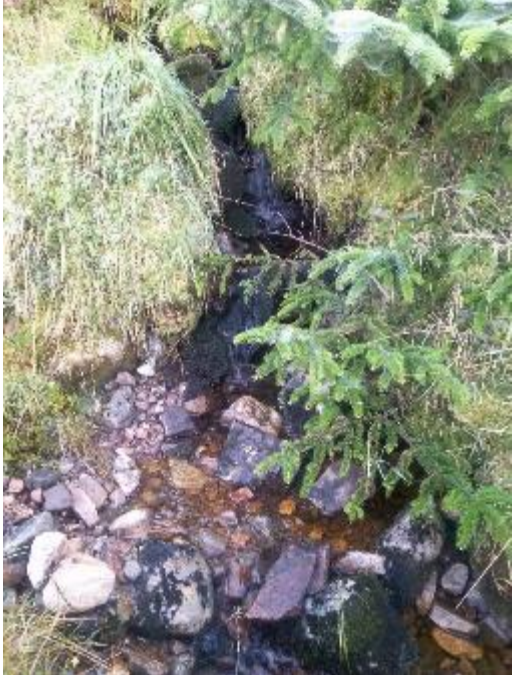
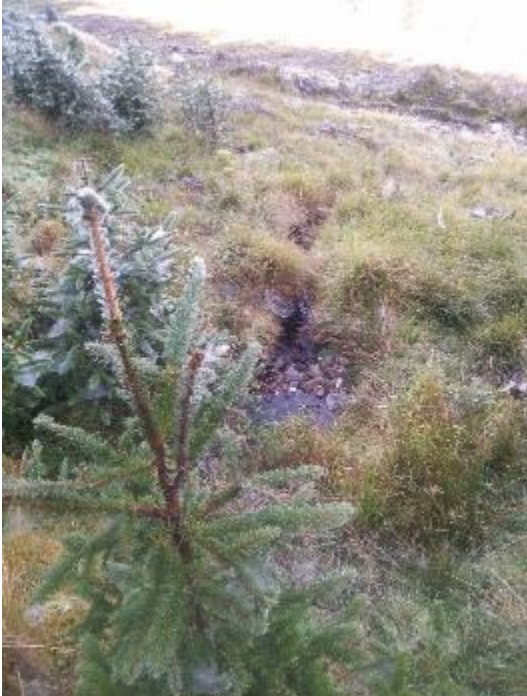
| Watercourse Crossing ID | WX44 |
|---|---|
| Watercourse Crossing Details | <p><b>Grid Reference:</b> E 209933 / N 800061</p> <p><b>Status:</b> Existing</p> <p><b>Crossing Type:</b> Culvert</p> <p><b>Crossing Size:</b> Unknown but small</p> <p><b>Watercourse Width:</b> 0.4 m</p> <p><b>Watercourse Depth:</b> 0.3 m</p> <p><b>Notes:</b> Minor culvert difficult to access during survey.</p> |
| Photograph Looking Upstream | |
| Photograph Looking Downstream | |

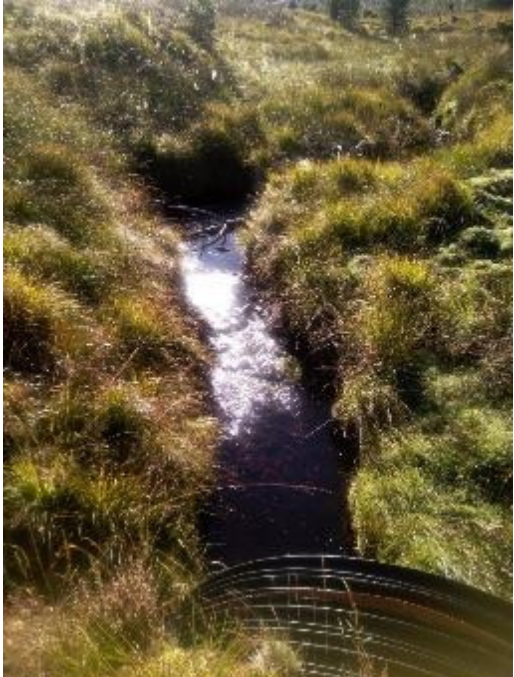
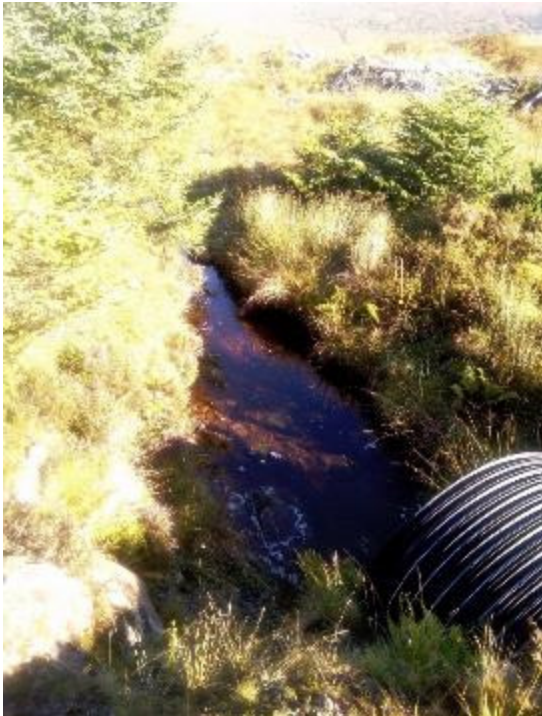
| Watercourse Crossing ID | WX45 |
|---|---|
| Watercourse Crossing Details | <p><b>Grid Reference:</b> E 210682 / N 800105</p> <p><b>Status:</b> Existing</p> <p><b>Crossing Type:</b> Plastic circular culvert</p> <p><b>Crossing Size:</b> 1.5 m diameter</p> <p><b>Watercourse Width:</b> 1.5 m</p> <p><b>Watercourse Depth:</b> 0.6 m</p> <p><b>Notes:</b> None.</p> |
| Photograph Looking Upstream | |
| Photograph Looking Downstream | |
