## **Fearna Pumped Storage Hydro Scheme EIA Report**

### **Appendix 12.4 – Schedule of Water Crossings**

**February 2025**

## Fearna Pumped Storage Hydro Project

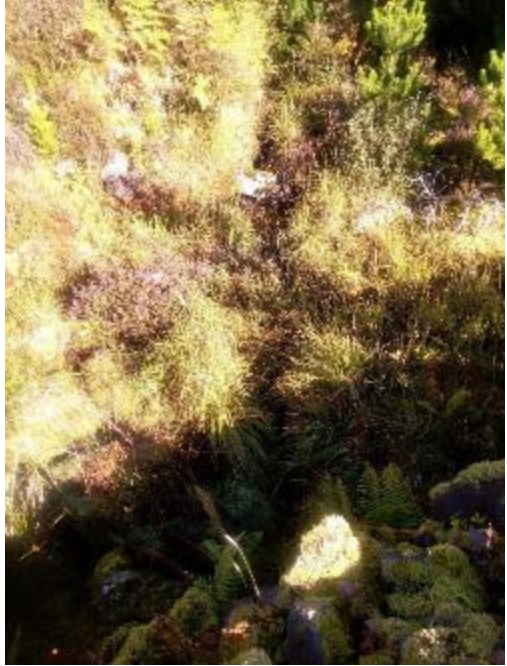
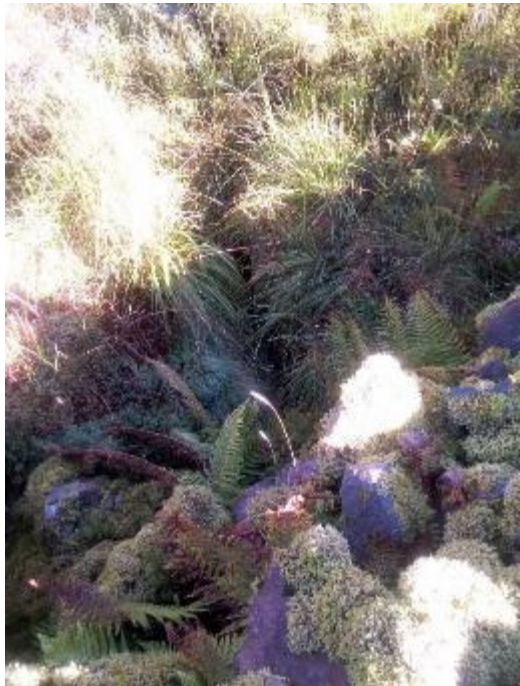
| Watercourse Crossing ID | WX46 |
|---|---|
| Watercourse Crossing Details | <p><b>Grid Reference:</b> E 211492 / N 799968</p> <p><b>Status:</b> Existing</p> <p><b>Crossing Type:</b> Unknown</p> <p><b>Crossing Size:</b> Unknown</p> <p><b>Watercourse Width:</b> 0.3 m</p> <p><b>Watercourse Depth:</b> 0.2 m</p> <p><b>Notes:</b> Heavily vegetated so unable to survey the existing crossing however it is expected to be a small culvert.</p> |
| Photograph Looking Upstream | |
| Photograph Looking Downstream | |

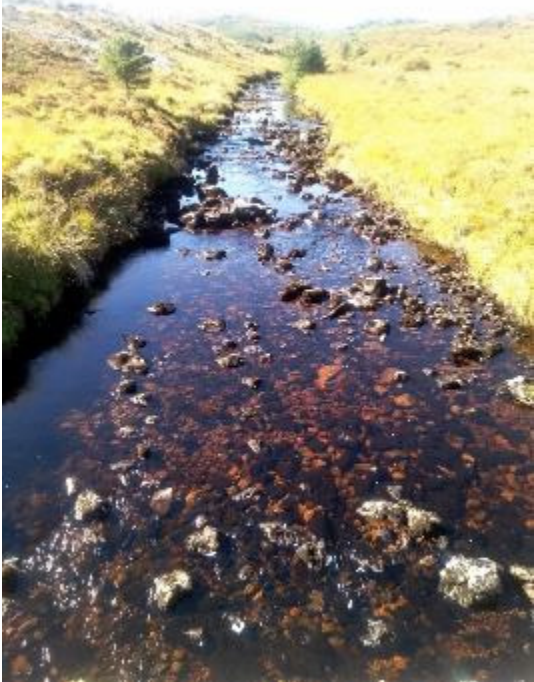
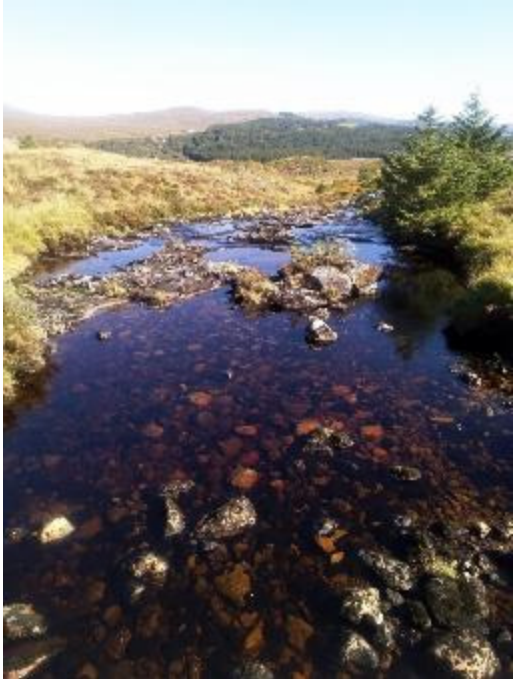
| Watercourse Crossing ID | WX47 |
|---|---|
| Watercourse Crossing Details | <p><b>Grid Reference:</b> E 212798 / N 799984</p> <p><b>Status:</b> Existing</p> <p><b>Crossing Type:</b> Open span bridge</p> <p><b>Crossing Size:</b> 15 m long, 4 m wide</p> <p><b>Watercourse Width:</b> 10 to 15 m</p> <p><b>Watercourse Depth:</b> 0.5 m</p> <p><b>Notes:</b> Watercourse noted wider downstream of existing crossing.</p> |

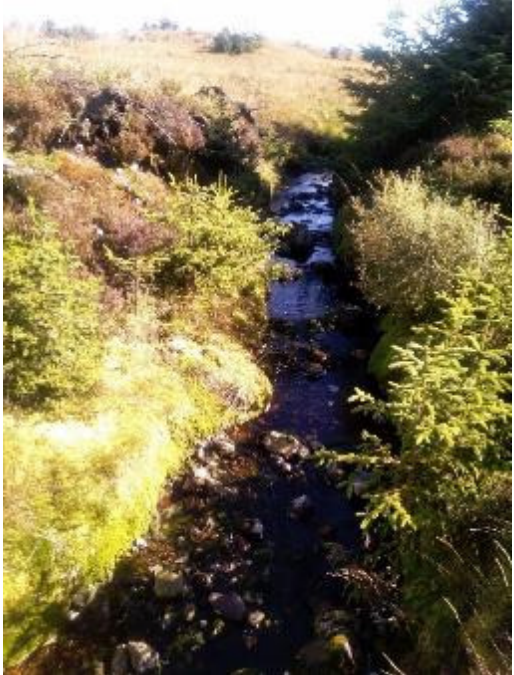
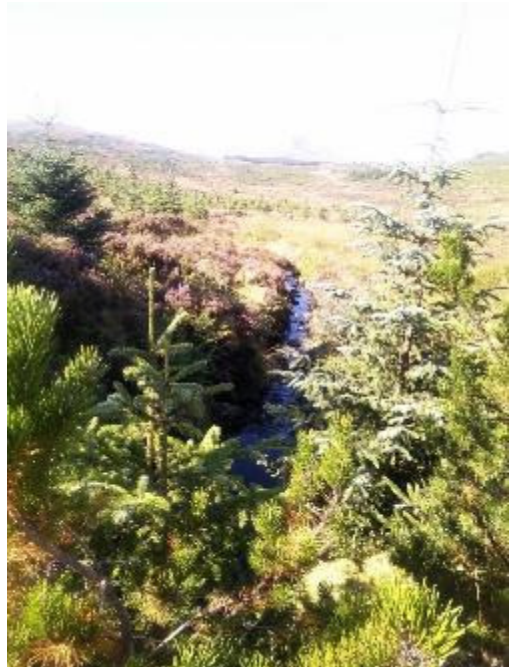
| Watercourse Crossing ID | WX49 |
|---|---|
| Watercourse Crossing Details | <p><b>Grid Reference:</b> E 212959 / N 799587</p> <p><b>Status:</b> Existing</p> <p><b>Crossing Type:</b> Unknown</p> <p><b>Crossing Size:</b> Unknown</p> <p><b>Watercourse Width:</b> 1 to 1.5 m</p> <p><b>Watercourse Depth:</b> 0.1 to 0.3 m</p> <p><b>Notes:</b> Culvert entrance and exit heavily vegetated so unable to survey. Expected to be similar to watercourse dimensions.</p> |
| Photograph Looking Upstream | |
| Photograph Looking Downstream | |

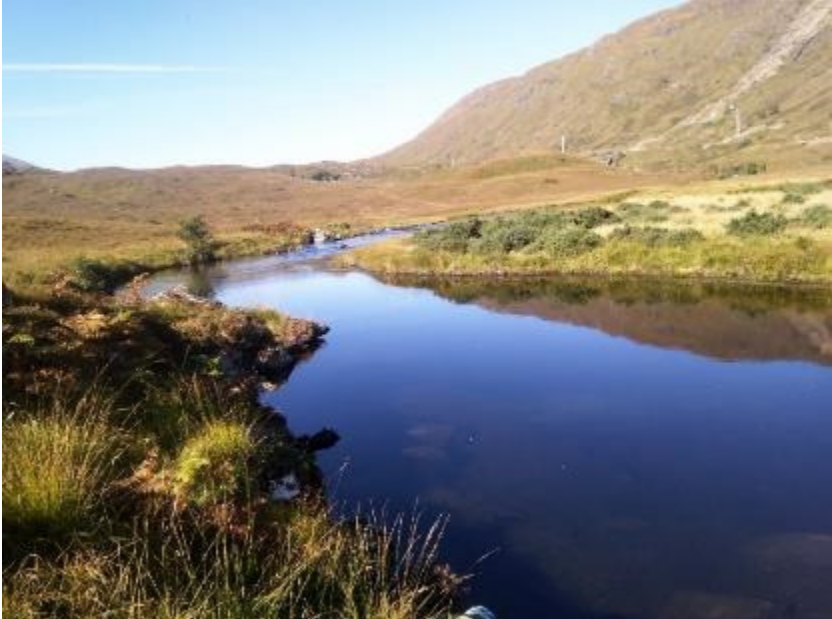
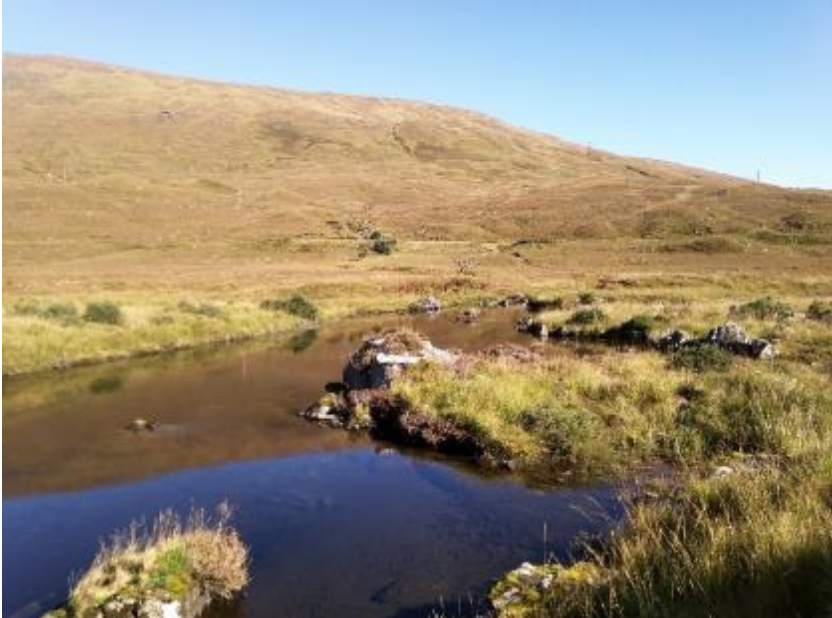
| Watercourse Crossing ID | WX31 (Gear Garry) |

| Watercourse Crossing ID | WX31 (Gear Garry) |
|---|---|
| Watercourse Crossing Details | <p><b>Grid Reference:</b> E 208069 / N 802235</p> <p><b>Status:</b> New bridge</p> <p><b>Watercourse Width:</b> Approximately 20 m</p> <p><b>Watercourse Depth:</b> 1.5 m</p> <p><b>Notes:</b> Large watercourse with silty bed.</p> |
| Photograph Looking Upstream | |
| Photograph Looking Downstream | |

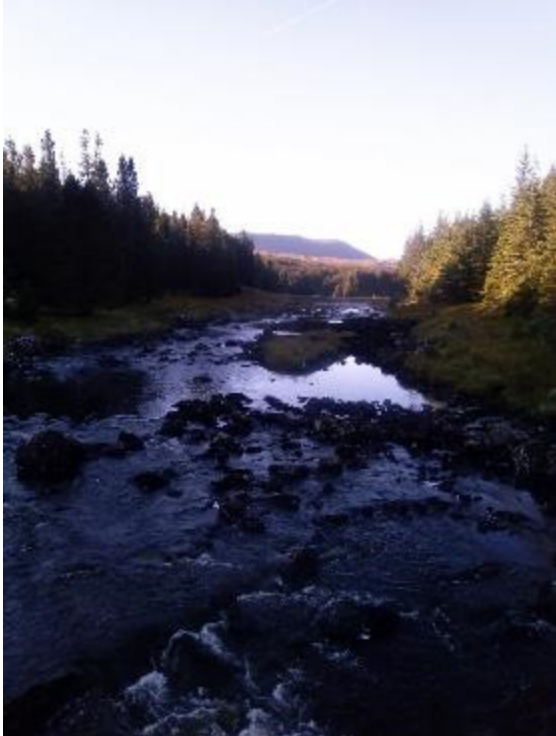
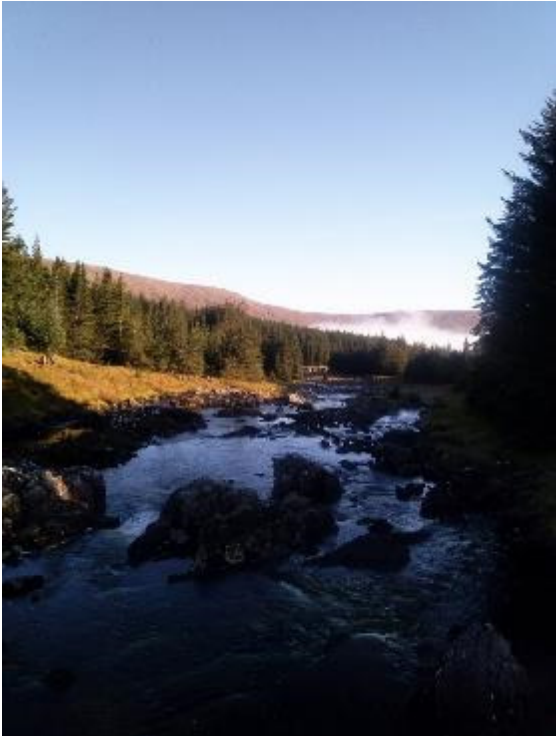
| Watercourse Crossing ID | WX42 (River Kingie) |
|---|---|
| Watercourse Crossing Details | <p><b>Grid Reference:</b> E 209055 / N 799820</p> <p><b>Status:</b> New bridge</p> <p><b>Watercourse Width:</b> Approximately 25 m</p> <p><b>Watercourse Depth:</b> 1.5 m</p> <p><b>Notes:</b> Large meandering watercourse with rocky bed with islands and small rapids.</p> |
| Photograph Looking Upstream | |
| Photograph Looking Downstream | |

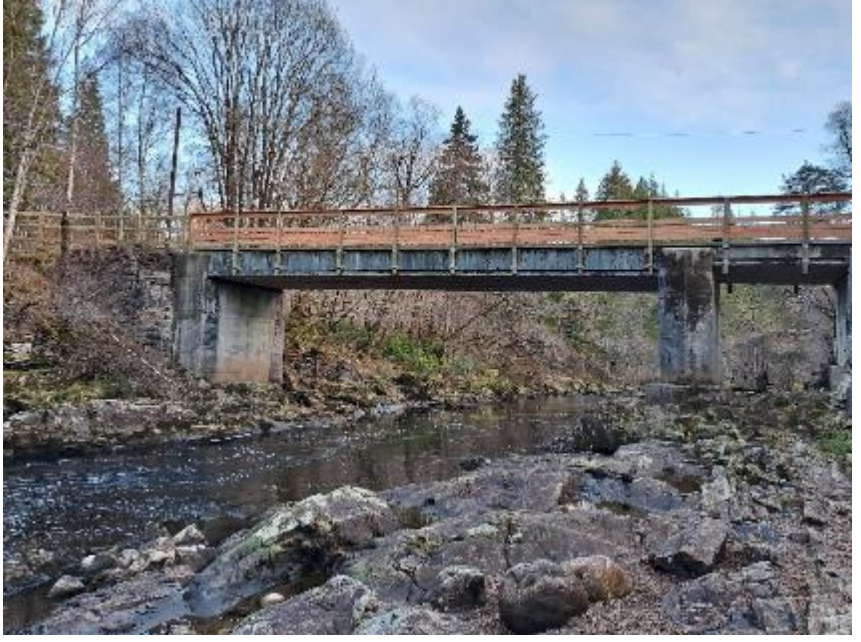
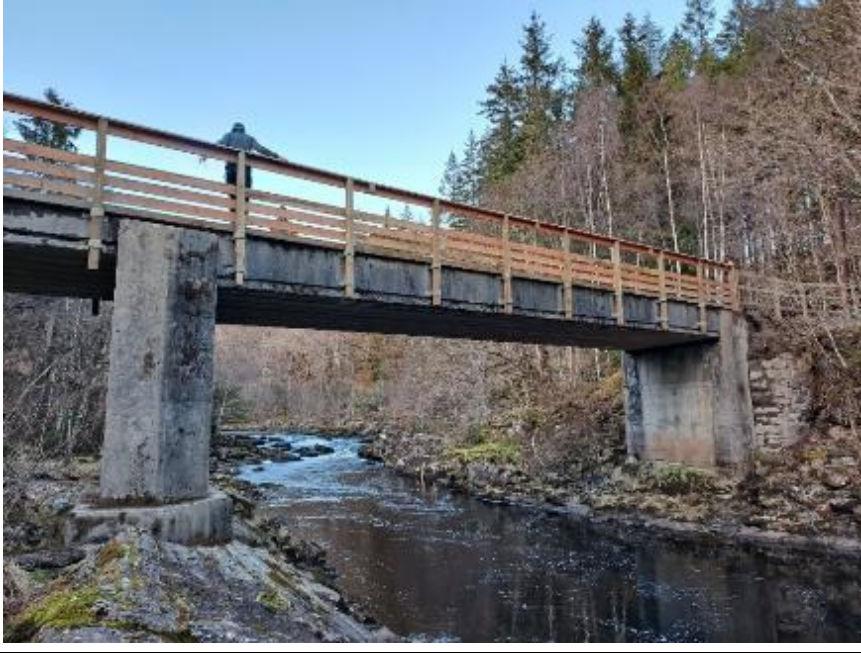
| Watercourse Crossing ID | WX51 (River Garry) |
|---|---|
| Watercourse Crossing Details | <p><b>Grid Reference:</b> E 228364 / N 801353</p> <p><b>Status:</b> Existing bridge to be upgraded</p> <p><b>Crossing Type:</b> Open span concrete bridge</p> <p><b>Crossing Size:</b> 20 m long, 3.5m wide</p> <p><b>Watercourse Width:</b> Approximately 10 m</p> <p><b>Watercourse Depth:</b> 1.5 m</p> <p><b>Notes:</b> None.</p> |
| Photograph Looking at Bridge from Upstream | |
| Photograph Looking at Bridge from Downstream | |
