## **Fearna Pumped Storage Hydro Scheme - EIA Report**

### **Appendix D – Geomorphology Report Southern Access Route (SAR)**

# **Fearna Pumped Storage Hydro Scheme Geomorphology Report:**

## **A. Southern Access Route**

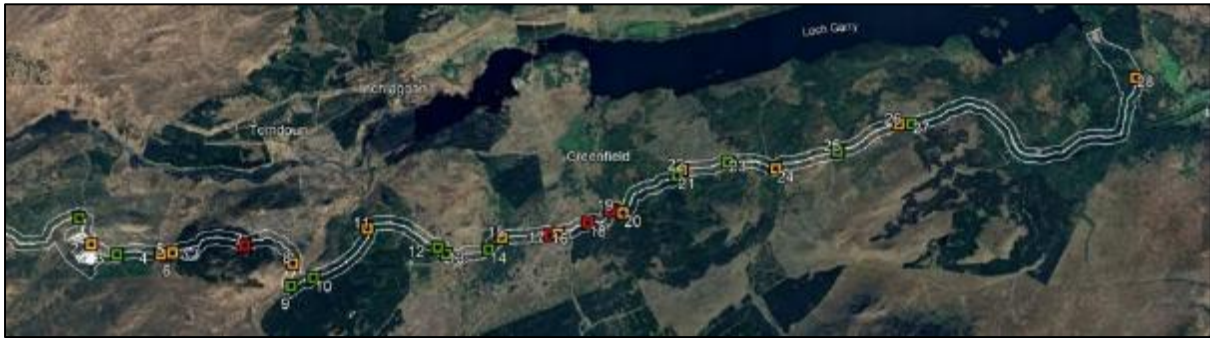
**Figure 1.** Location of the downstream 28 stream crossings identified on the 24<sup>th</sup> April 2025 survey (see Table 1). Colour coding refers to the categories in point 8 and included in Table 1.

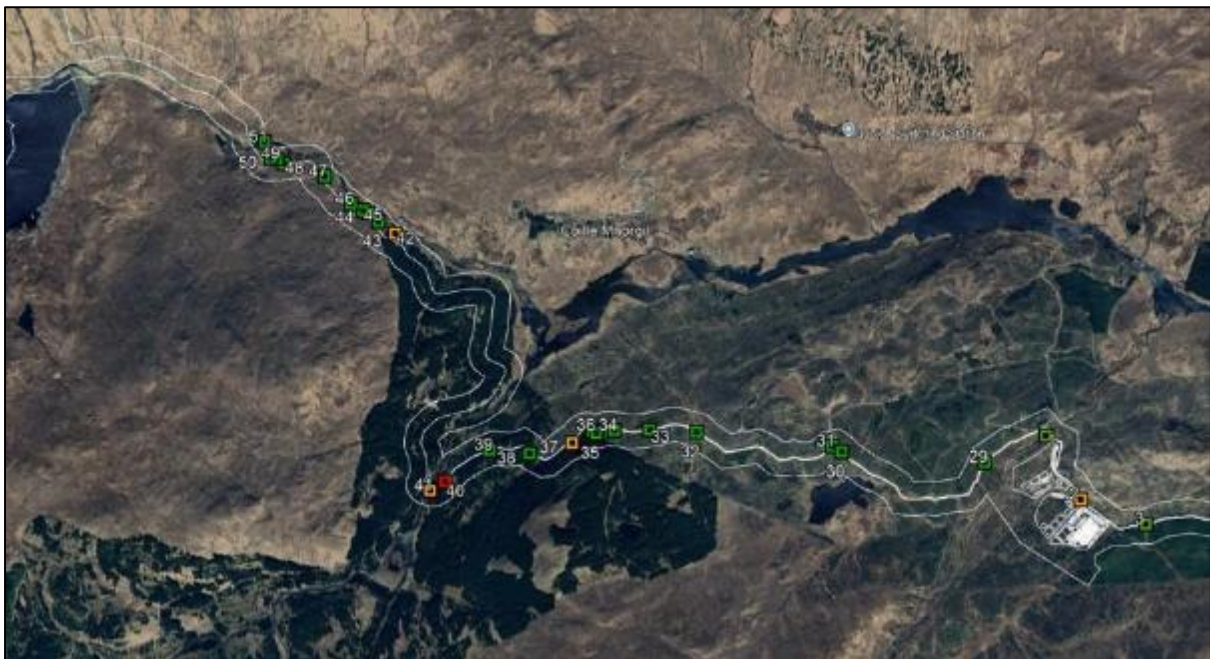
**Figure 2.** Location of the downstream 23 stream crossings identified on the 1<sup>st</sup> August 2025 survey (see Table 2). Colour coding refers to the categories in point 8 and included in Table 2.

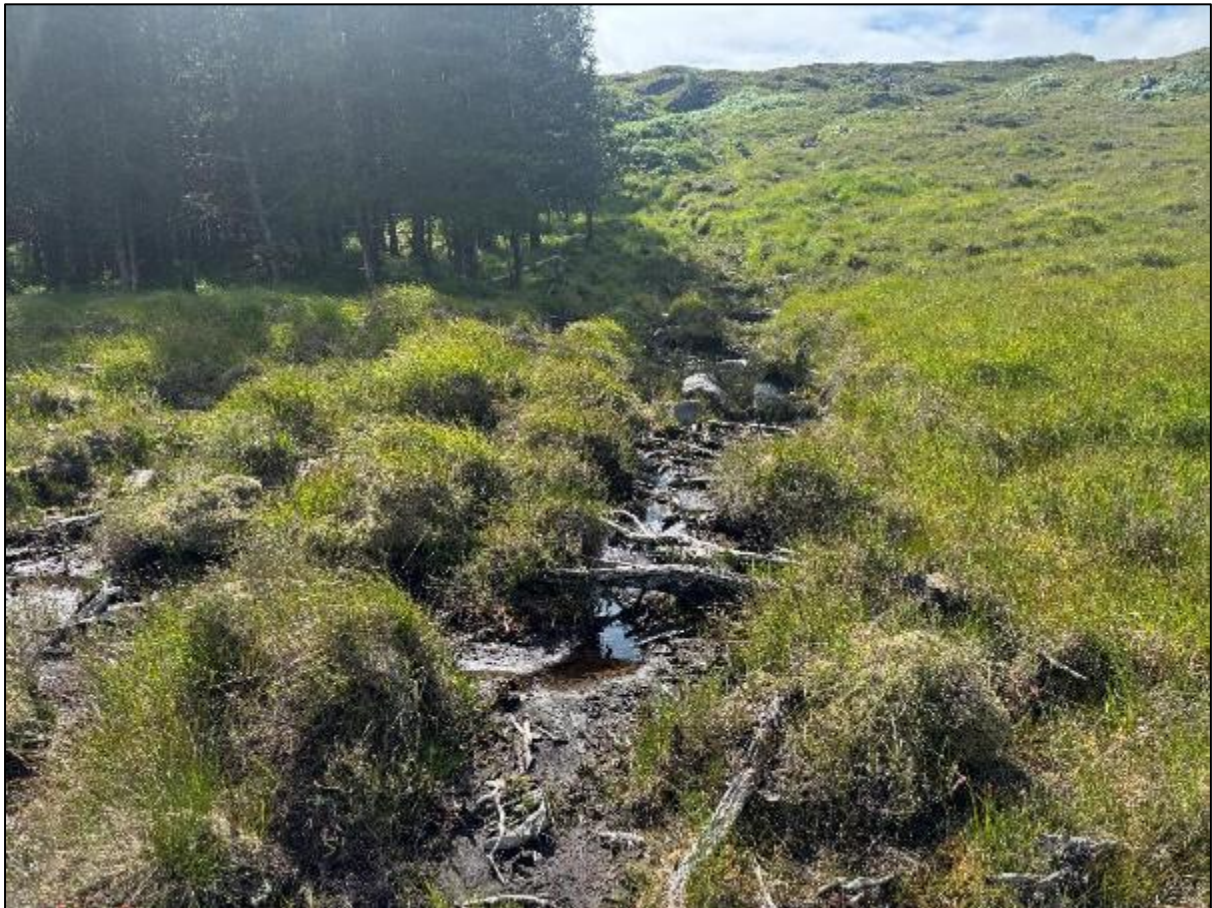
| Crossing No. | OS NGR | CA (km <sup>2</sup> ) | Figure No.* | Notes |
|---|---|---|---|---|
| 42 | NH 08934 01376 | <0.5 | A42 | Small, incised stream with some evidence of sediment transport/ storage. Possible partial avulsion upstream causing overland flow into peat (causing erosion). |

**Figure 13.** Erosion of peat associated with the stream proposed for SAR crossing 42.

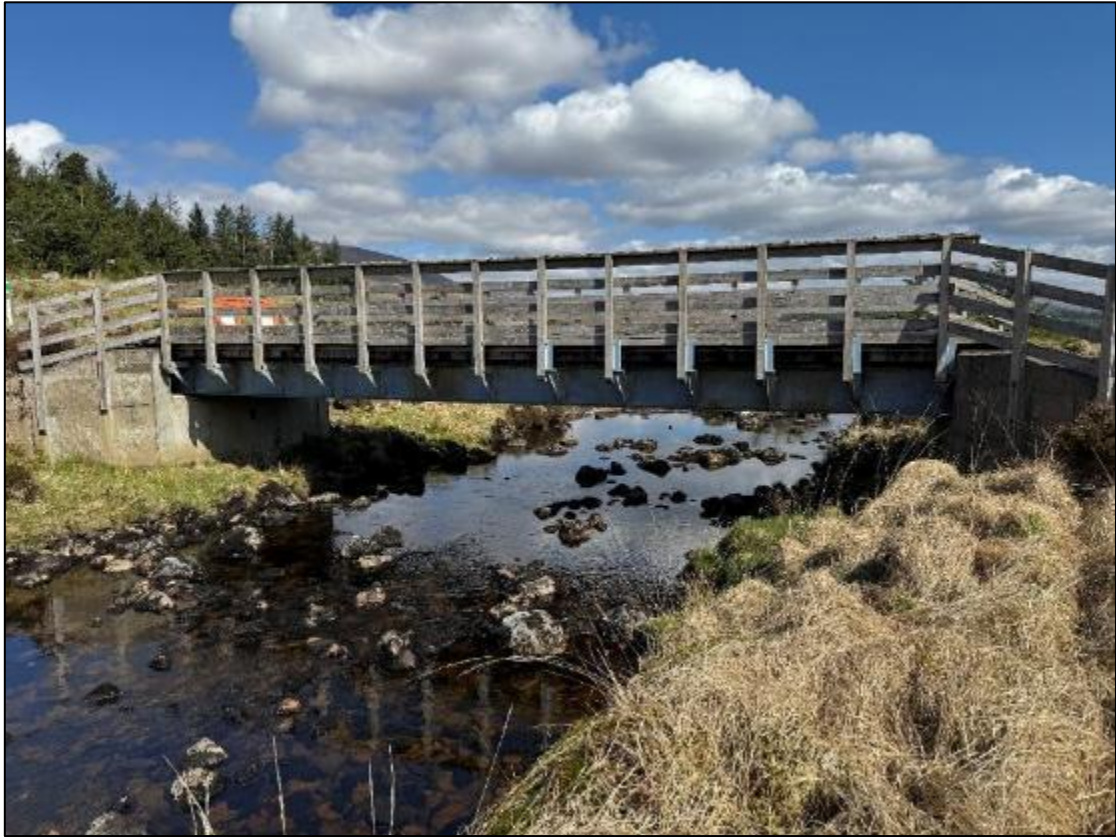
| Crossing No. | OS NGR | CA (km <sup>2</sup> ) | Figure No.* | Notes |
|---|---|---|---|---|
| 1 | NN 12799 99979 | 14.3 | A1 | Allt Choire a' Bhalachain. Furthest upstream bridge - undynamic channel, suitable span. |

**Figure A1.** Photograph of stream crossing 1. Looking downstream.

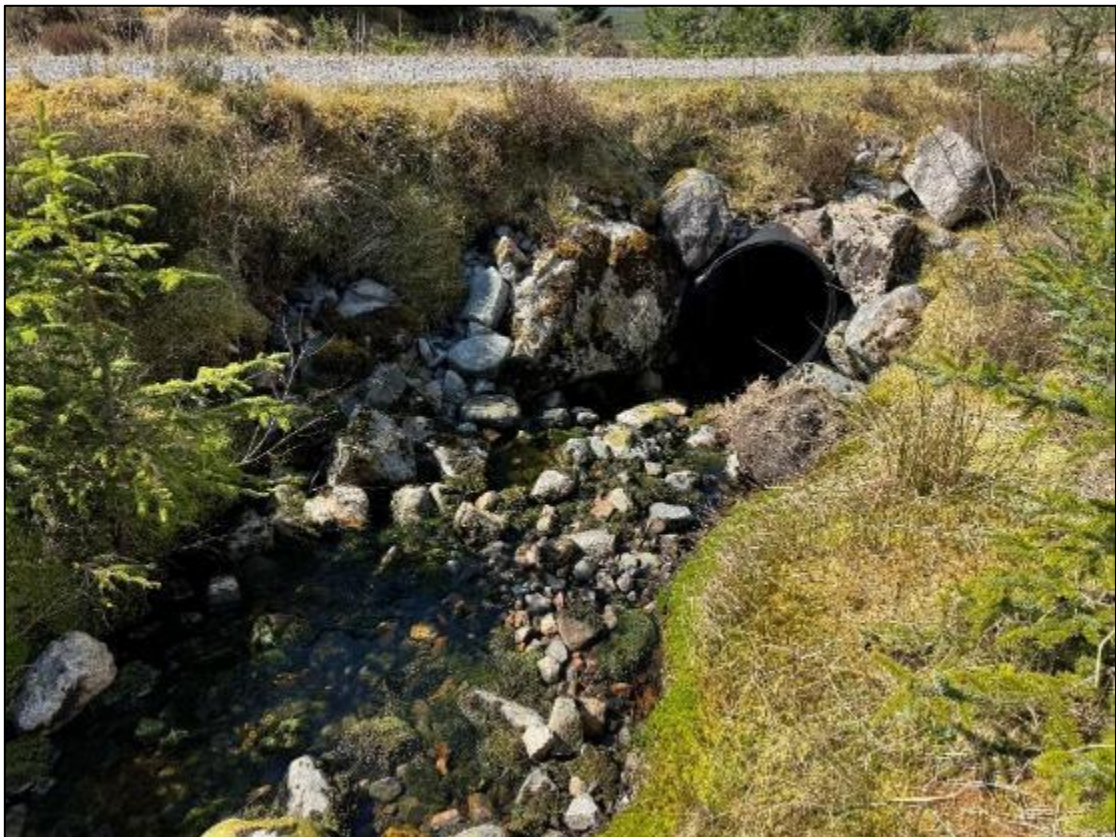
| Crossing No. | OS NGR | CA (km <sup>2</sup> ) | Figure No.* | Notes |
|---|---|---|---|---|
| 2 | NN 12968 99571 | 0.71 | A2 | Small stream but potentially under-sized culvert. Some sed build up. Low dynamic channel. |

**Figure A2.** Photograph of stream crossing 2. Culvert entrance.

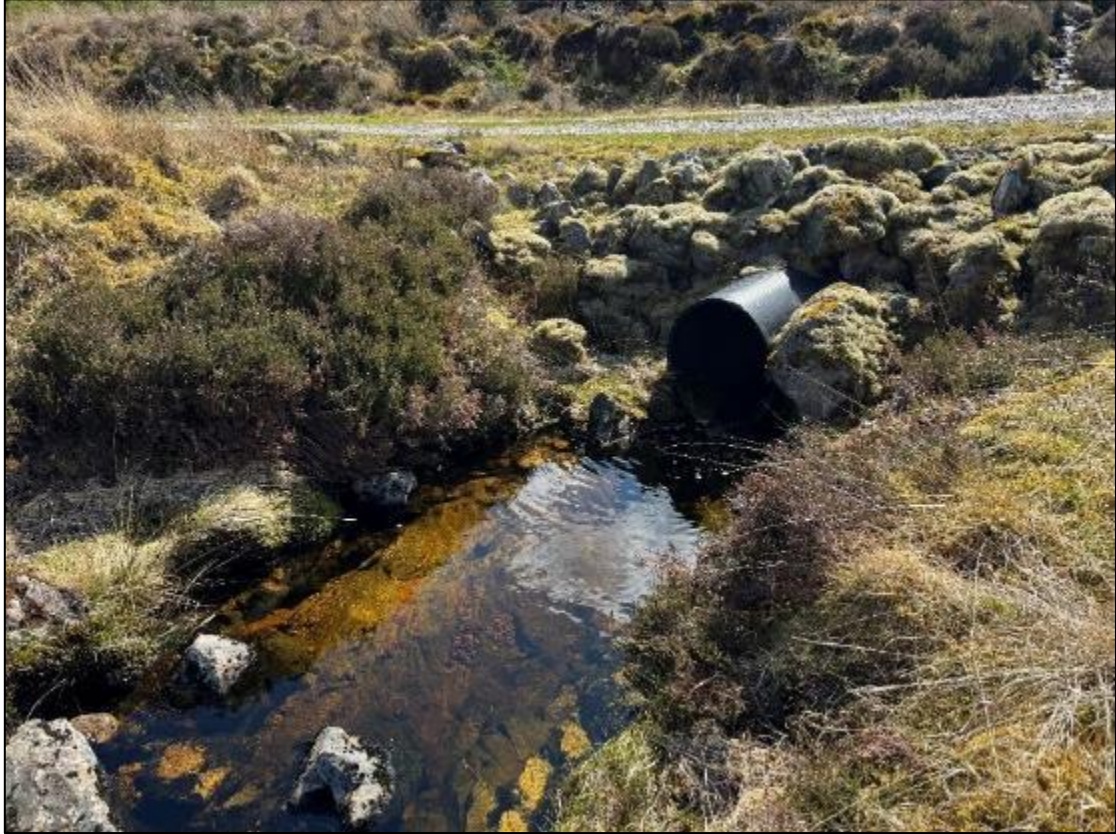
| Crossing No. | OS NGR | CA (km <sup>2</sup> ) | Figure No.* | Notes |
|---|---|---|---|---|
| 3 | NN 13338 99414 | 0.57 | A3 | Small steep bedrock dominated stream. Culvert pipe (~900mm). Little sediment storage. |

**Figure A3.** Photograph of stream crossing 3. Culvert outfall.

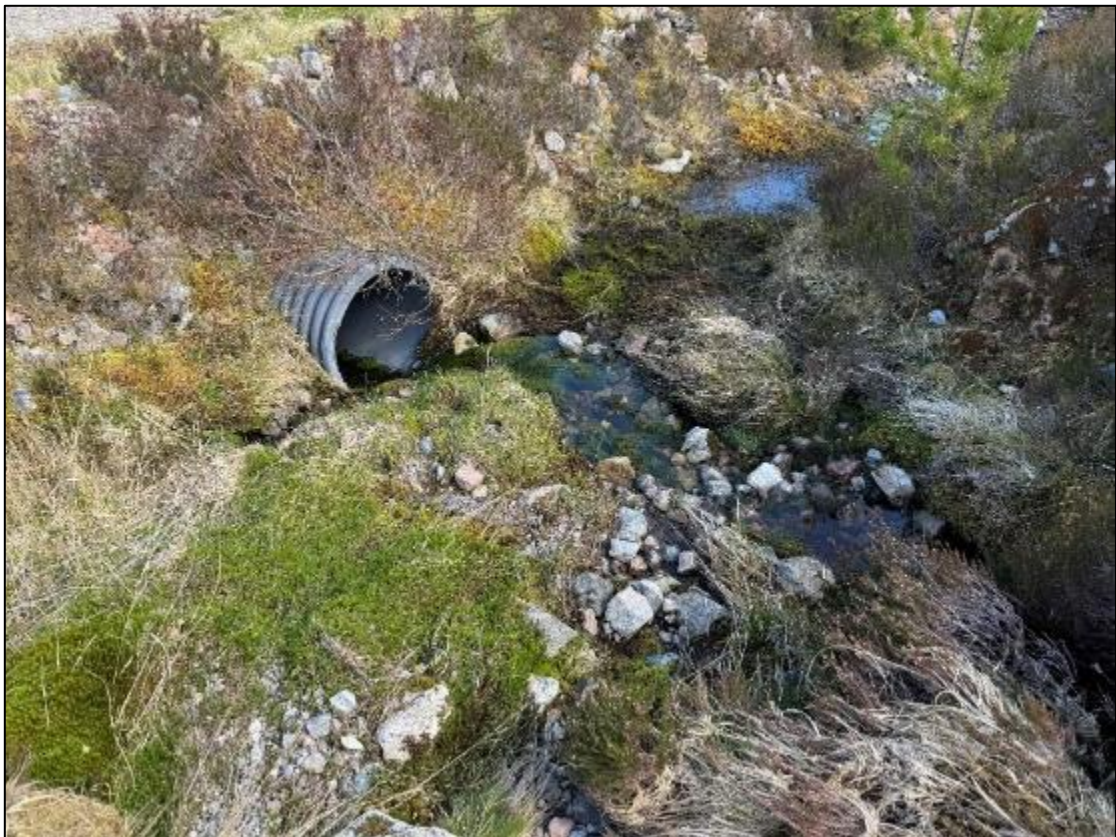
| Crossing No. | OS NGR | CA (km <sup>2</sup> ) | Figure No.* | Notes |
|---|---|---|---|---|
| 4 | NN 13970 99402 | <0.5 | A4 | Very small stream but some gravel storage. Pipe culvert (~600mm). |

**Figure A4.** Photograph of stream crossing 4. Culvert entrance.

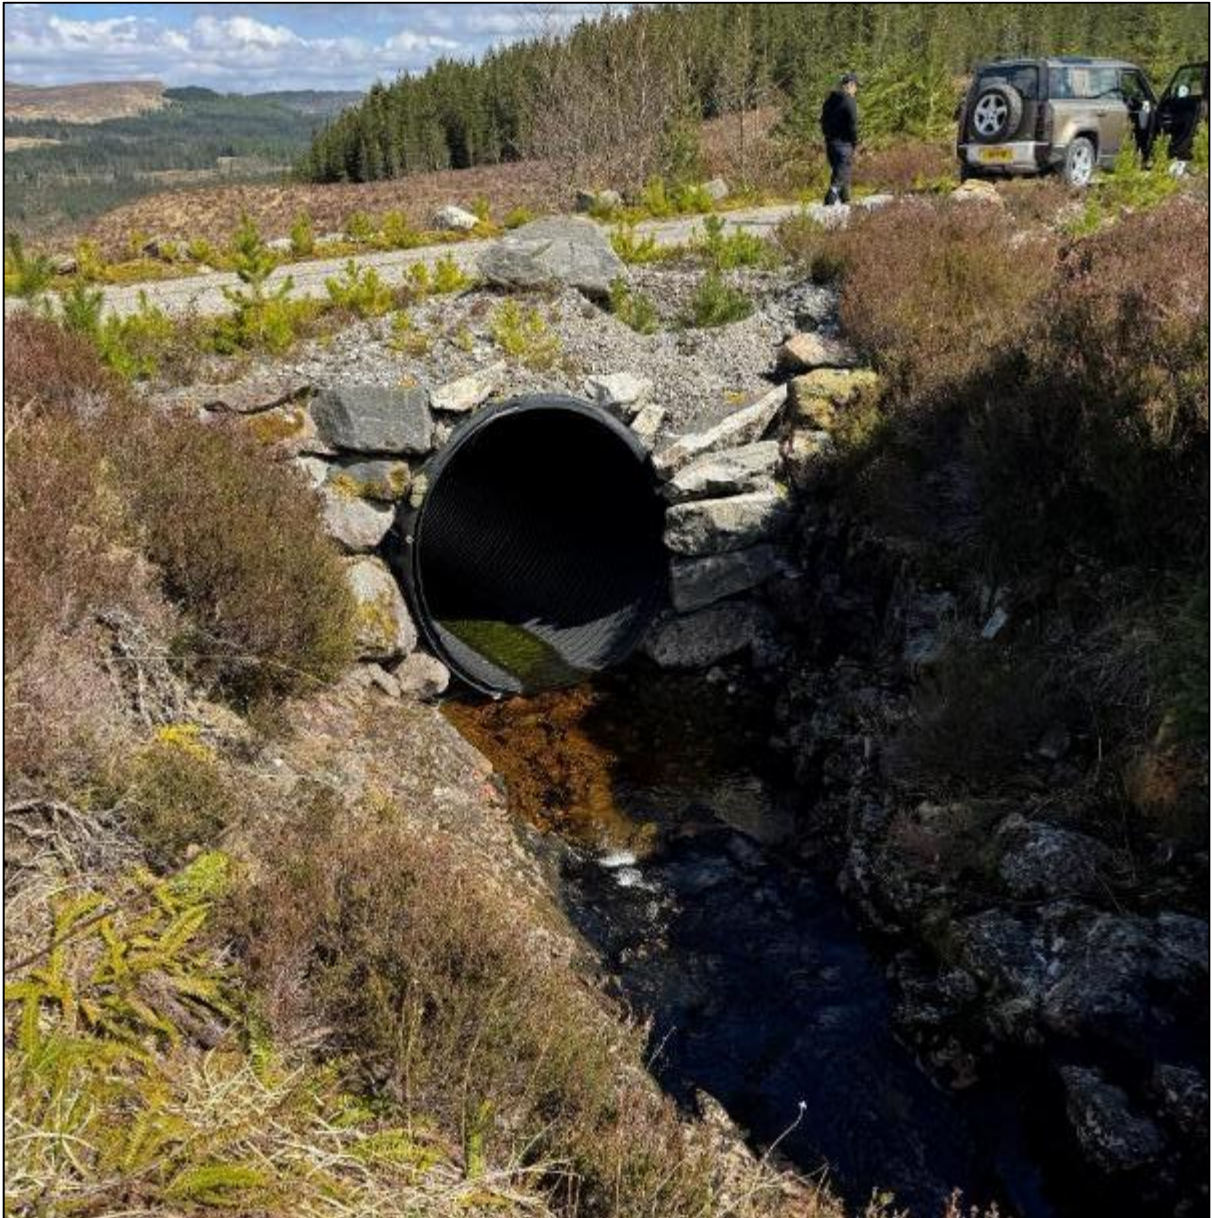
| Crossing No. | OS NGR | CA (km <sup>2</sup> ) | Figure No.* | Notes |
|---|---|---|---|---|
| 5 | NN 14050 99403 | 1.39 | A5 | Significant tributary (Allt Fionn-dhail) but bedrock dominated and little sediment storage. Pipe culvert (~2m). |

**Figure A5.** Photograph of stream crossing 5. Culvert entrance.

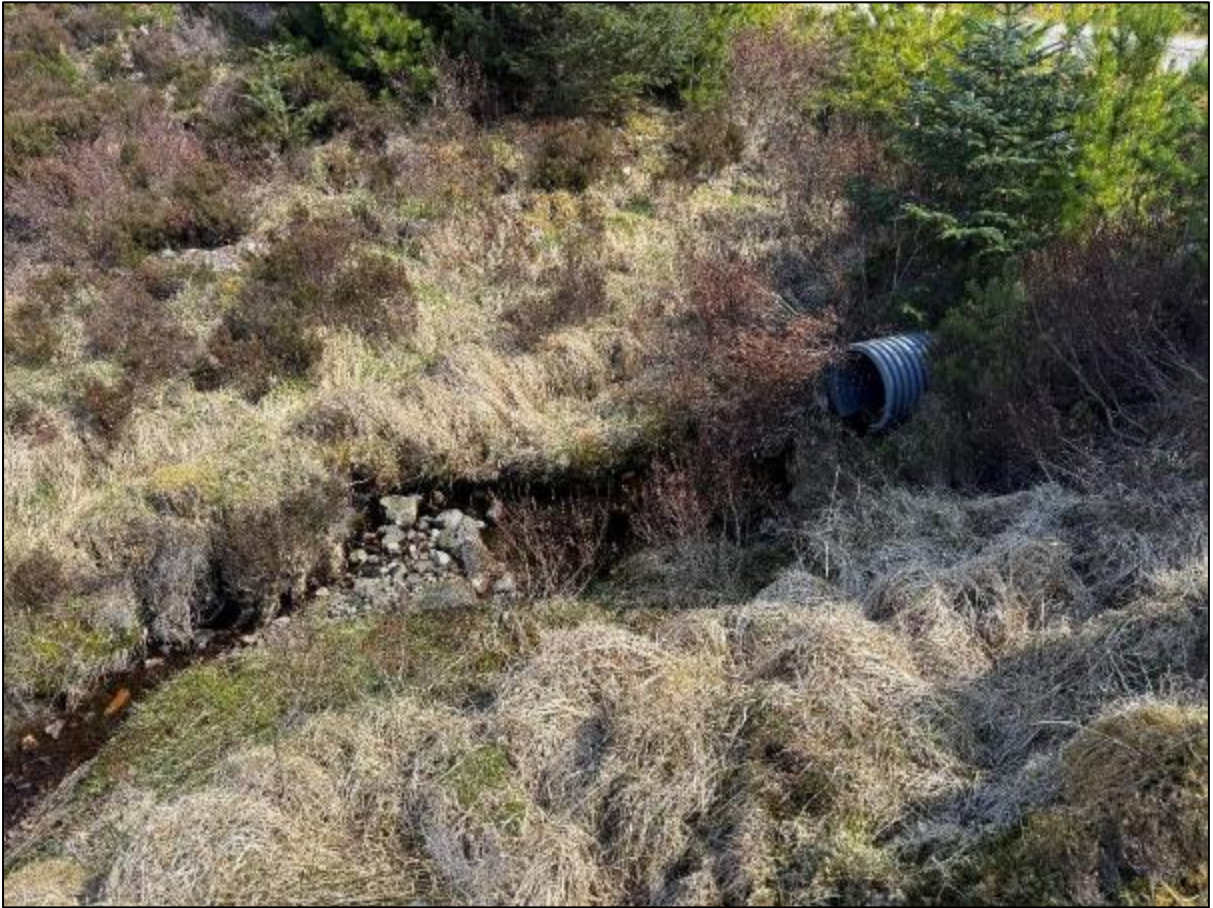
| Crossing No. | OS NGR | CA (km <sup>2</sup> ) | Figure No.* | Notes |
|---|---|---|---|---|
| 6 | NN 14147 99408 | <0.5 | A6 | Very small stream. Some gravel gravel storage. Pipe culvert (~400mm). |

**Figure A6.** Photograph of stream crossing 6. Culvert outfall.

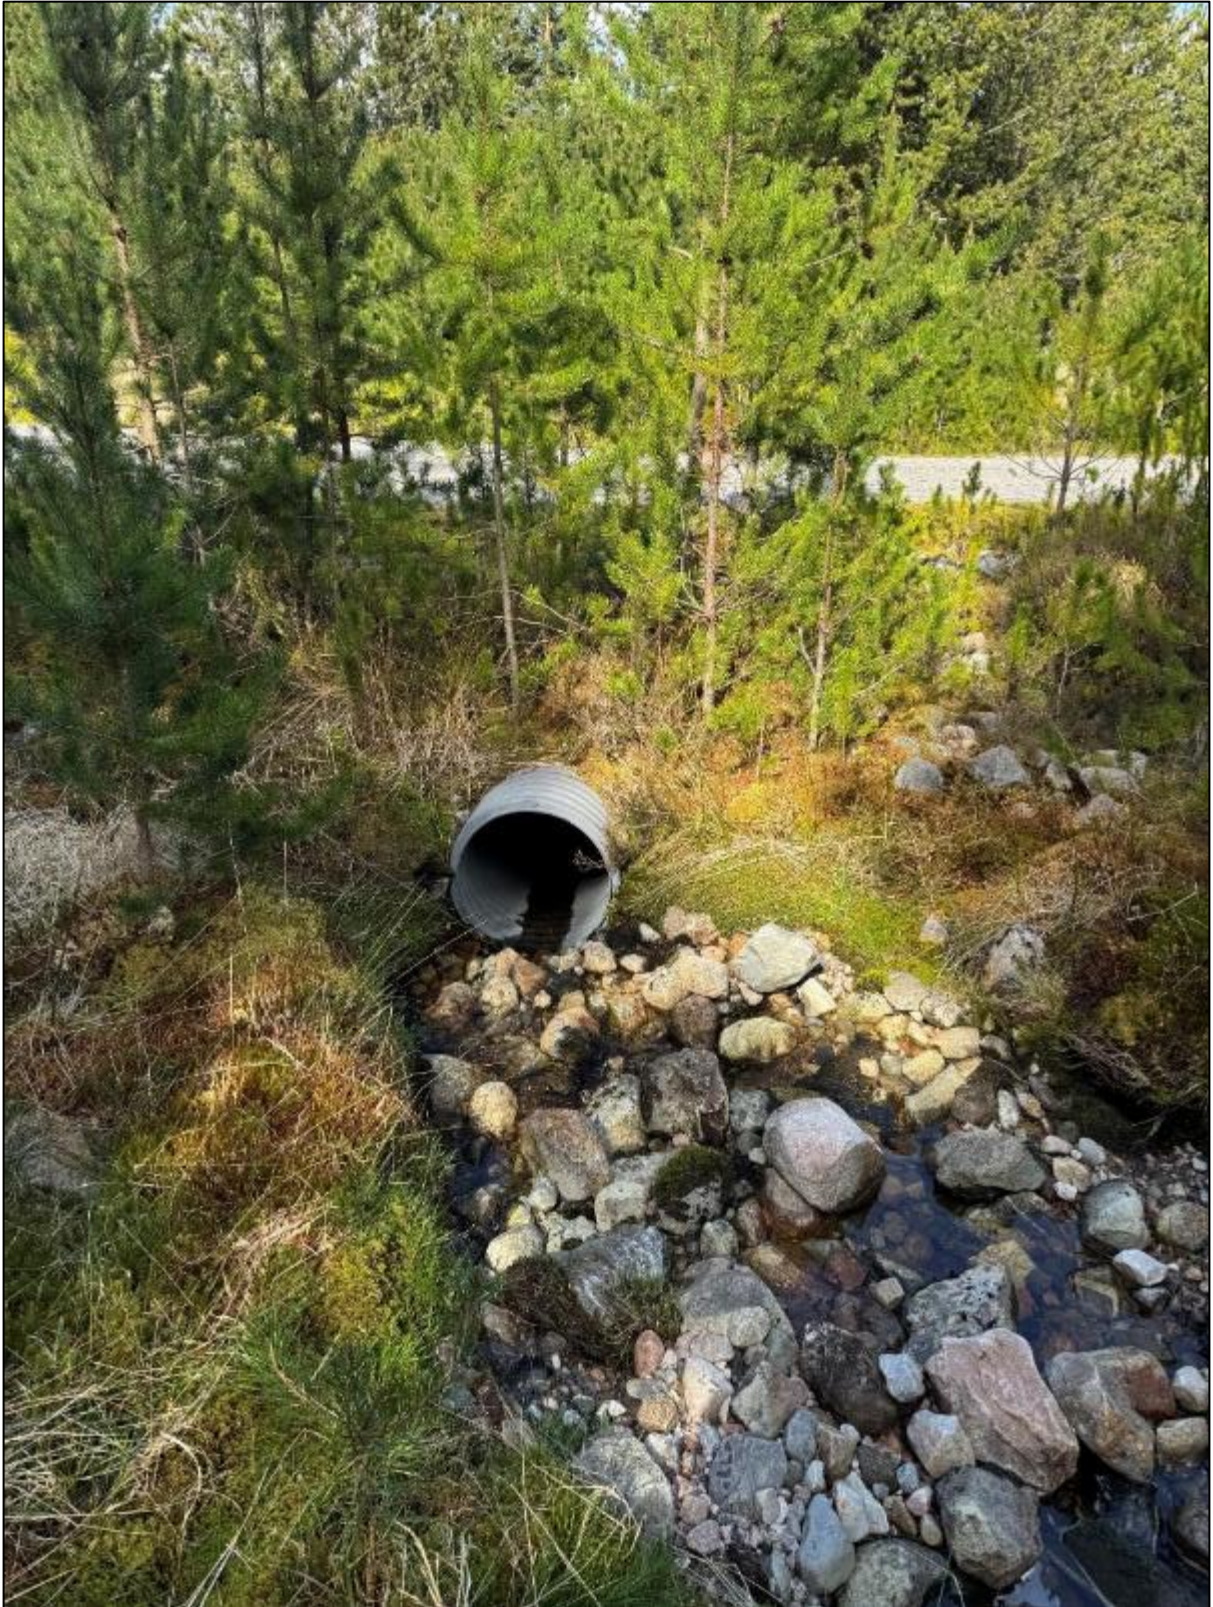
| Crossing No. | OS NGR | CA (km <sup>2</sup> ) | Figure No.* | Notes |
|---|---|---|---|---|
| 7 | NN 15199 99486 | 0.51 | A7 | Small steep stream but significant coarse sed transport. Pipe culvert (~500mm) - undersized and perched on downstream side. |

**Figure A7.** Photograph of stream crossing 7. Culvert outfall.

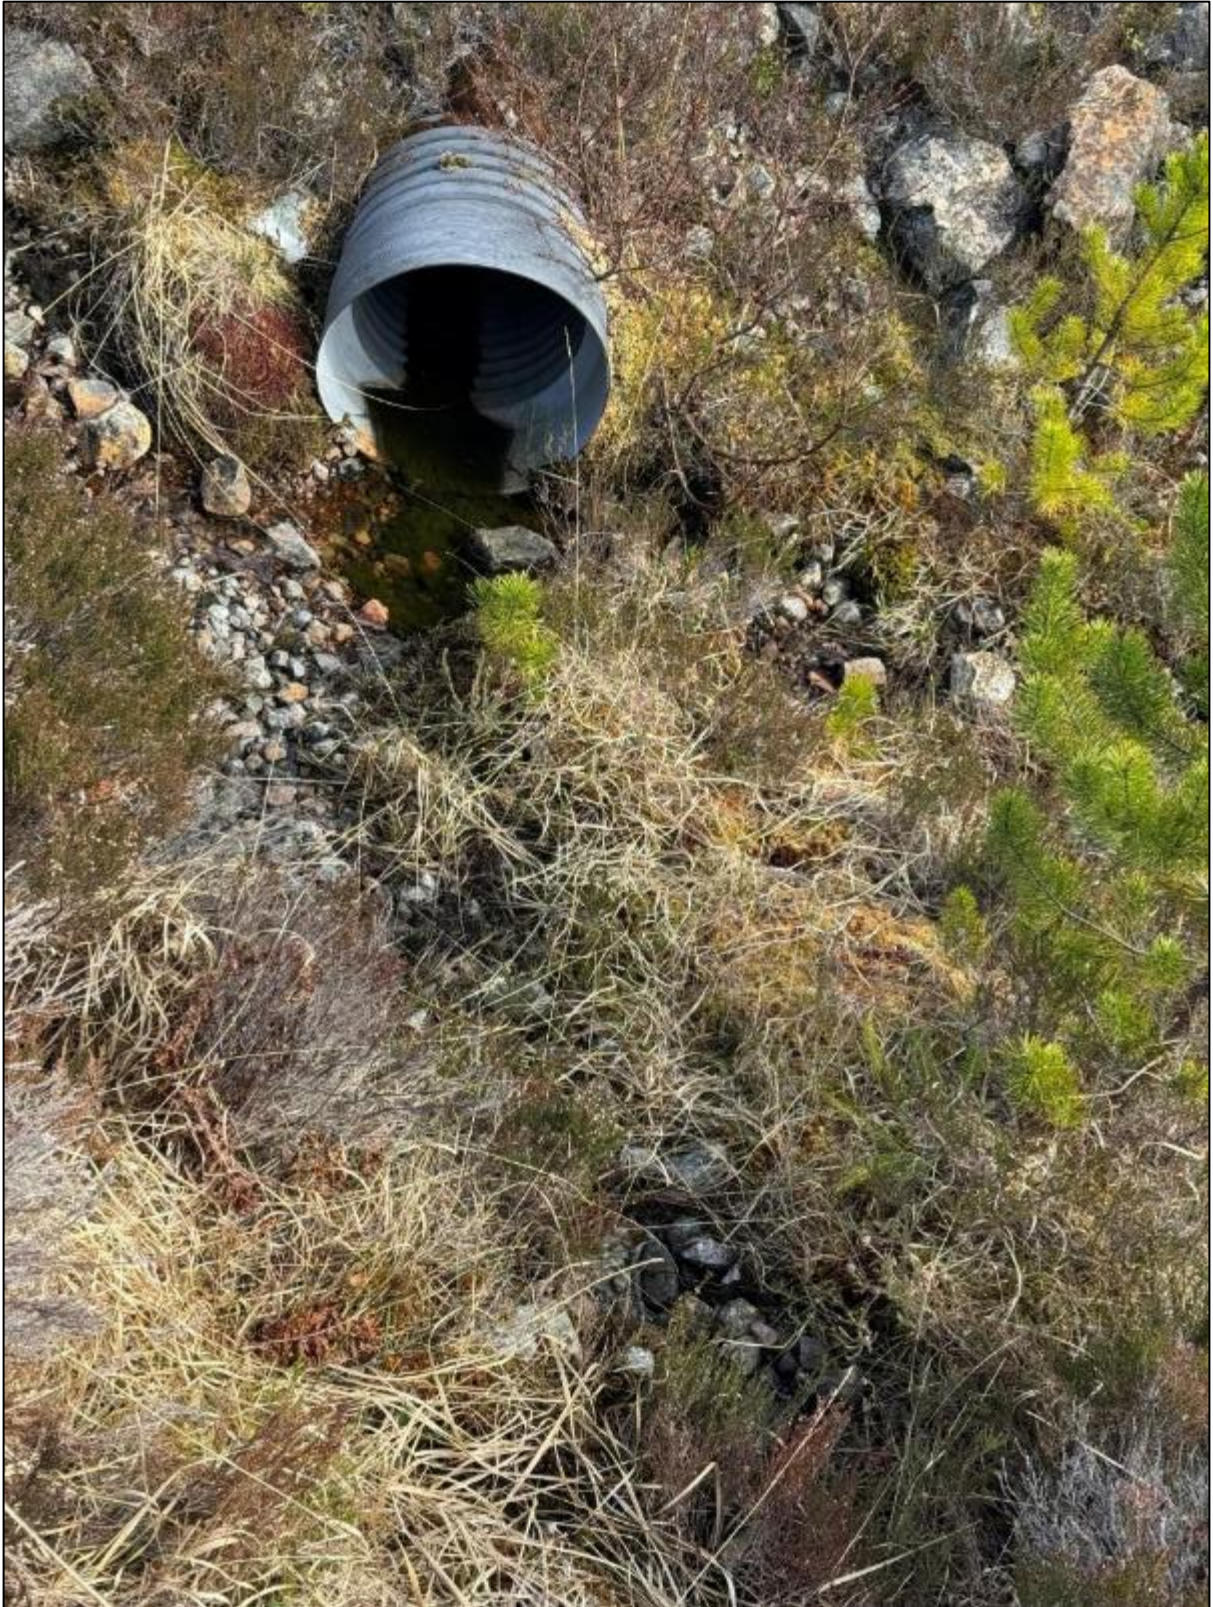
| Crossing No. | OS NGR | CA (km <sup>2</sup> ) | Figure No.* | Notes |
|---|---|---|---|---|
| 8 | NN 15897 99187 | <0.5 | A8 | Very small stream. Some gravel storage. Pipe culvert (~400mm). |

**Figure A8.** Photograph of stream crossing 8. Culvert entrance.

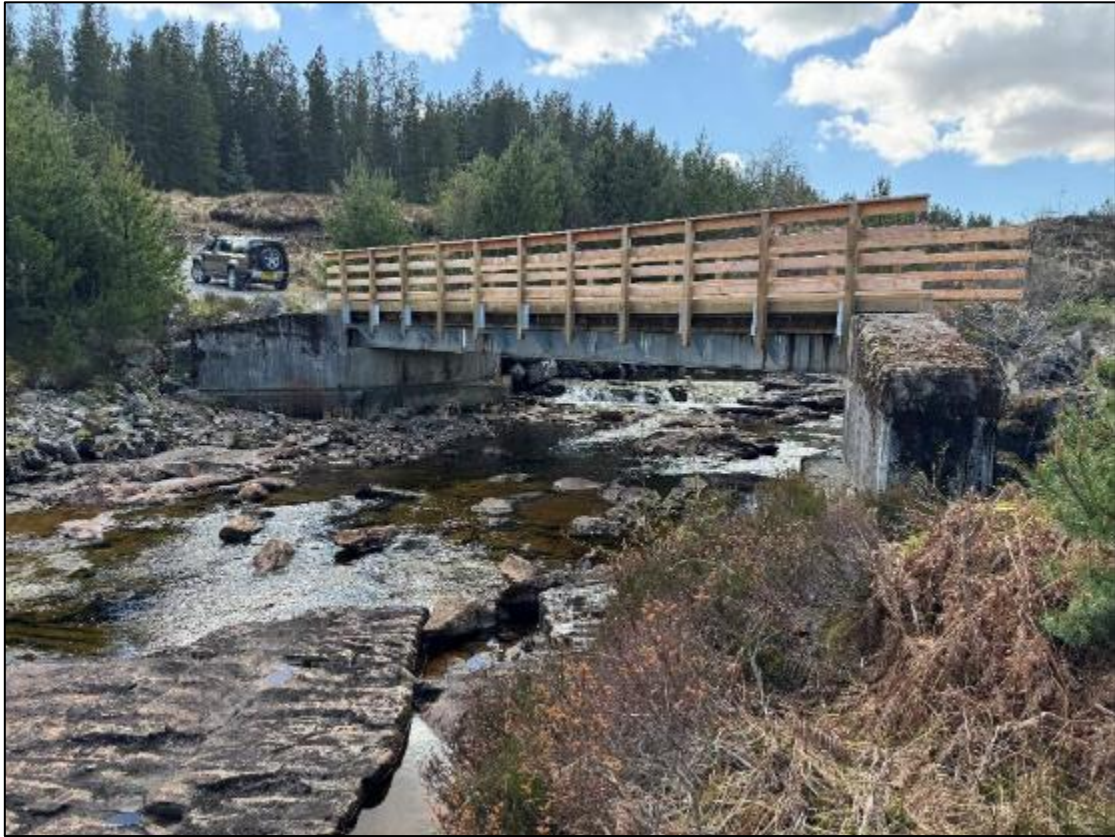
| Crossing No. | OS NGR | CA (km <sup>2</sup> ) | Figure No.* | Notes |
|---|---|---|---|---|
| 9 | NN 15855 98852 | 17.7 | A9 | Significant tributary (Allt Garaidh Ghualaich). Bedrock channel - little sediment supply or storage. HP intake ~100m dstm with no evidence of significant sediment storage in headpond. |

**Figure A9.** Photograph of stream crossing 9. Looking upstream.

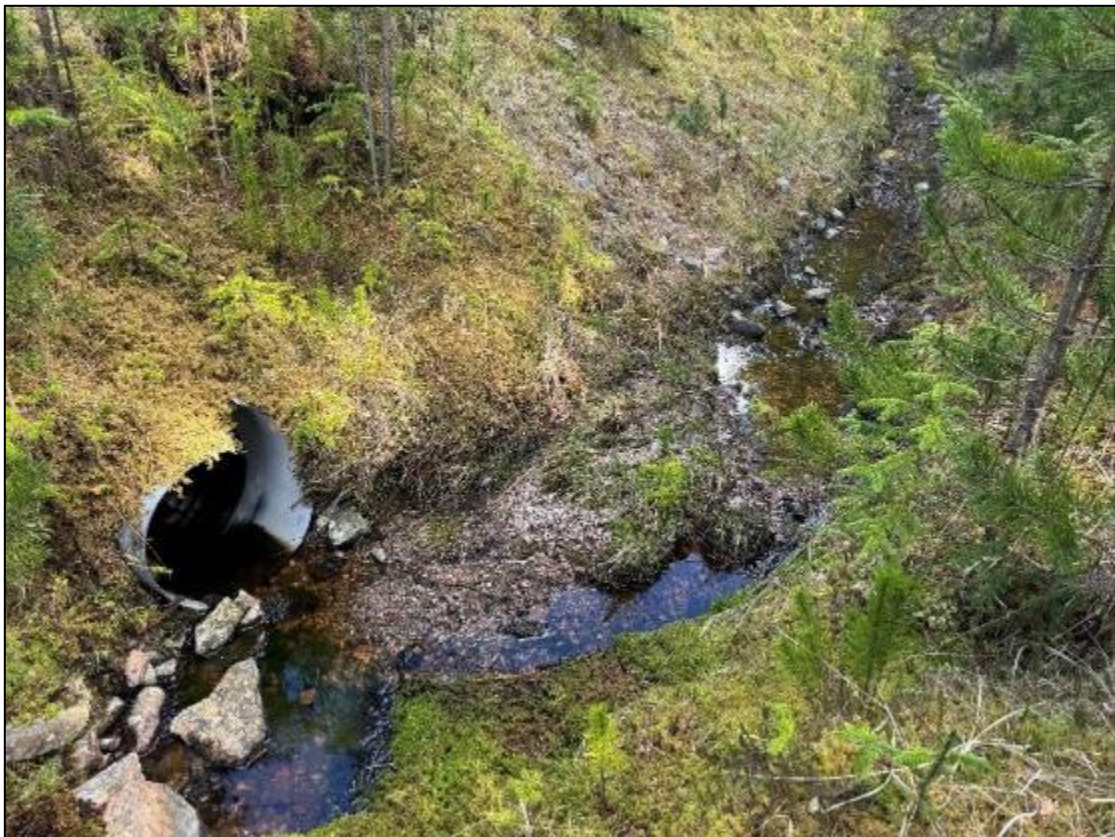
| Crossing No. | OS NGR | CA (km <sup>2</sup> ) | Figure No.* | Notes |
|---|---|---|---|---|
| 10 | NN 16188 98967 | <0.5 | A10 | Very small stream. Runs into ditch along track after coming off slope before passing through culvert. Some fine gravel storage. Pipe culvert (~400mm pipe). |

**Figure A10.** Photograph of stream crossing 10. Culvert entrance.

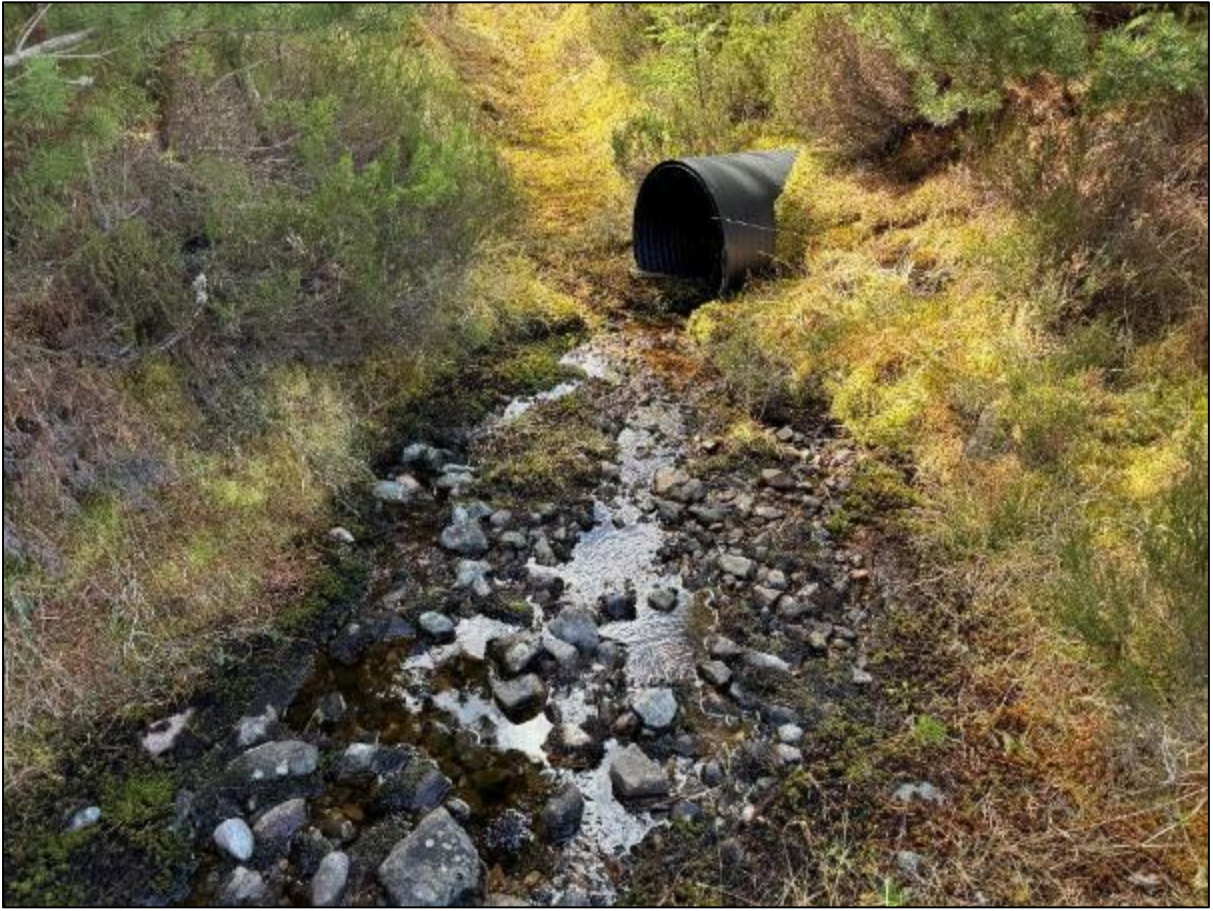
| Crossing No. | OS NGR | CA (km <sup>2</sup> ) | Figure No.* | Notes |
|---|---|---|---|---|
| 11 | NN 16991 99641 | <0.5 | A11 | Very small stream. Some gravel/ cobble storage. Pipe culvert (~600mm). |

**Figure A11.** Photograph of stream crossing 11. Culvert entrance.

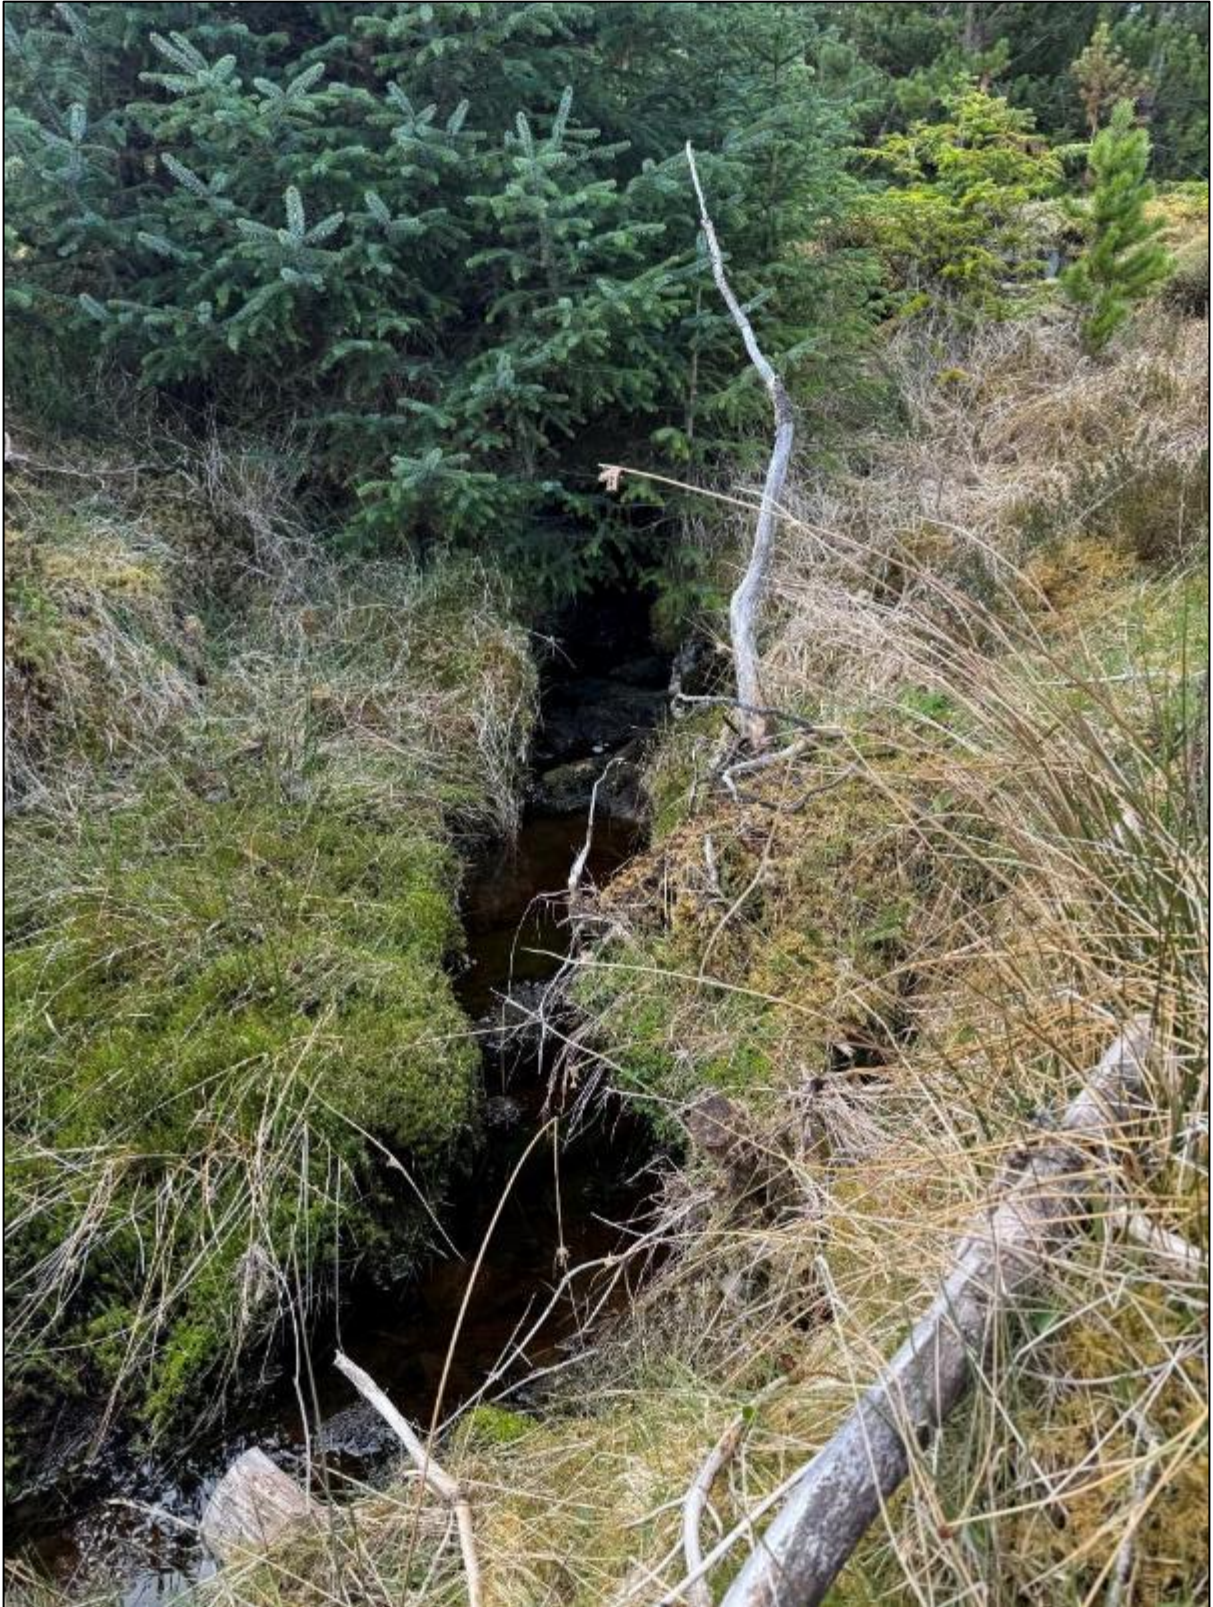
| Crossing No. | OS NGR | CA (km <sup>2</sup> ) | Figure No.* | Notes |
|---|---|---|---|---|
| 12 | NN 18009 99314 | 0.85 | A12 | Small stream with very little sediment. Pipe culvert (~400mm). |

**Figure A12.** Photograph of stream crossing 12. Culvert outfall.

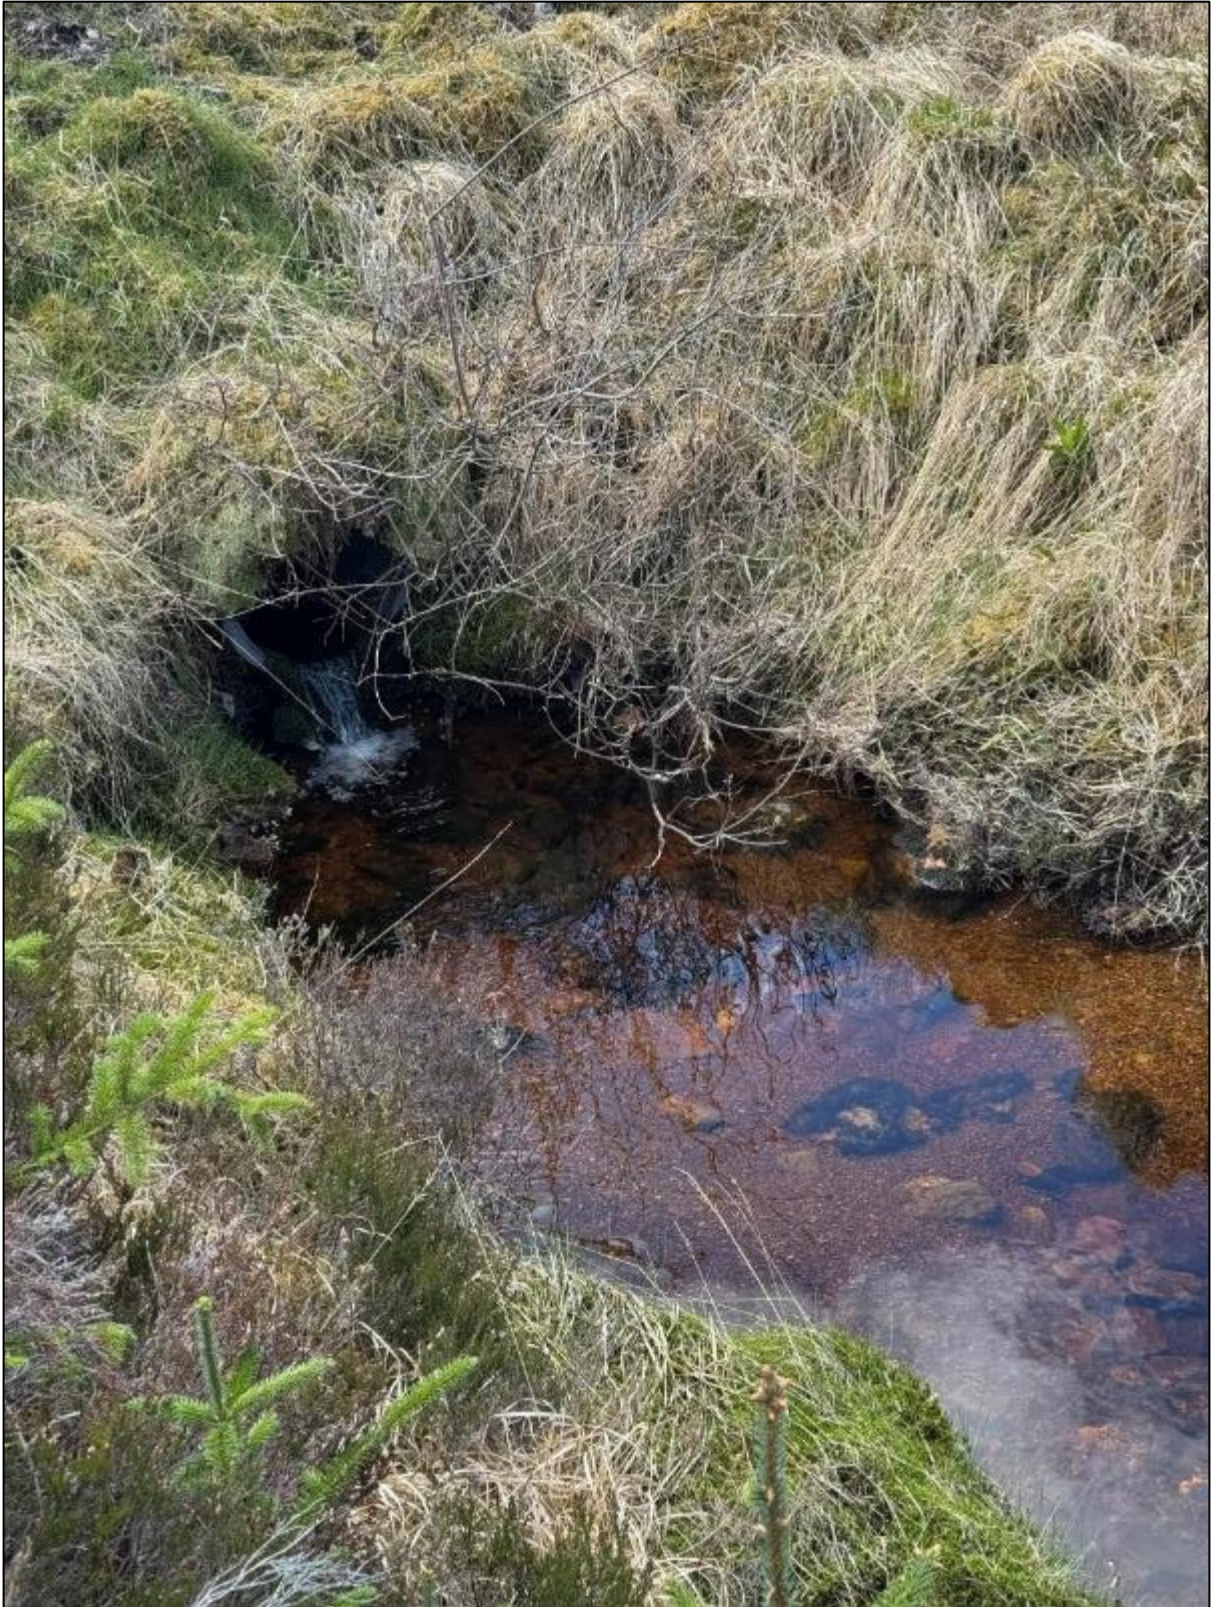
| Crossing No. | OS NGR | CA (km <sup>2</sup> ) | Figure No.* | Notes |
|---|---|---|---|---|
| 13 | NN 18109 99221 | <0.5 | A13 | Small stream. Not much obvious coarse sediment supply but fine gravel deposited in pool downstream. Pipe culvert (~400mm). |

**Figure A13.** Photograph of stream crossing 13. Culvert outfall.

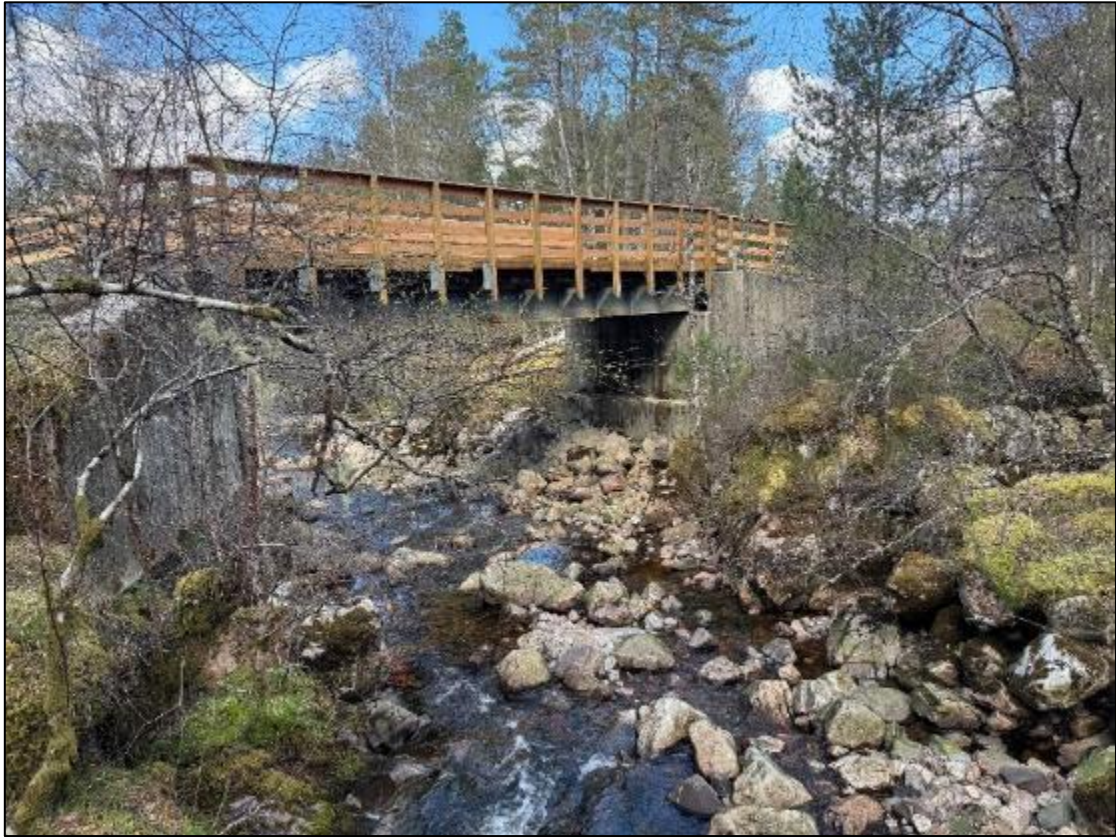
| Crossing No. | OS NGR | CA (km <sup>2</sup> ) | Figure No.* | Notes |
|---|---|---|---|---|
| 14 | NN 18742 99279 | 8.96 | A14 | Significant tributary (Greenfield Burn). Steep channel with bedrock, boulders and patches of gravel/ cobble deposits (although relatively low sediment storage). Appropriate bridge crossing. |

**Figure A14.** Photograph of stream crossing 14. Looking downstream.

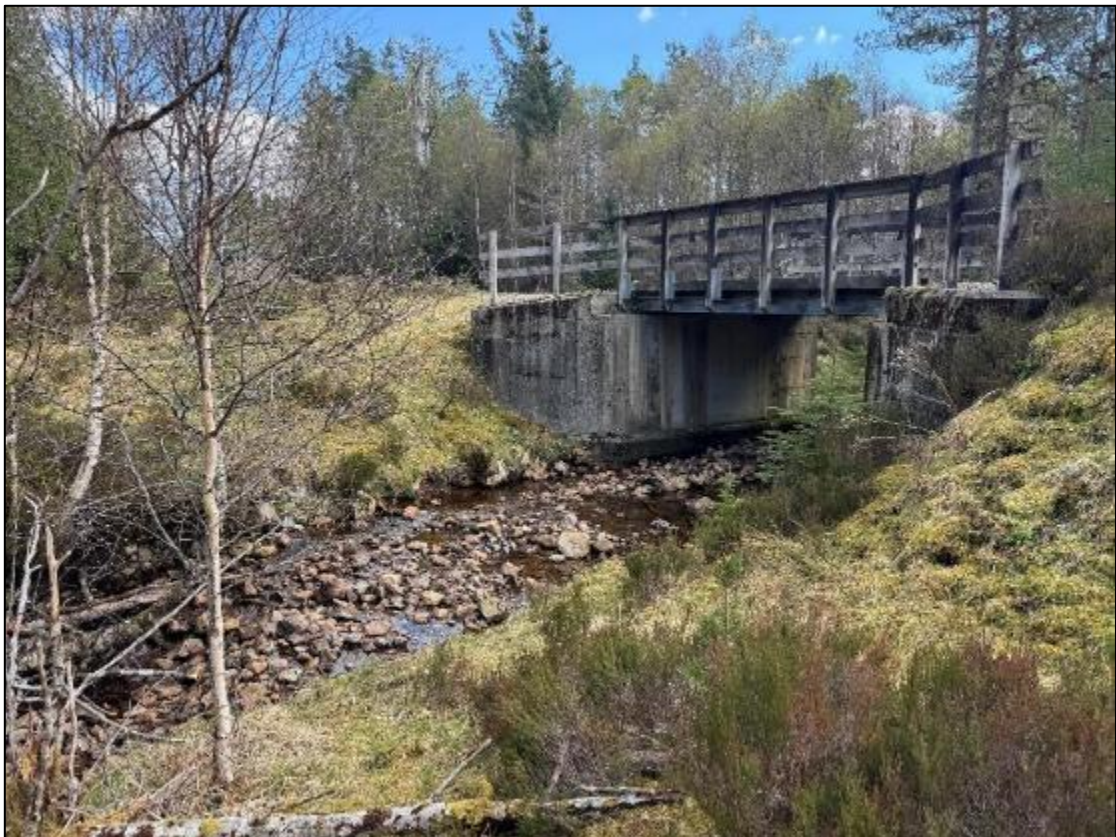
| Crossing No. | OS NGR | CA (km <sup>2</sup> ) | Figure No.* | Notes |
|---|---|---|---|---|
| 15 | NN 18927 99405 | 1.92 | A15 | Moderately sized tributary (Allt na Gearr Leacainn). Reasonable gravel/ cobble stored in bar feature. About appropriate single span bridge crossing (could be slightly wider, ideally). |

**Figure A15.** Photograph of stream crossing 15. Looking upstream.
