## **Fearna Pumped Storage Hydro Scheme - EIA Report**

### **Appendix D – Geomorphology Report Southern Access Route (SAR)**

# **Fearna Pumped Storage Hydro Scheme Geomorphology Report:**

## **A. Southern Access Route**

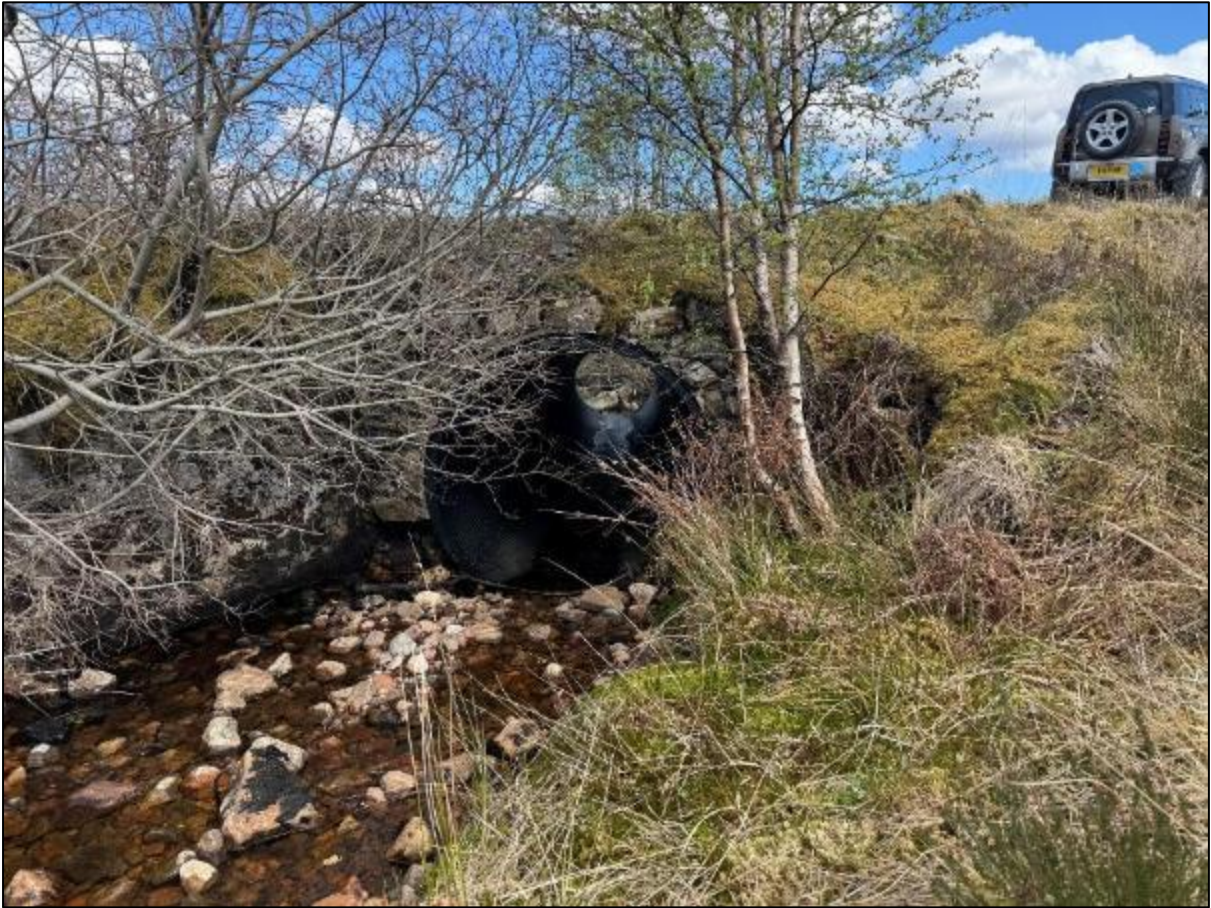
| Crossing No. | OS NGR | CA (km <sup>2</sup> ) | Figure No.* | Notes |
|---|---|---|---|---|
| 16 | NN 19635 99427 | 1.12 | A16 | Moderately sized tributary (Allt Giubhais). Significant gravel/ cobble transport and storage. Pipe culvert (~1.2m) likely undersized for imposed sediment supply/ transport conditions. |

**Figure A16.** Photograph of stream crossing 16. Culvert entrance.

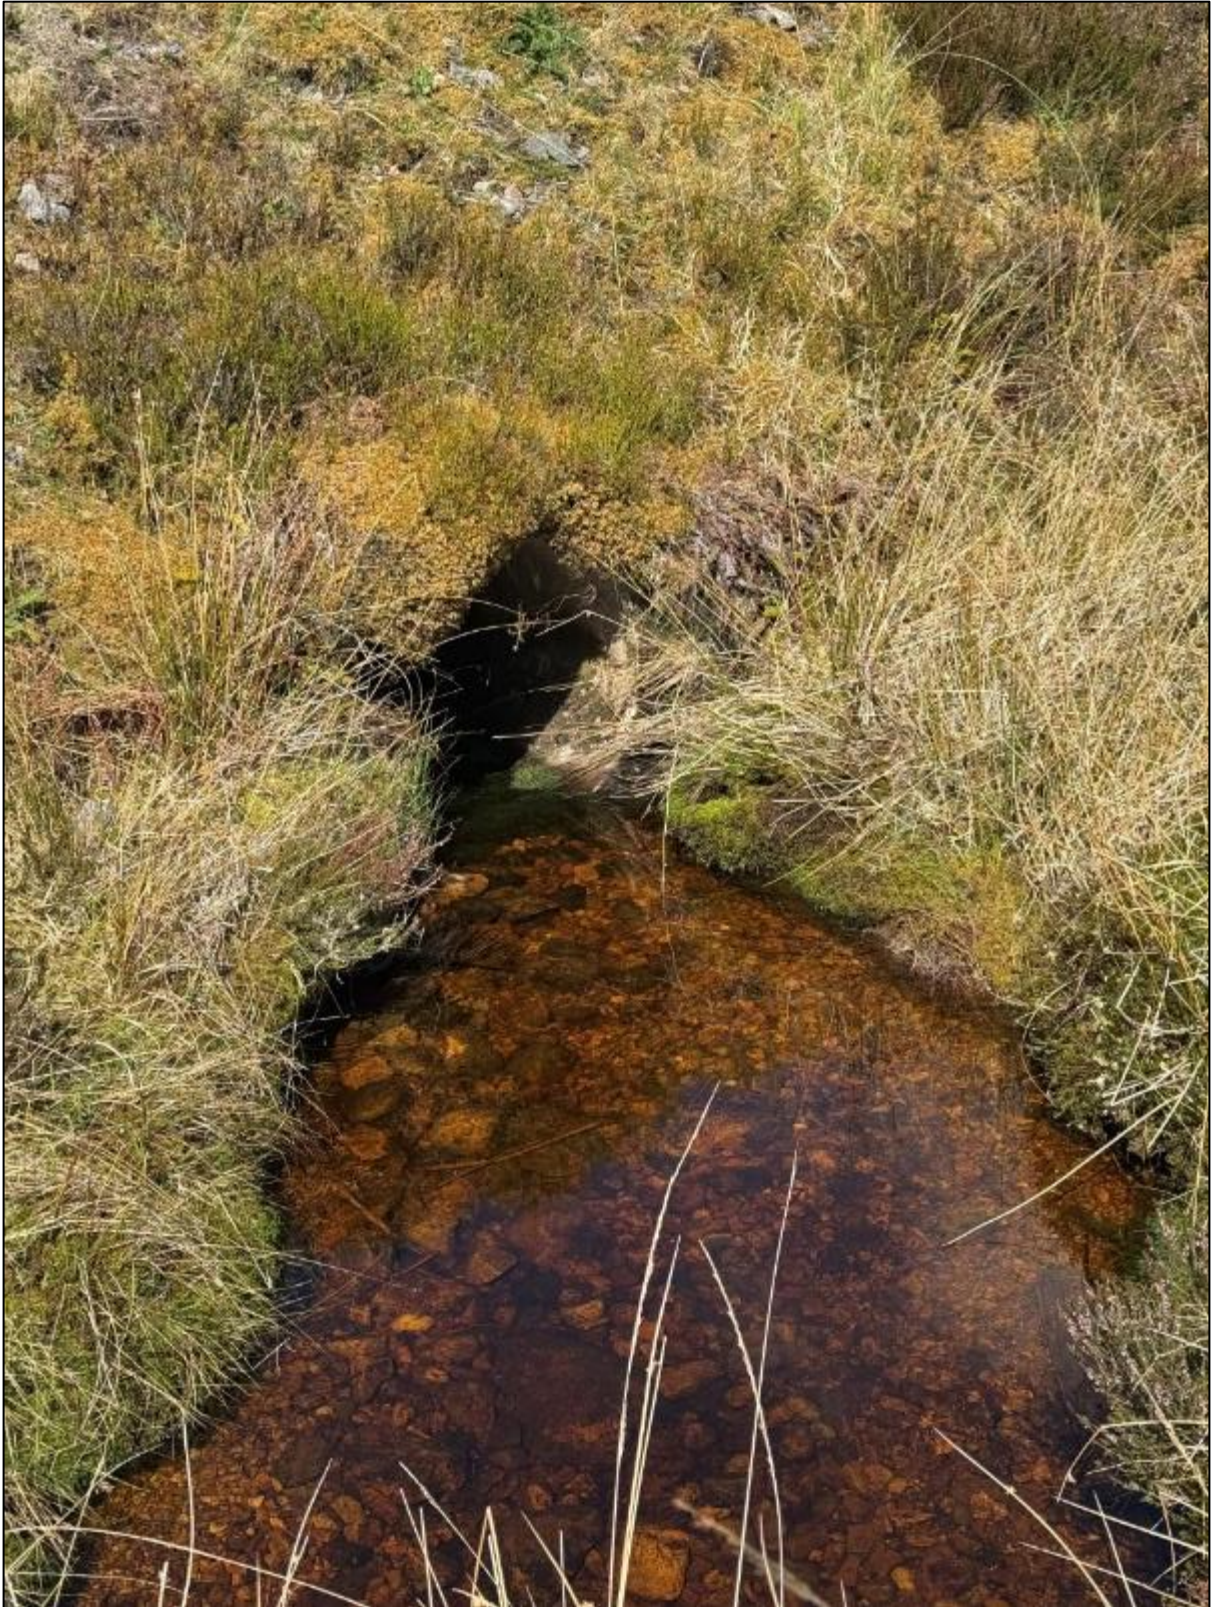
| Crossing No. | OS NGR | CA (km <sup>2</sup> ) | Figure No.* | Notes |
|---|---|---|---|---|
| 17 | NN 19750 99432 | <0.5 | A17 | Very small stream. Some gravel transport/ storage. Pipe culvert (~600mm). Perched outfall on downstream side, with coarser sediment in channel. |

**Figure A17.** Photograph of stream crossing 17. Culvert entrance.

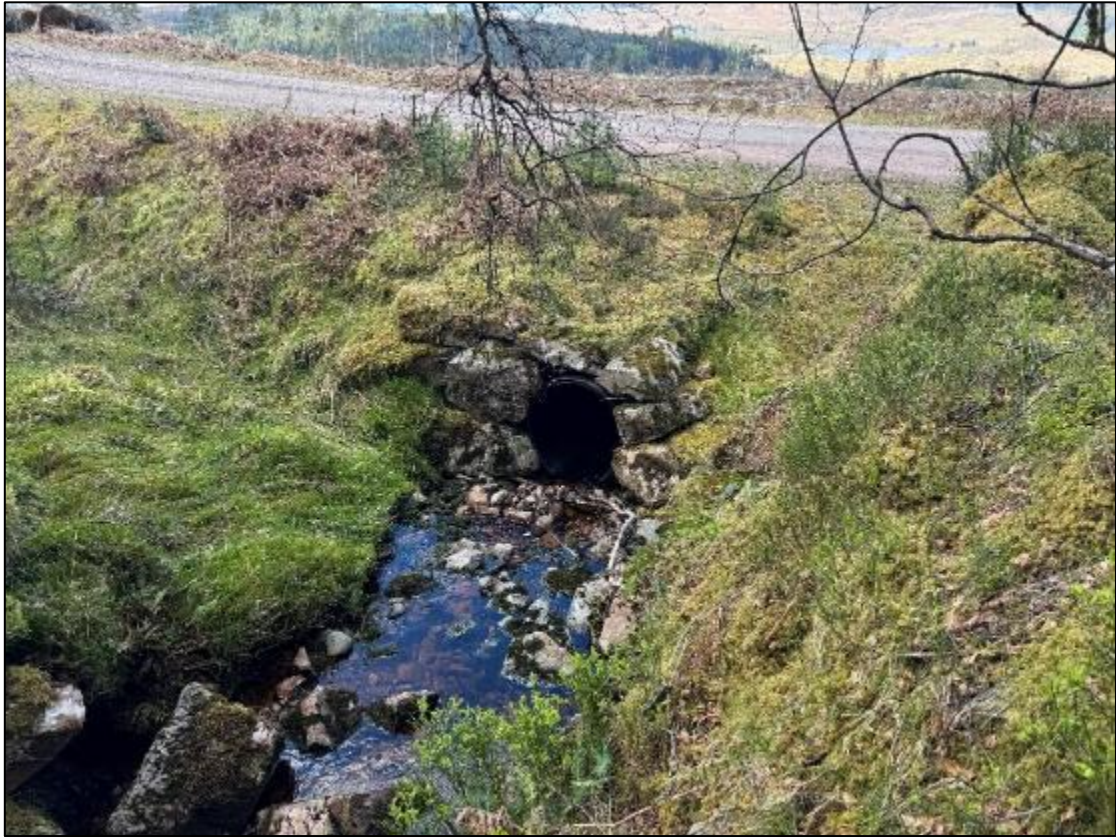
| Crossing No. | OS NGR | CA (km <sup>2</sup> ) | Figure No.* | Notes |
|---|---|---|---|---|
| 18 | NN 20211 99579 | 0.86 | A18 | Small, steep stream (Allt nan Corp). Some gravel/ cobble transport/ storage. Pipe culvert (~600 pipe) and perched on the downstream side - likely too small. |

**Figure A18.** Photograph of stream crossing 18. Culvert entrance.

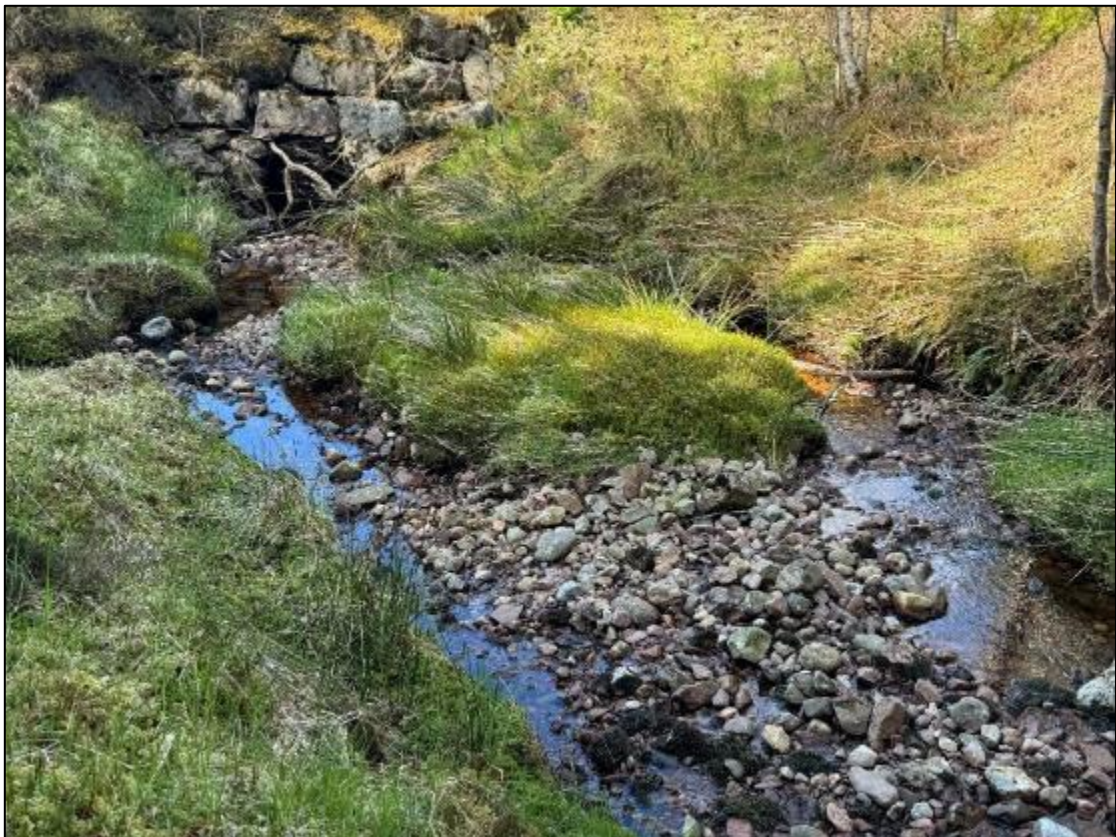
| Crossing No. | OS NGR | CA (km <sup>2</sup> ) | Figure No.* | Notes |
|---|---|---|---|---|
| 19 | NN 20552 99744 | 0.84 | A19 | Small, steep tributary (Allt na Plaide) but with significant sediment accumulation at undersized pipe culvert (~600mm). |

**Figure A19.** Photograph of stream crossing 19. Culvert entrance.

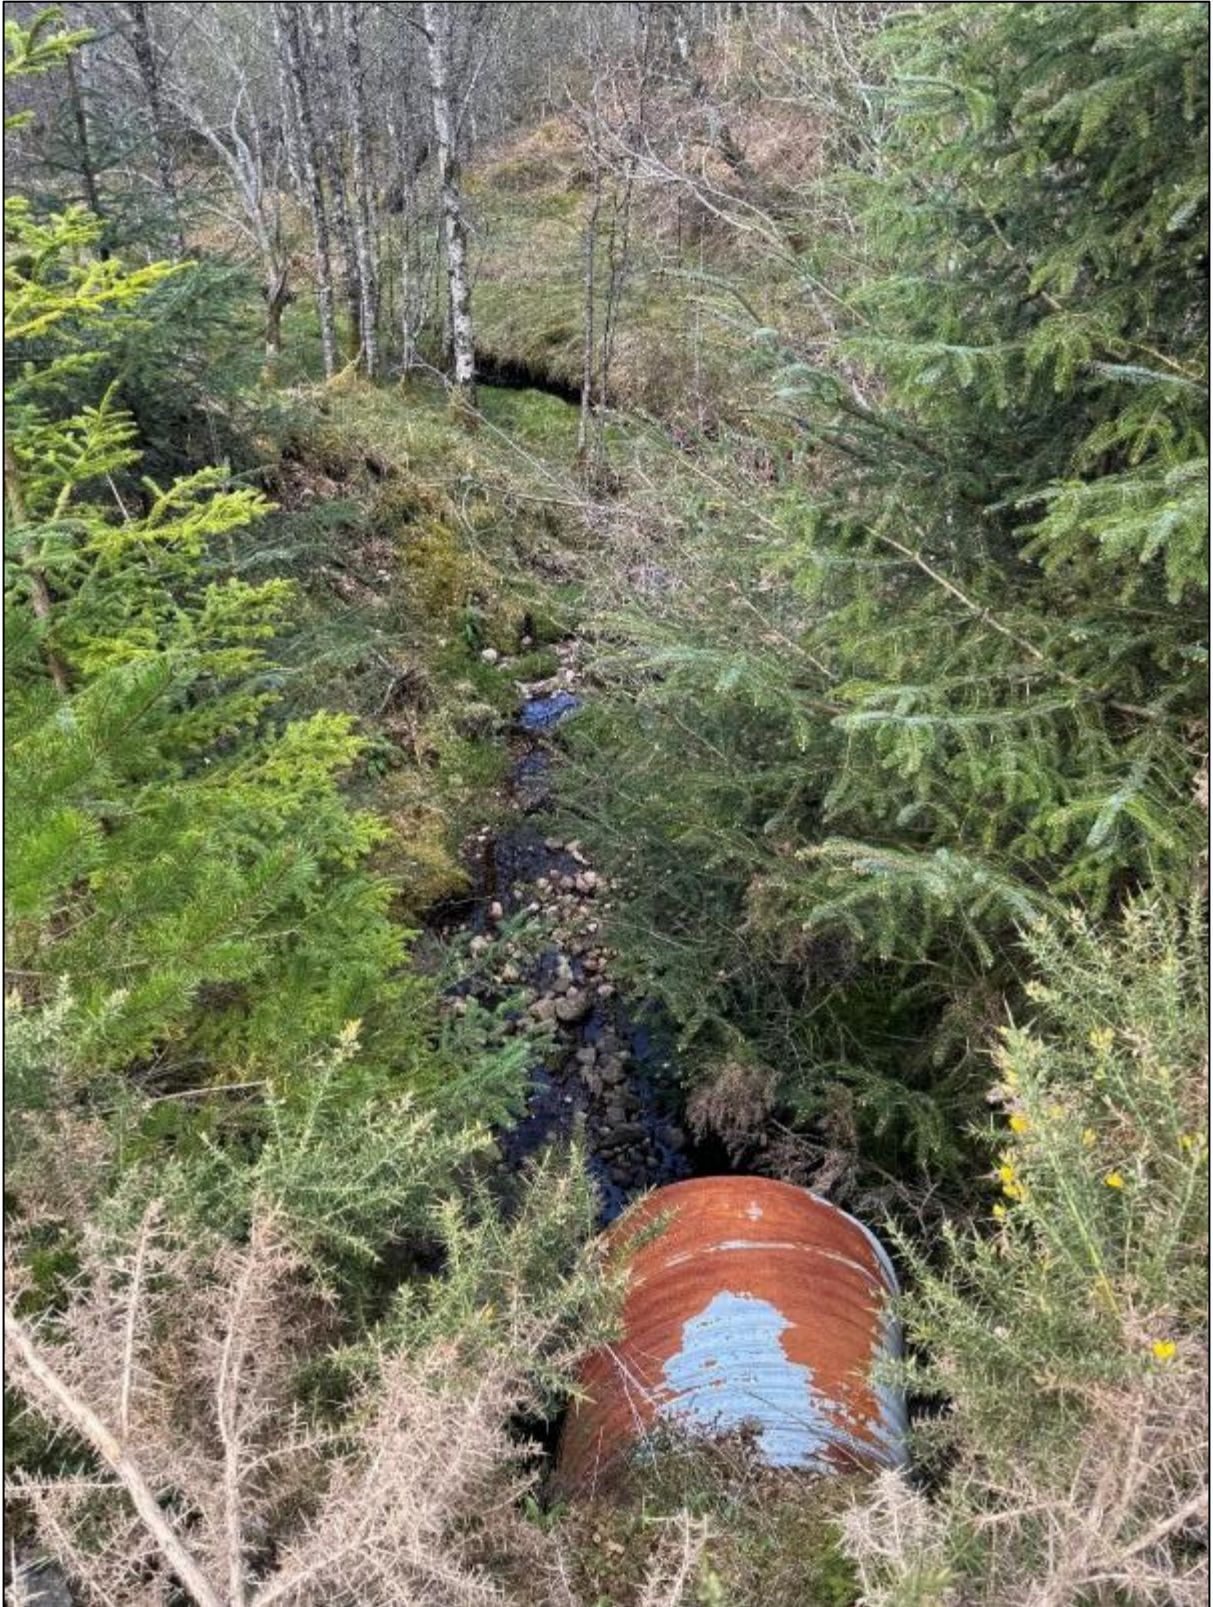
| Crossing No. | OS NGR | CA (km <sup>2</sup> ) | Figure No.* | Notes |
|---|---|---|---|---|
| 20 | NN 20723 99706 | <0.5 | A20 | Small stream, with some evidence of gravel/ cobble transport/ storage. Pipe culvert (~900mm), oblique to flow upstream and with perched outfall downstream. |

**Figure A20.** Photograph of stream crossing 20. Culvert outfall.

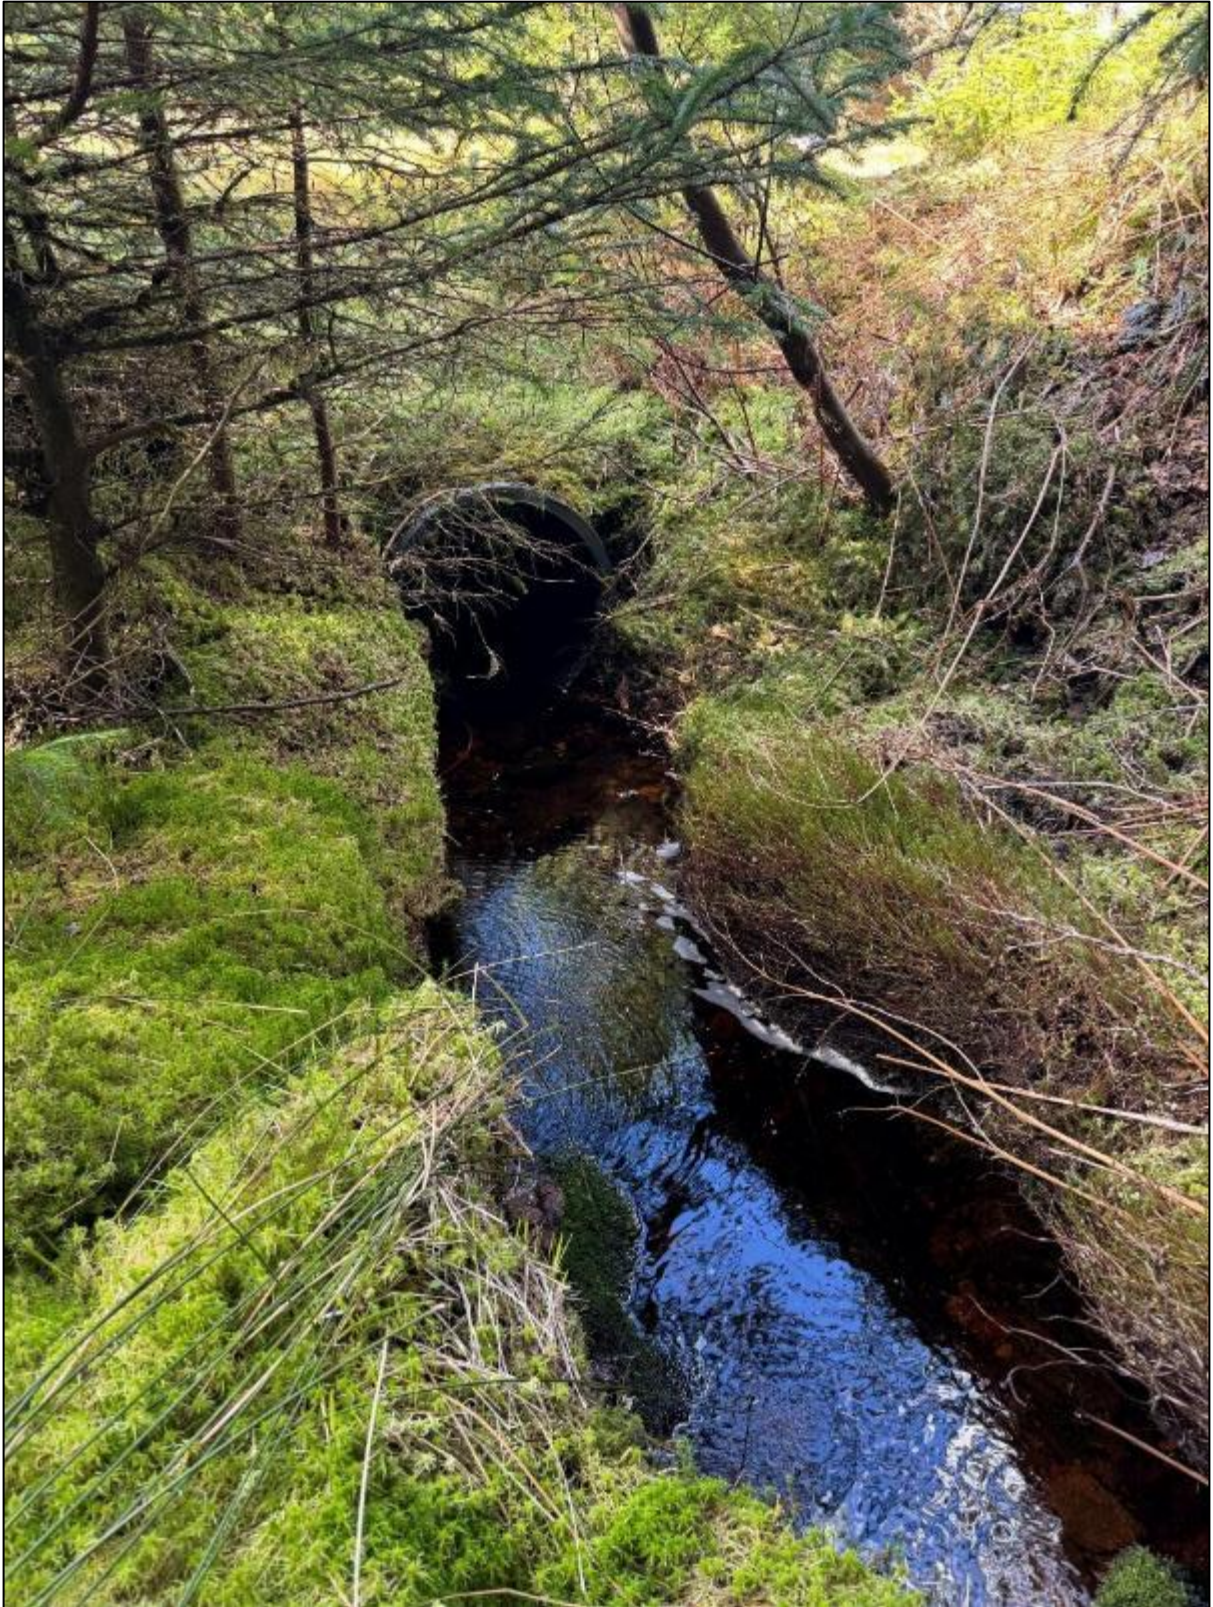
| Crossing No. | OS NGR | CA (km <sup>2</sup> ) | Figure No.* | Notes |
|---|---|---|---|---|
| 21 | NH 21535 00219 | 0.71 | A21 | Small stream (Allt Criche) with little sediment transport/ storage. Pipe culvert (~500mm). |

**Figure A21.** Photograph of stream crossing 21. Culvert entrance.

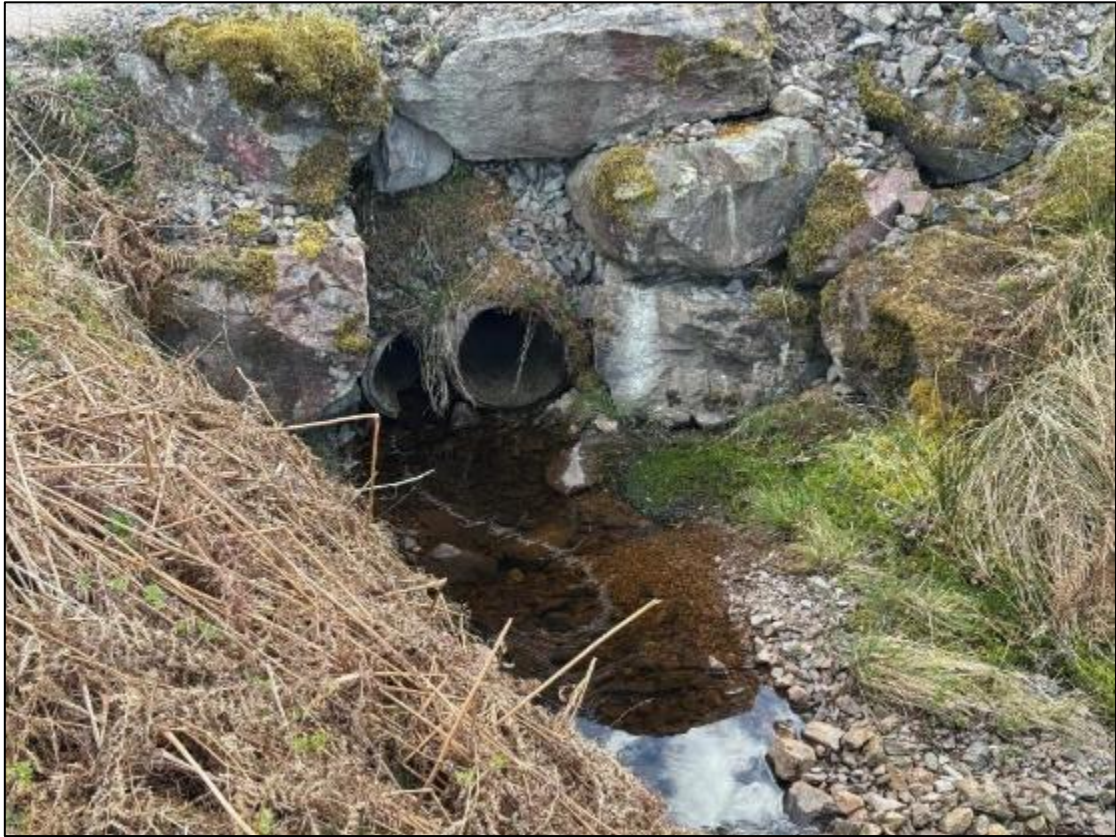
| Crossing No. | OS NGR | CA (km <sup>2</sup> ) | Figure No.* | Notes |
|---|---|---|---|---|
| 22 | NH 21606 00288 | <0.5 | A22 | Very small stream, with some gravel deposition downstream. Double pipe culvert (~200mm and ~300mm). |

**Figure A22.** Photograph of stream crossing 22. Culvert outfall.

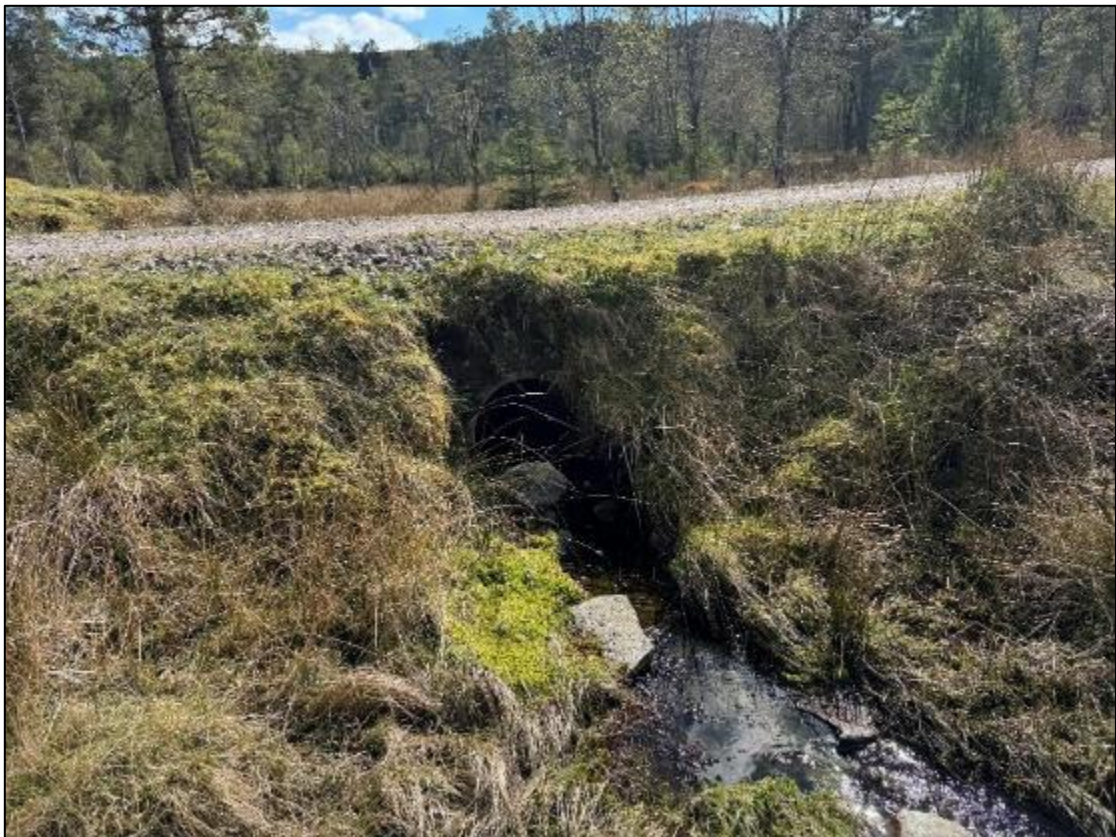
| Crossing No. | OS NGR | CA (km <sup>2</sup> ) | Figure No.* | Notes |
|---|---|---|---|---|
| 23 | NH 22286 00371 | <0.5 | A23 | Very small stream draining wetland area with little evidence of sediment transport. Pipe culvert (~600mm). |

**Figure A23.** Photograph of stream crossing 23. Culvert outfall.

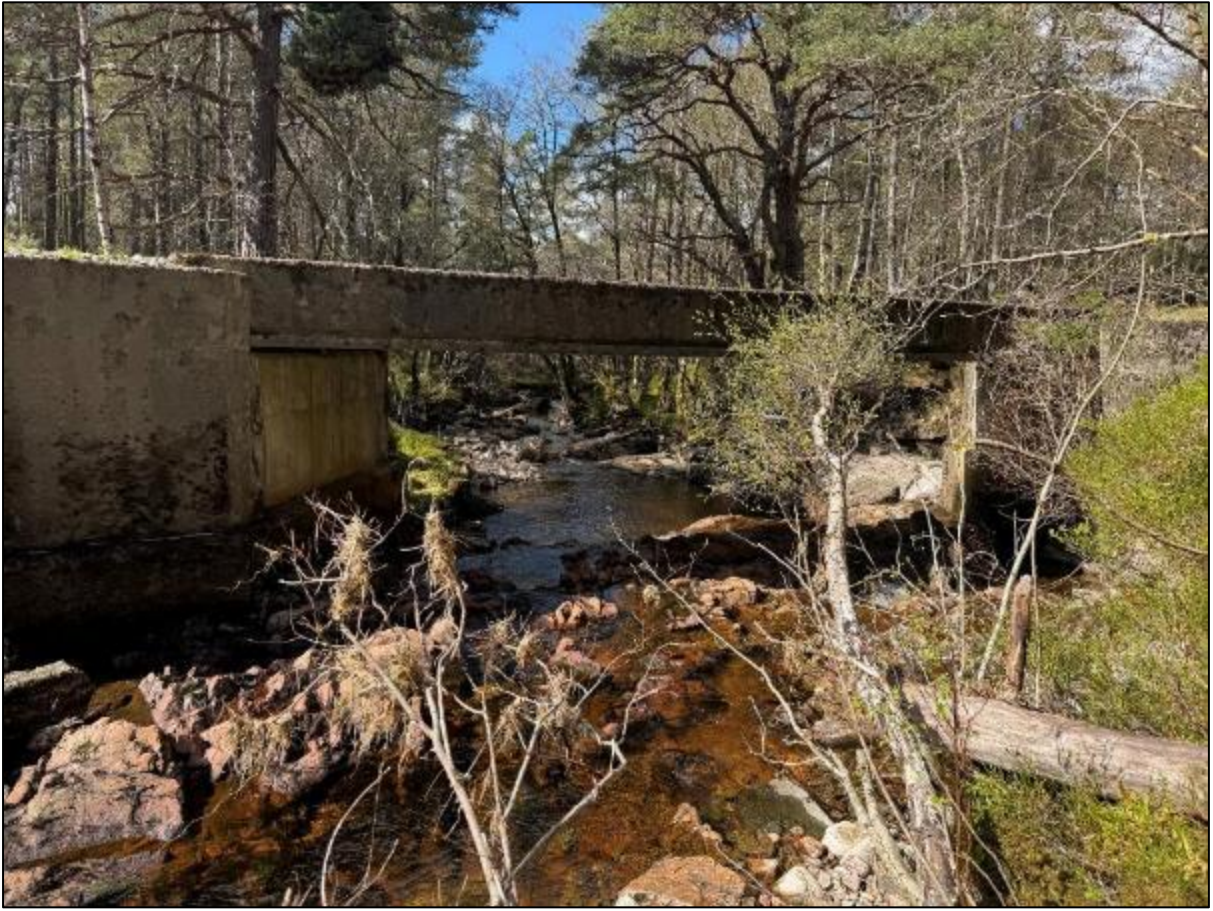
| Crossing No. | OS NGR | CA (km <sup>2</sup> ) | Figure No.* | Notes |
|---|---|---|---|---|
| 24 | NH 22982 00252 | 15.5 | A24 | Significant, steep tributary (Allt Ladaidh) with bedrock and cobble/ boulder bed. River left (i.e. west) bridge abutment will impede high flows. |

**Figure A24.** Photograph of stream crossing 24. Looking upstream.

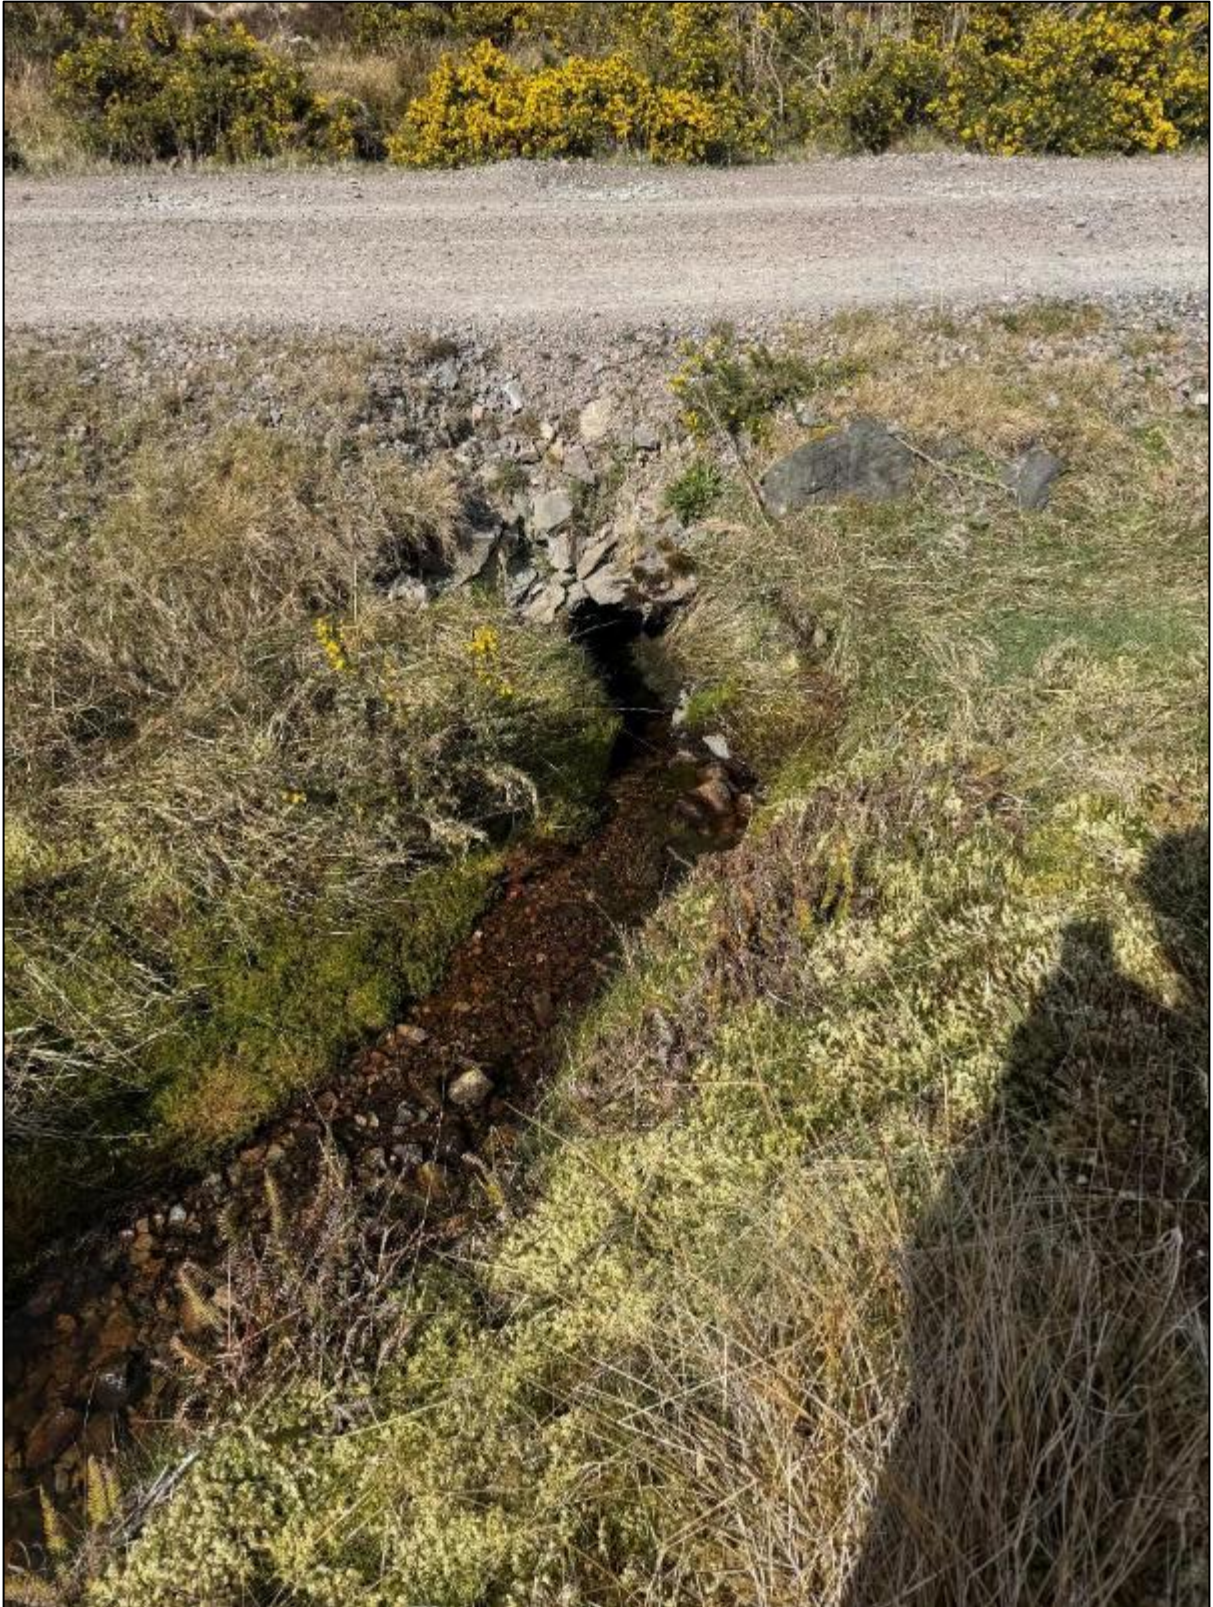
| Crossing No. | OS NGR | CA (km <sup>2</sup> ) | Figure No.* | Notes |
|---|---|---|---|---|
| 26 | NH 24793 00810 | 0.50 | A26 | Small stream (Allt Bolinn) but some gravel transport/ storage. Pipe culvert (~400mm). |

**Figure A26.** Photograph of stream crossing 26. Culvert entrance.

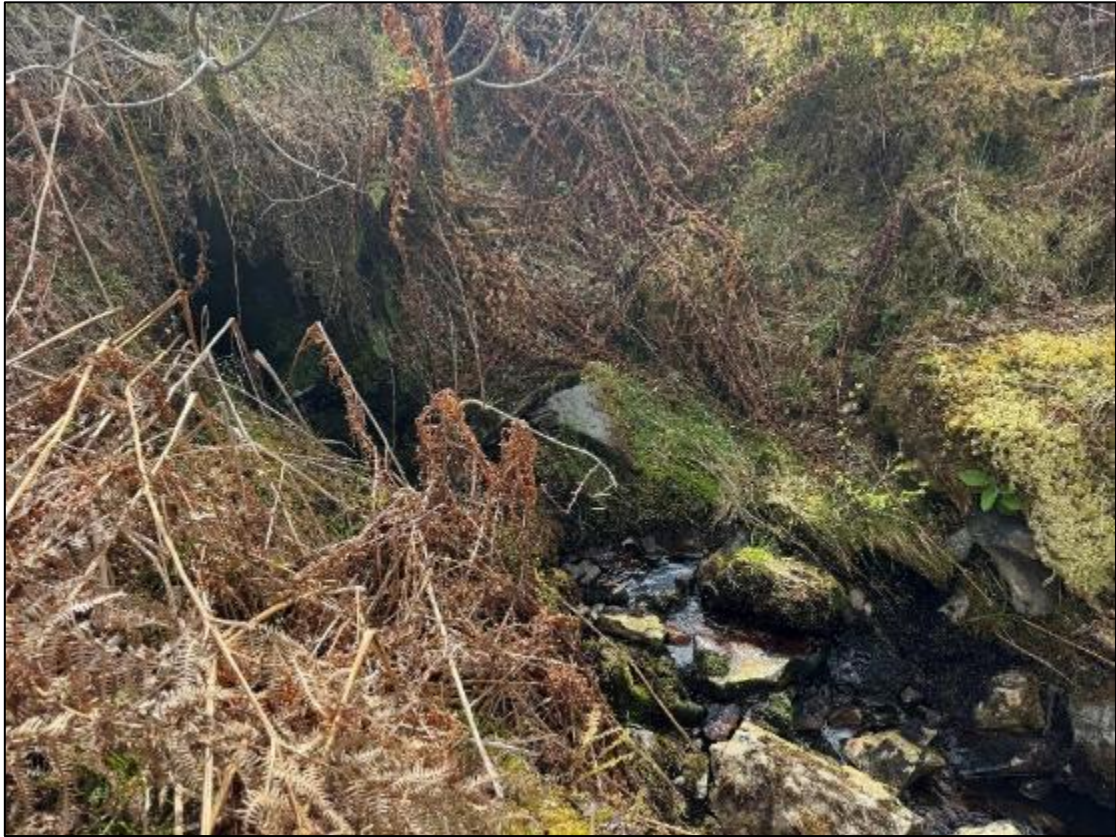
| Crossing No. | OS NGR | CA (km <sup>2</sup> ) | Figure No.* | Notes |
|---|---|---|---|---|
| 27 | NH 24986 00801 | <0.5 | A27 | Very small stream with limited gravel transport/ storage. Pipe culvert (~500mm). |

**Figure A27.** Photograph of stream crossing 27. Culvert outfall.

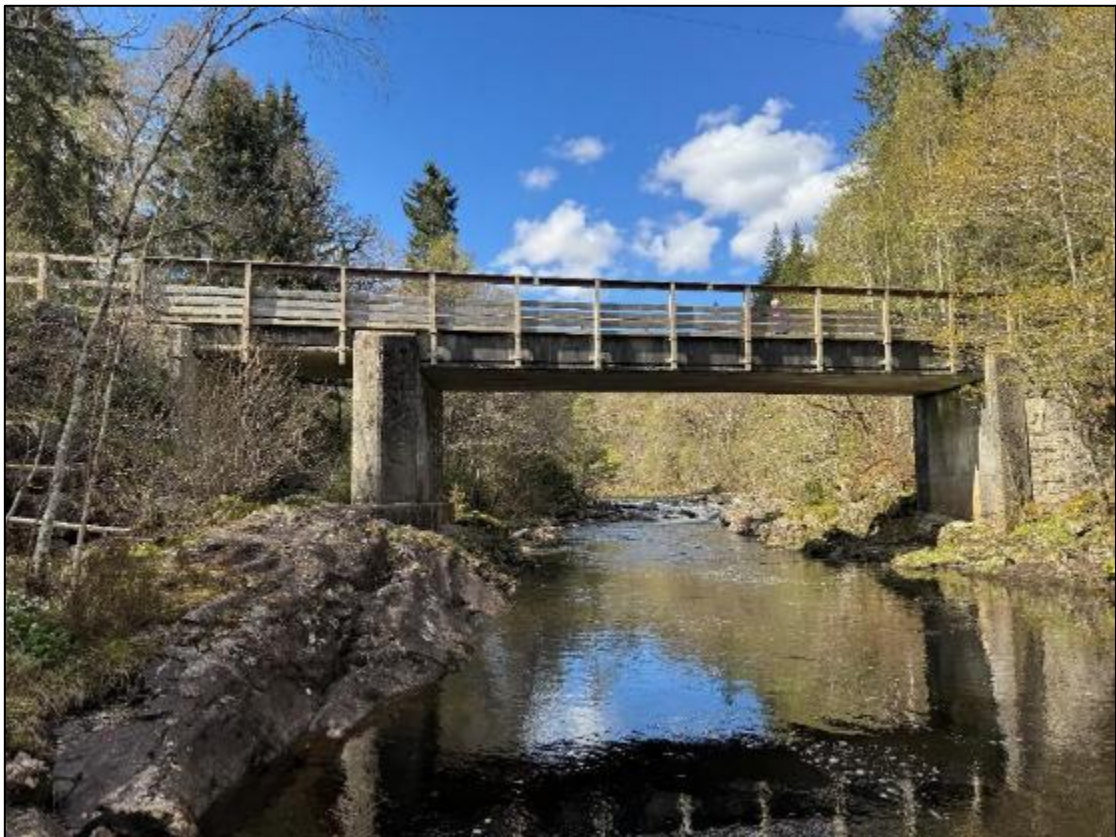
| Crossing No. | OS NGR | CA (km <sup>2</sup> ) | Figure No.* | Notes |
|---|---|---|---|---|
| 28 | NH 28362 01344 | 360.1 | A28 | White Bridge over River Garry. River right (i.e. west) pier in high flow channel - single span would be better in relation to physical processes. |

**Figure A28.** Photograph of stream crossing 28 (White Bridge over River Garry). Looking upstream.

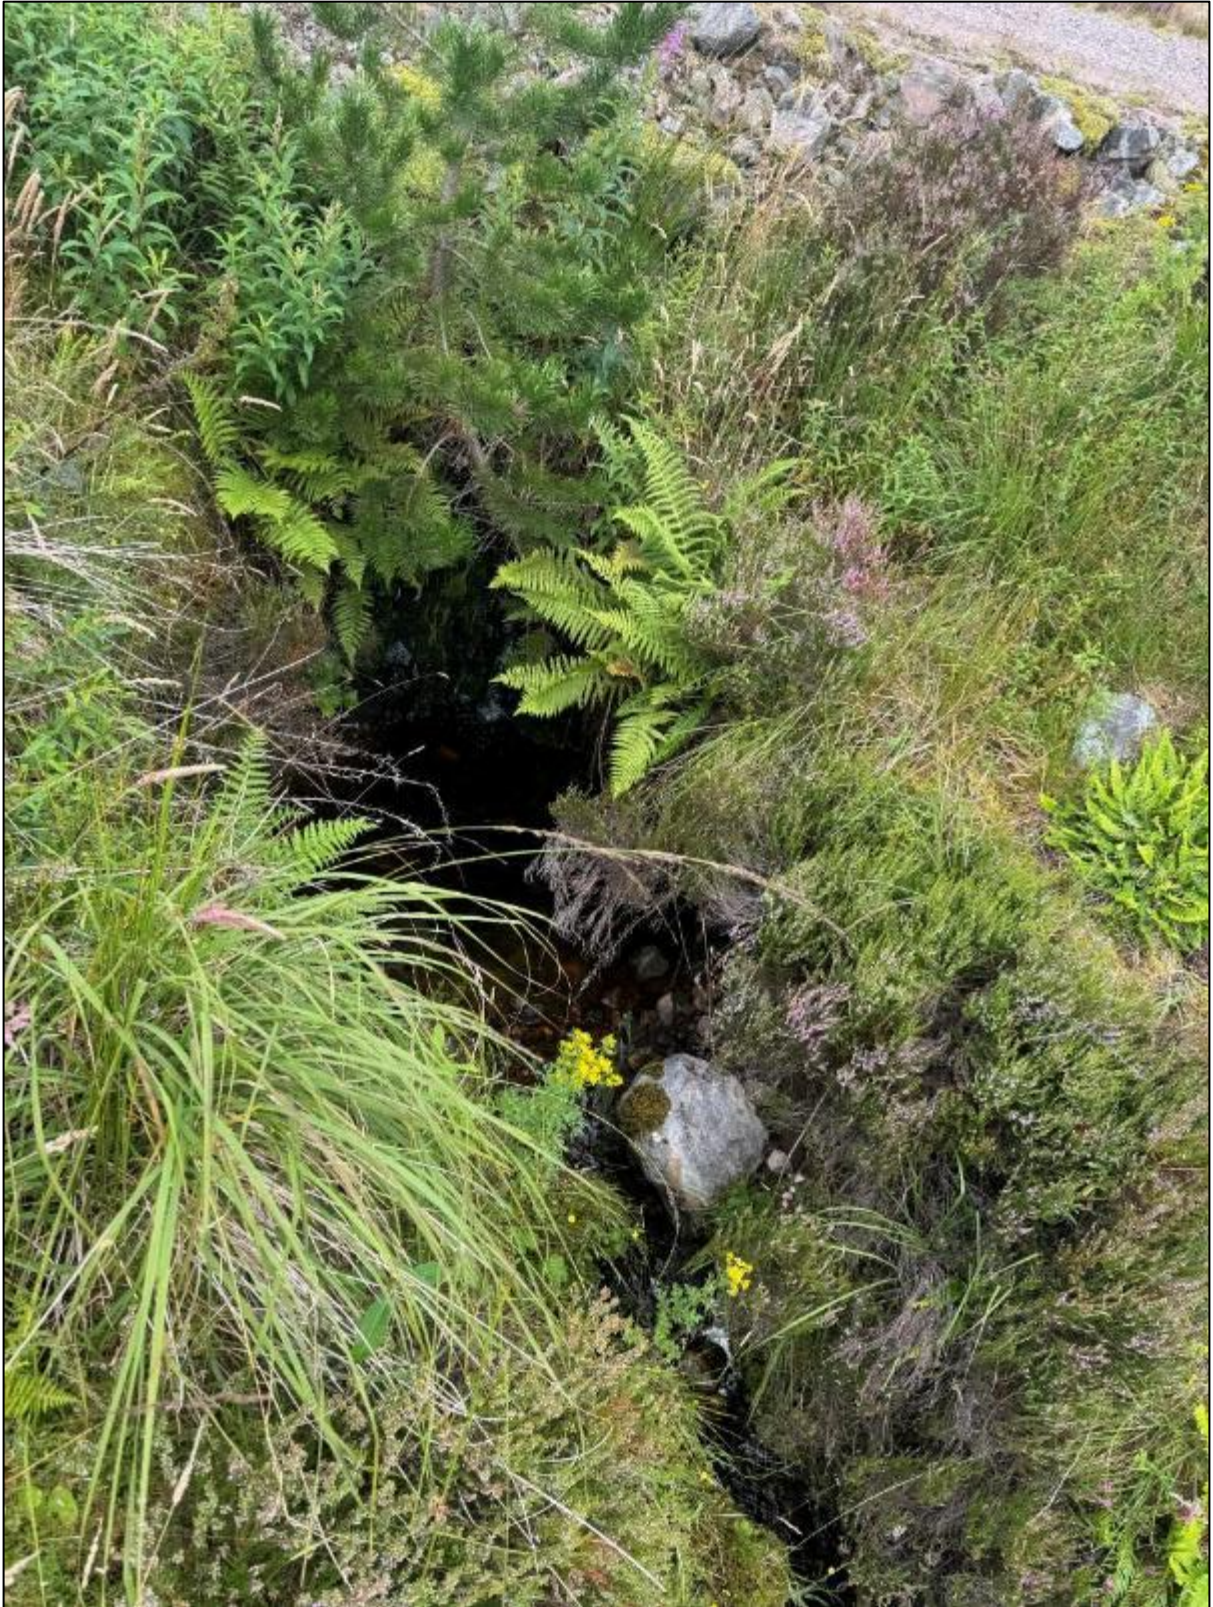
| Crossing No. | OS NGR | CA (km <sup>2</sup> ) | Figure No.* | Notes |
|---|---|---|---|---|
| 29 | NN 12507 99784 | <0.5 | A29 | Very small stream with little sediment transport/ storage. Pipe culvert (~400mm pipe). |

**Figure A29.** Photograph of stream crossing 29. Culvert entrance.

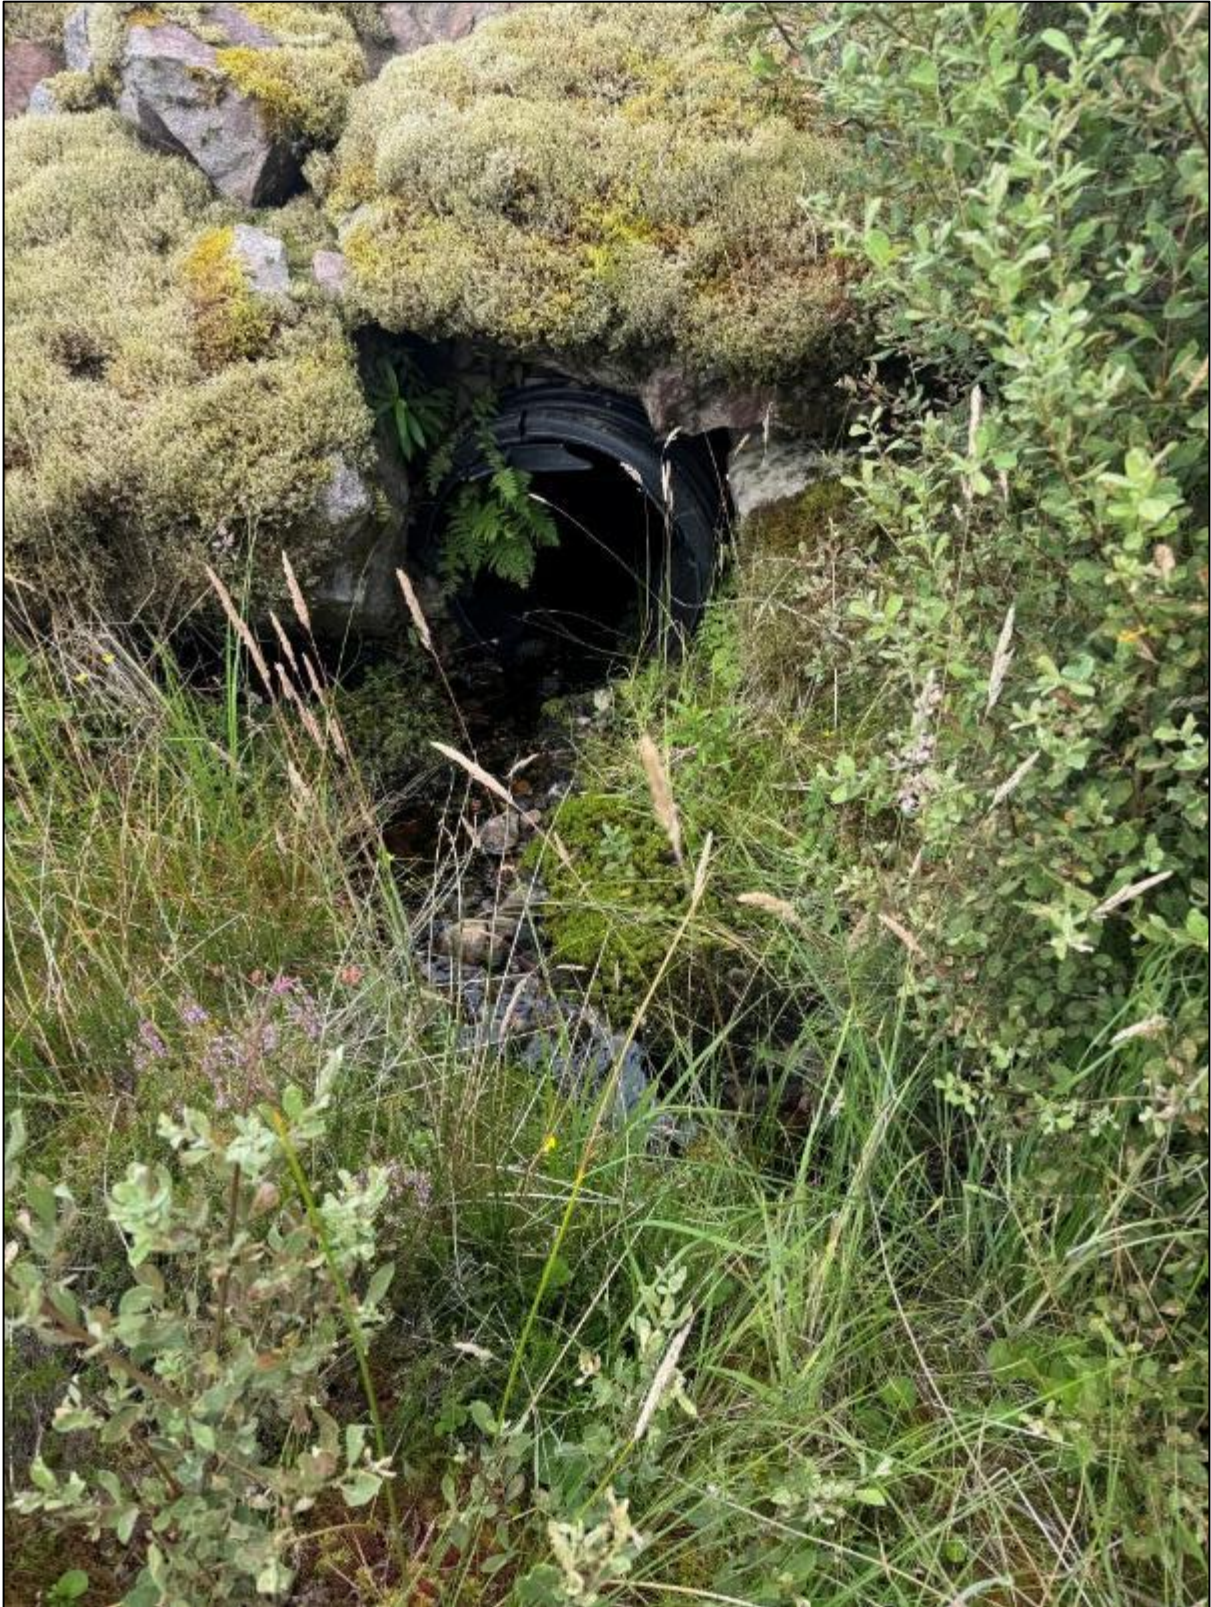
| Crossing No. | OS NGR | CA (km <sup>2</sup> ) | Figure No.* | Notes |
|---|---|---|---|---|
| 30 | NN 11539 99926 | 0.51 | A30 | Very small stream with little sediment transport/ storage. Pipe culvert (~500mm). |

**Figure A30.** Photograph of stream crossing 30. Culvert entrance.

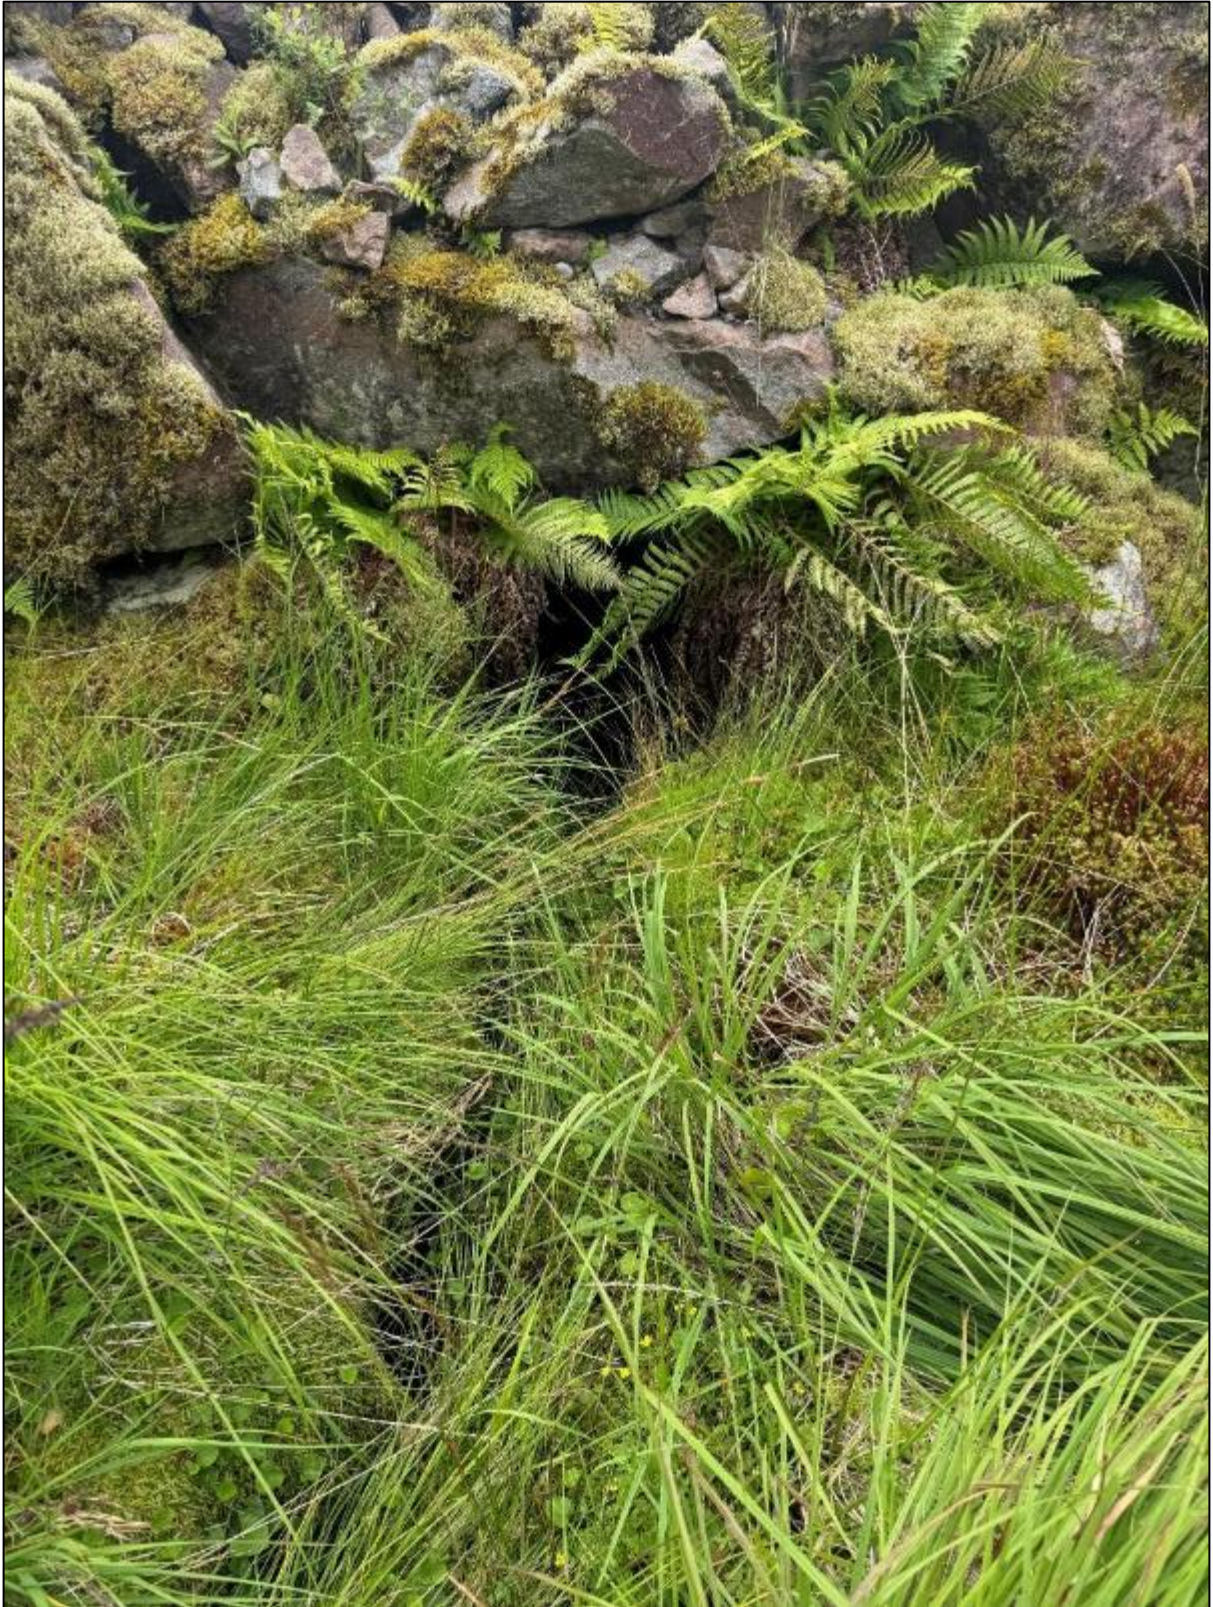
| Crossing No. | OS NGR | CA (km <sup>2</sup> ) | Figure No.* | Notes |
|---|---|---|---|---|
| 31 | NN 11484 99952 | <0.5 | A31 | Very small stream with little sediment transport/ storage. Pipe culvert (~500mm). |

**Figure A31.** Photograph of stream crossing 31. Culvert outfall.
