## **Fearna Pumped Storage Hydro Scheme - EIA Report**

### **Appendix D – Geomorphology Report Southern Access Route (SAR)**

# **Fearna Pumped Storage Hydro Scheme Geomorphology Report:**

## **A. Southern Access Route**

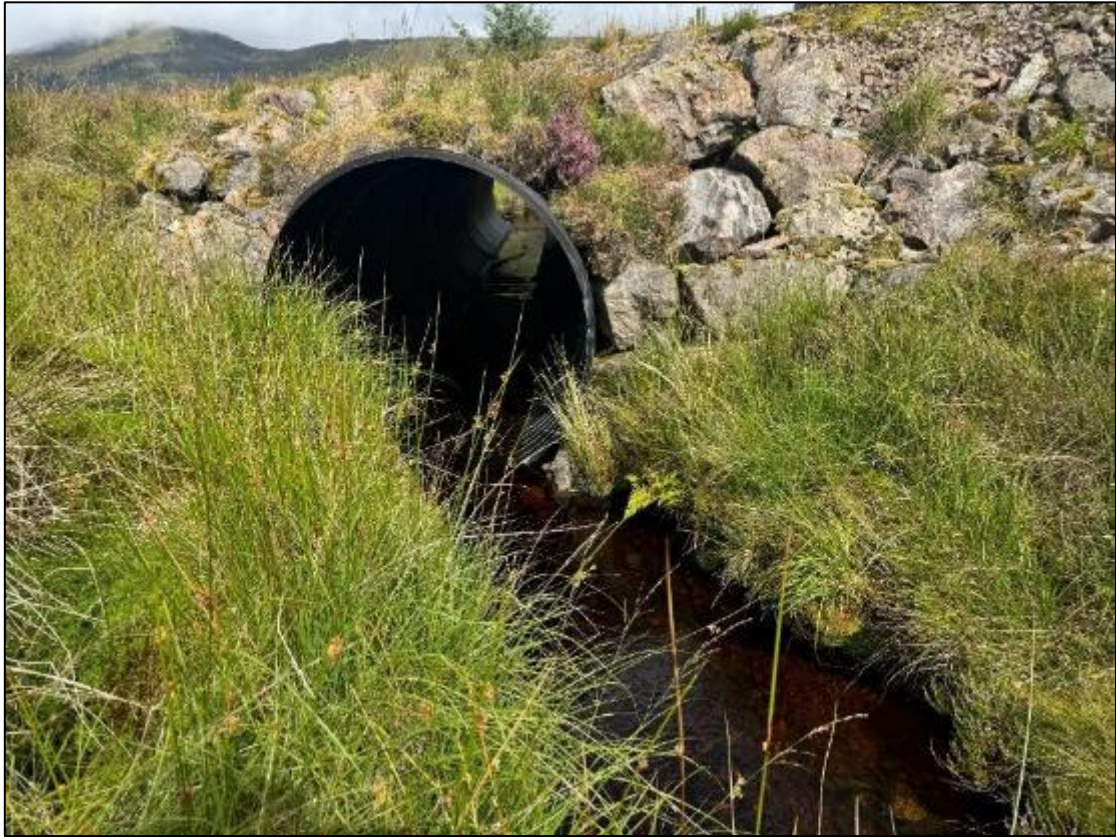
| Crossing No. | OS NGR | CA (km <sup>2</sup> ) | Figure No.* | Notes |
|---|---|---|---|---|
| 32 | NH 10694 00096 | 0.95 | A32 | Moderate sized stream (Allt Lochan na Curra) with some gravel storage upstream but not at culvert. 2m diameter pipe culvert- no sediment issues. |

**Figure A32.** Photograph of stream crossing 32. Culvert entrance.

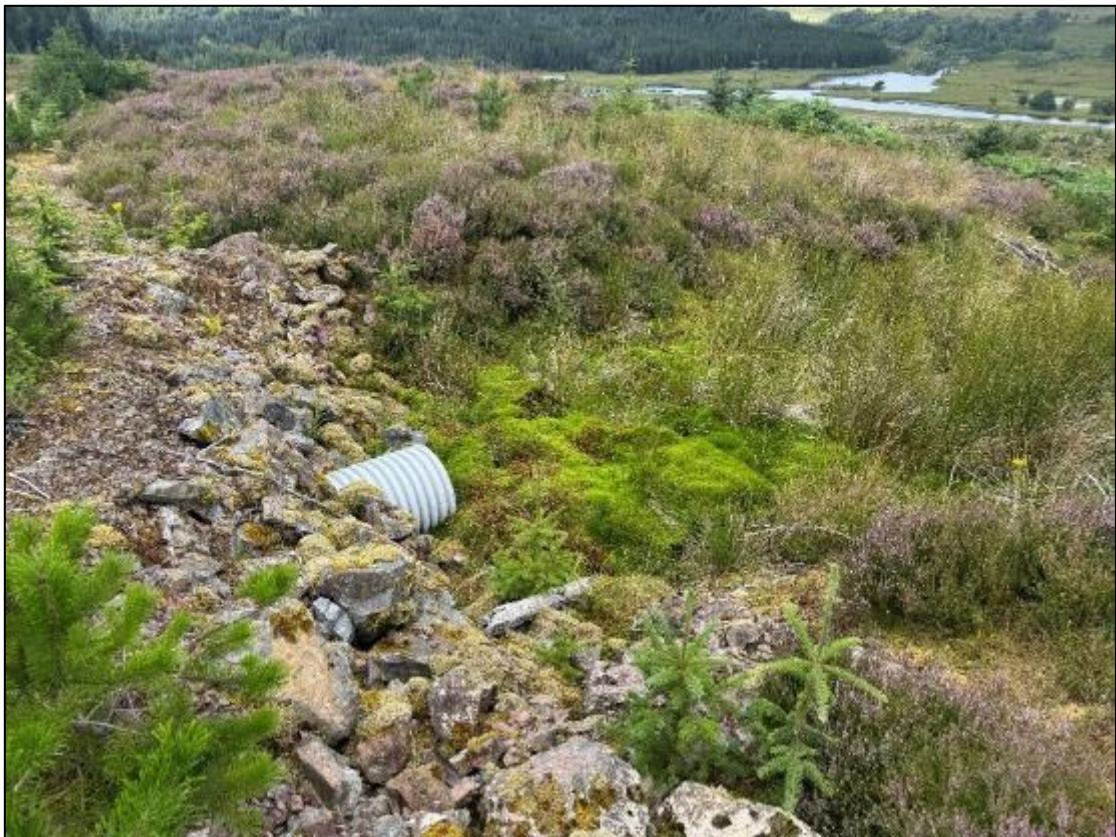
| Crossing No. | OS NGR | CA (km <sup>2</sup> ) | Figure No.* | Notes |
|---|---|---|---|---|
| 33 | NH 10406 00119 | <0.5 | A33 | Drainage ditch for track with little sediment transport/ storage. Pipe culvert (~500mm). |

**Figure A33.** Photograph of stream crossing 33. Culvert outfall.

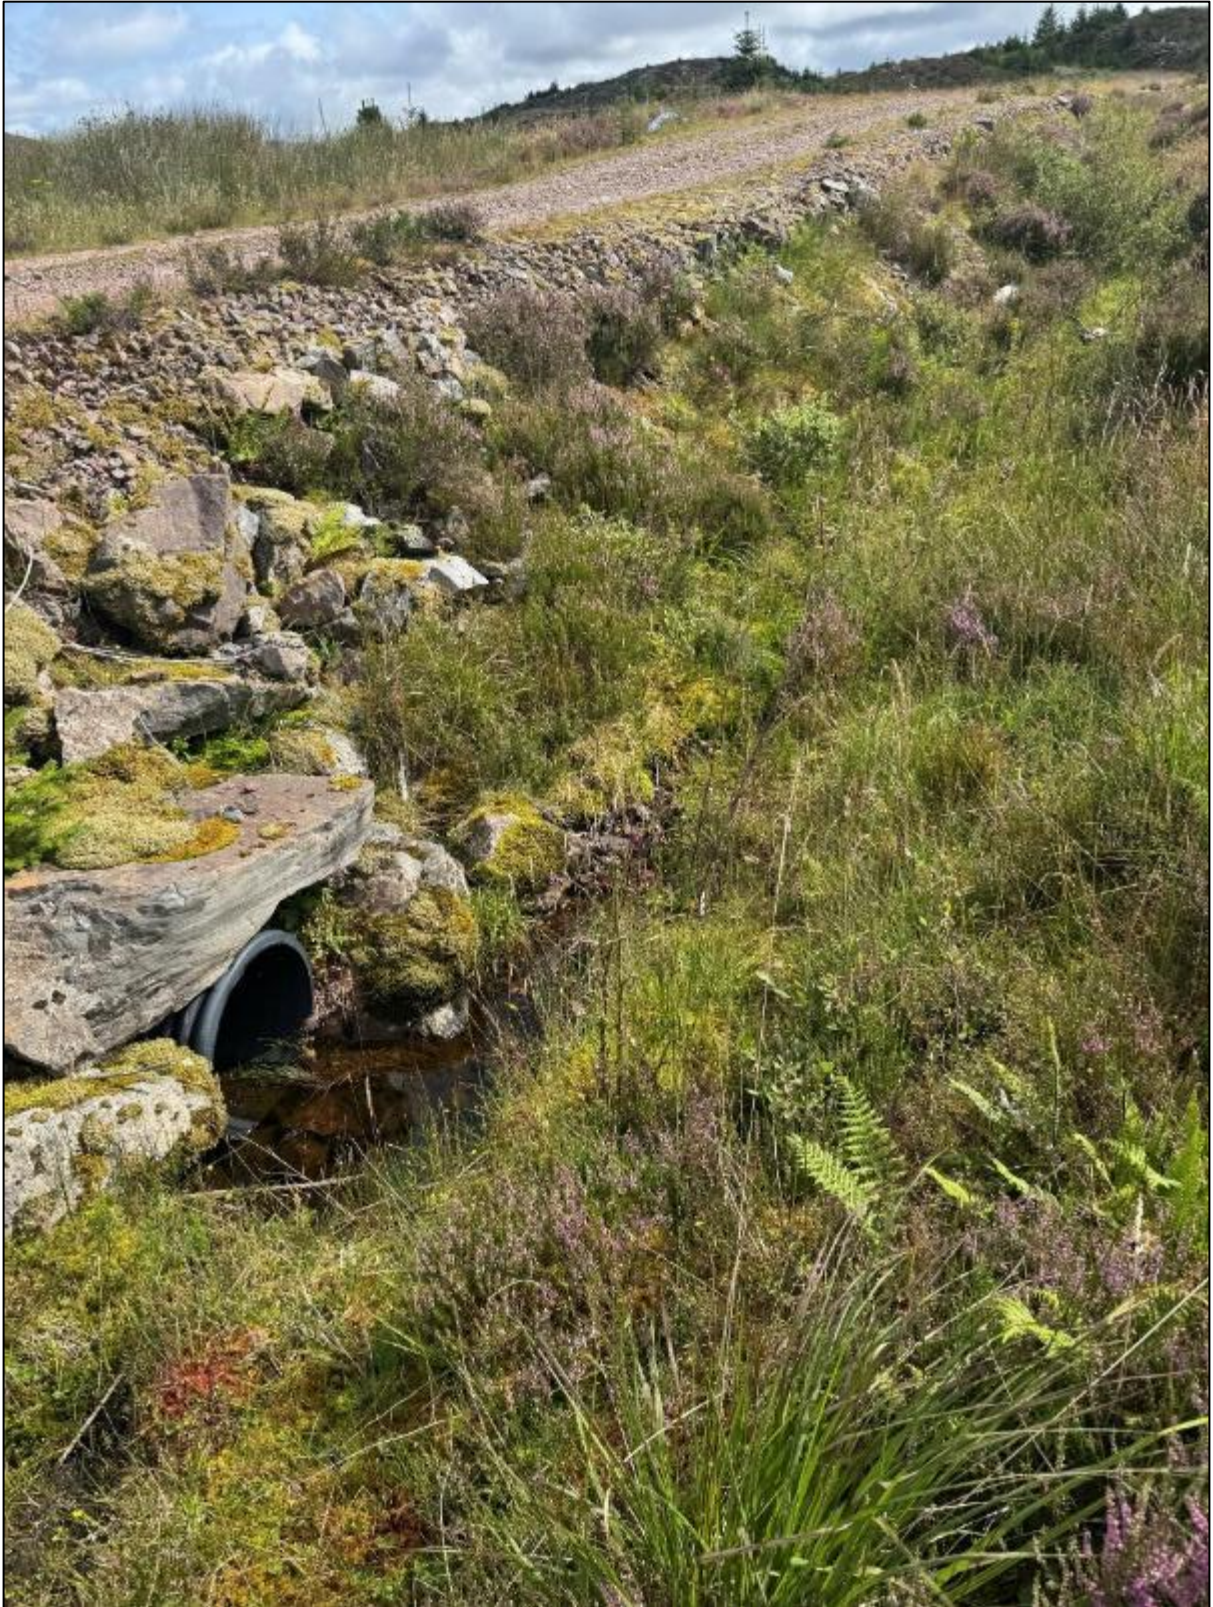
| Crossing No. | OS NGR | CA (km <sup>2</sup> ) | Figure No.* | Notes |
|---|---|---|---|---|
| 34 | NH 10196 00122 | <0.5 | A34 | Very small stream/ track ditch with little sediment transport/ storage. Pipe culvert (~500mm). |

**Figure A34.** Photograph of stream crossing 34. Culvert entrance.

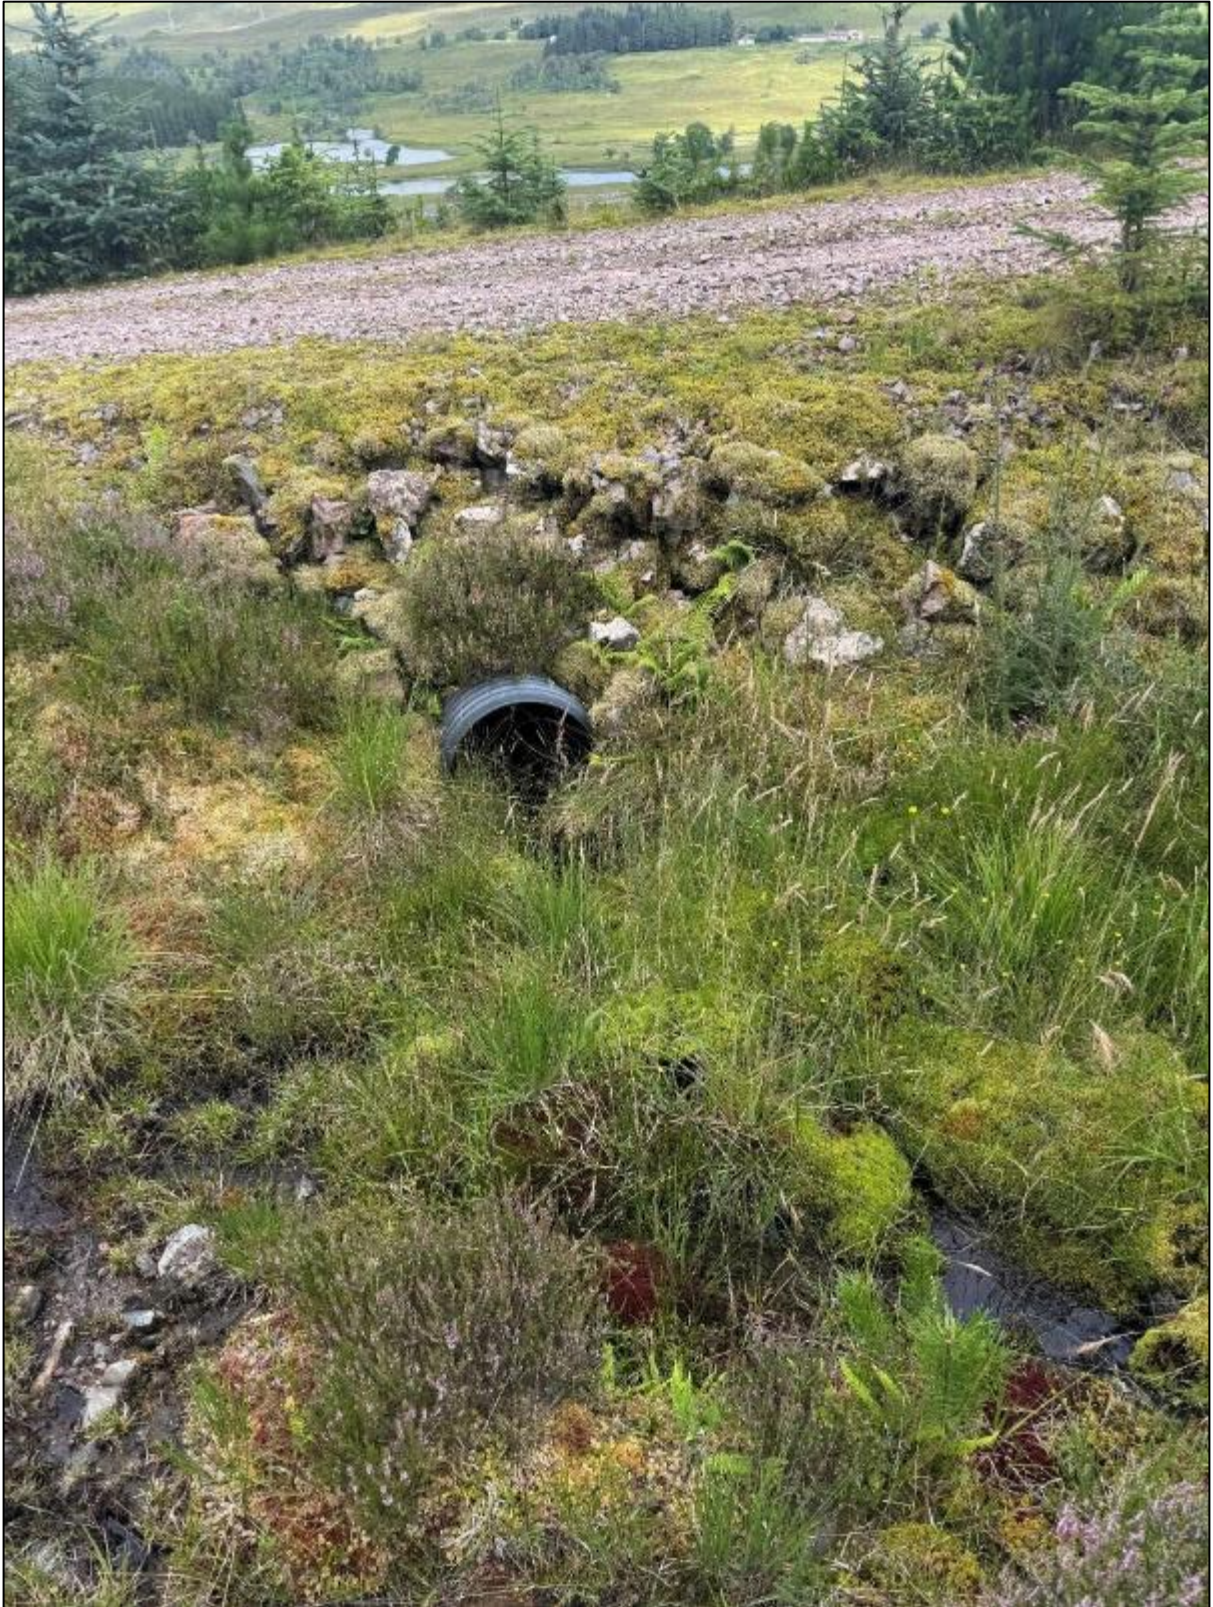
| Crossing No. | OS NGR | CA (km <sup>2</sup> ) | Figure No.* | Notes |
|---|---|---|---|---|
| 35 | NH 10086 00110 | <0.5 | A35 | Very small stream/ track ditch with little sediment transport/ storage. Pipe culvert (~500mm). |

**Figure A35.** Photograph of stream crossing 35. Culvert entrance.

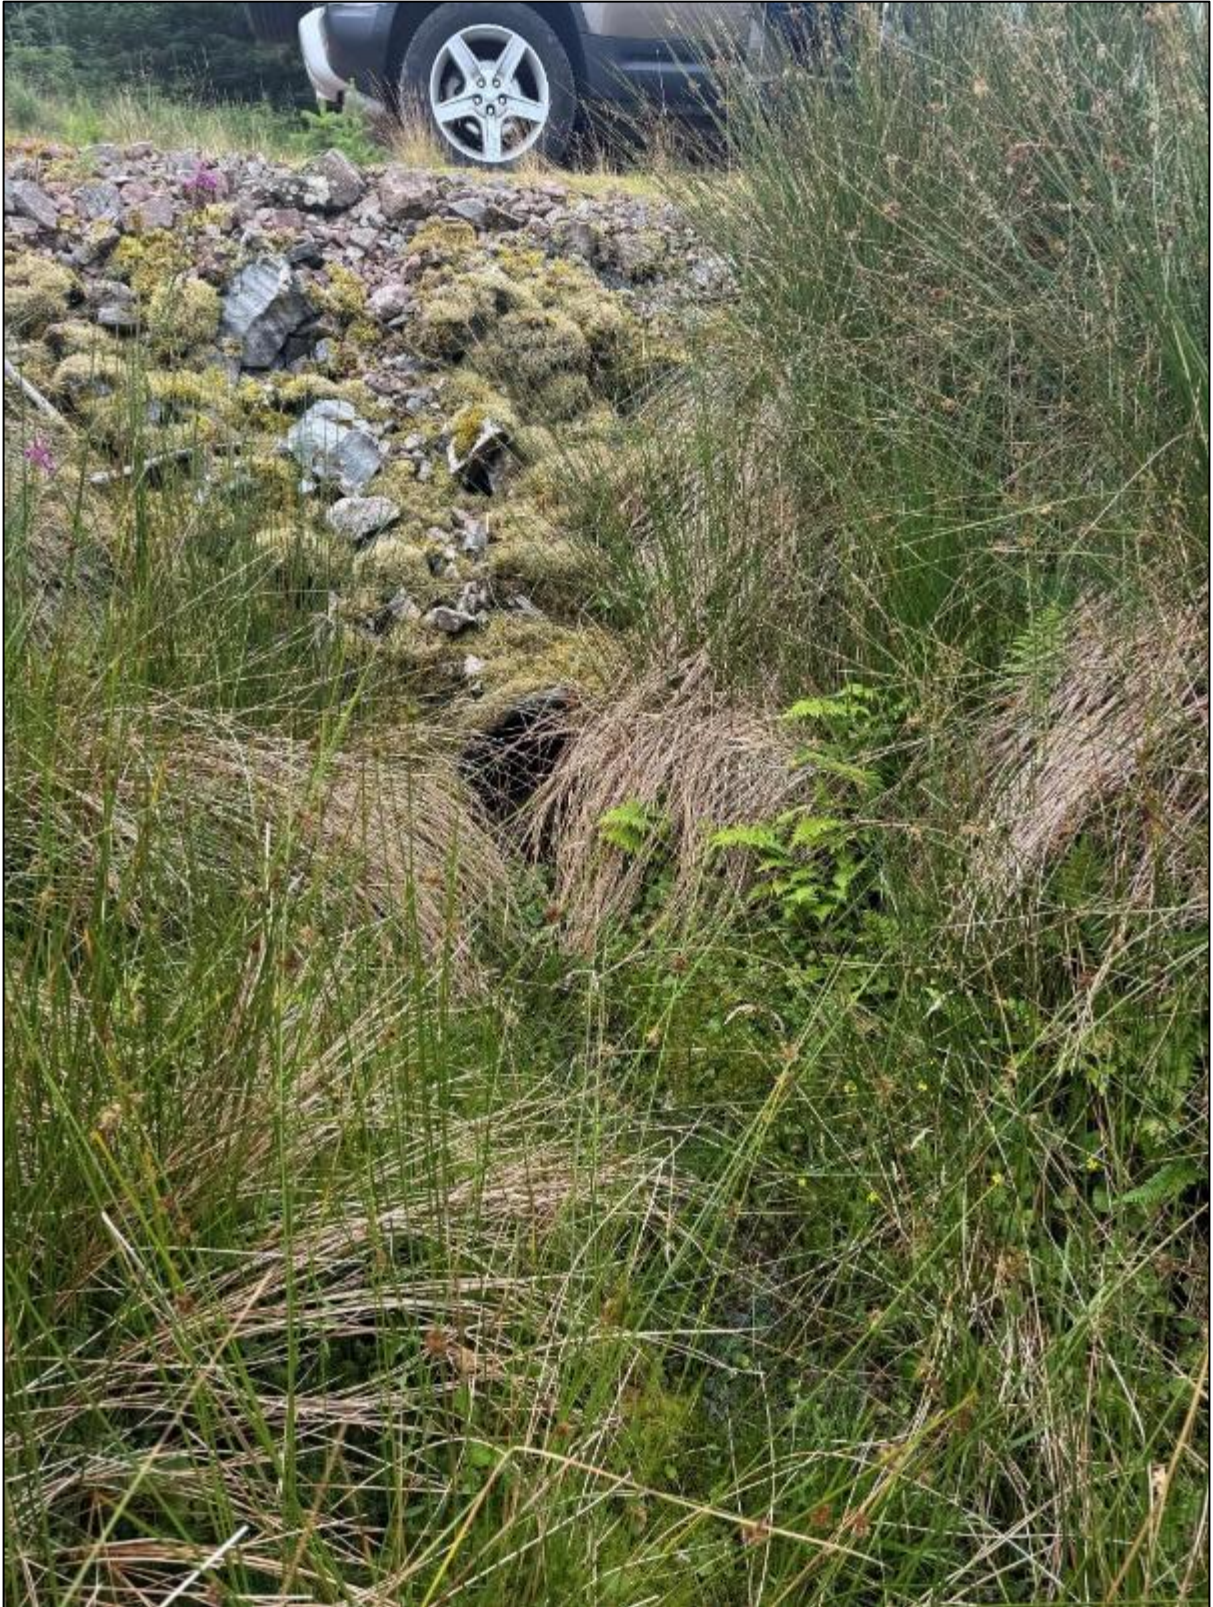
| Crossing No. | OS NGR | CA (km <sup>2</sup> ) | Figure No.* | Notes |
|---|---|---|---|---|
| 36 | NH 10062 00126 | <0.5 | A36 | Very small stream/ track ditch with little sediment transport/ storage. Pipe culvert (~500mm). Just west of cattle grid. |

**Figure A36.** Photograph of stream crossing 36. Culvert outfall.

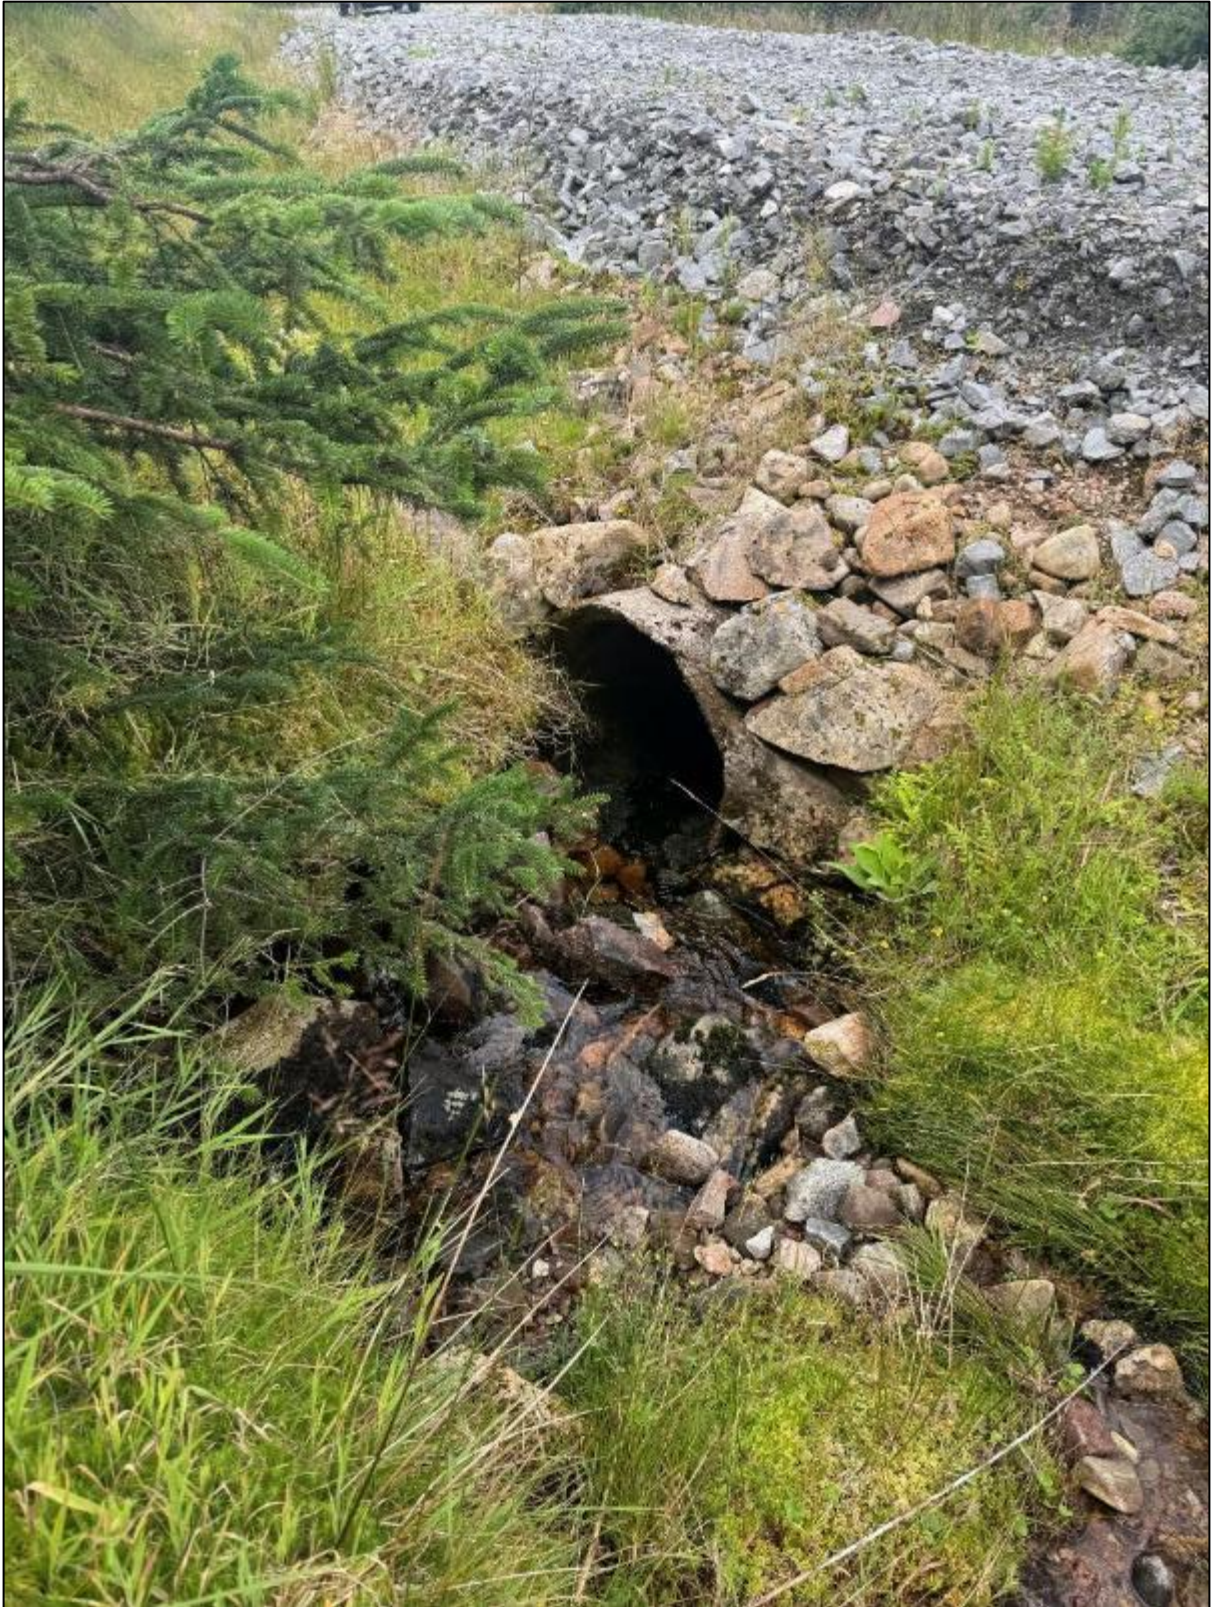
| Crossing No. | OS NGR | CA (km <sup>2</sup> ) | Figure No.* | Notes |
|---|---|---|---|---|
| 37 | NH 09938 00058 | 0.52 | A37 | Small, steep stream with some sediment transport/ storage. Concrete pipe culvert (~600mm), perched on downstream side. |

**Figure A37.** Photograph of stream crossing 37. Culvert entrance.

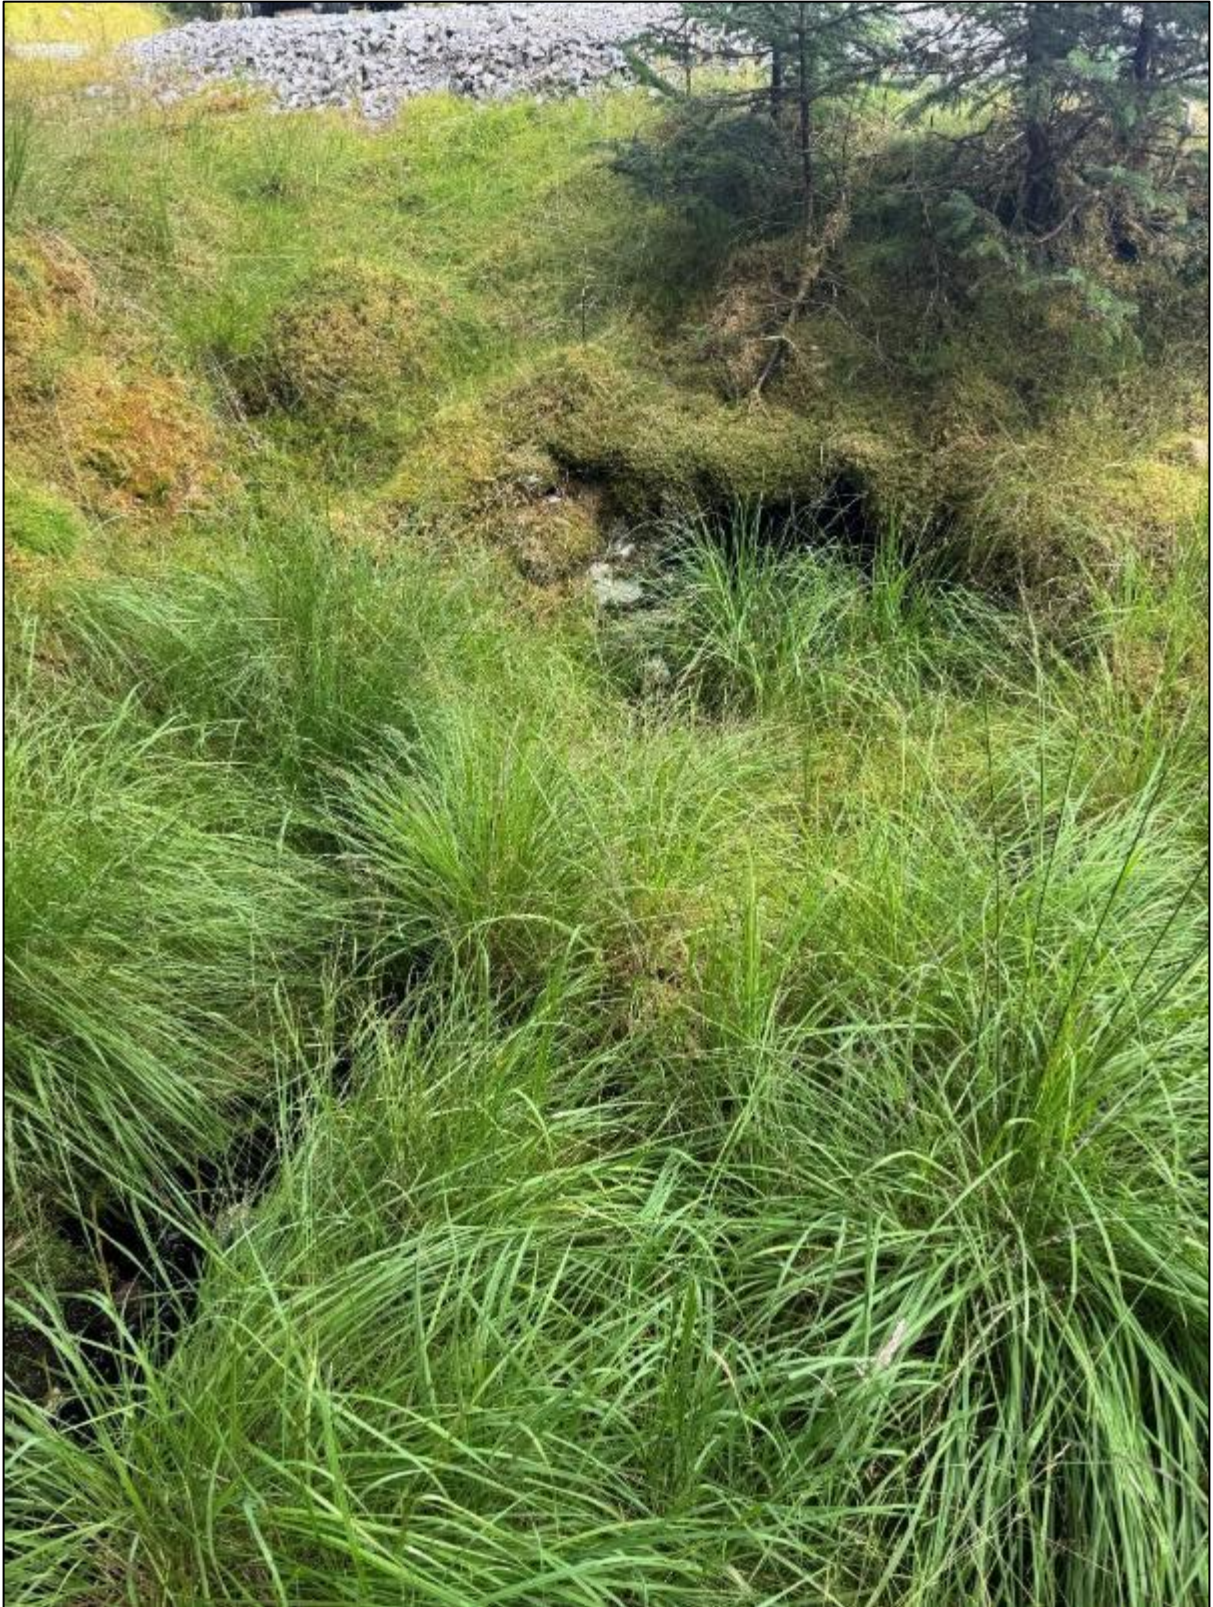
| Crossing No. | OS NGR | CA (km <sup>2</sup> ) | Figure No.* | Notes |
|---|---|---|---|---|
| 38 | NH 09677 00011 | <0.5 | A38 | Small, steep stream with little sediment transport/ storage. Metal pipe culvert (~1.2m). |

**Figure A38.** Photograph of stream crossing 38. Culvert entrance.

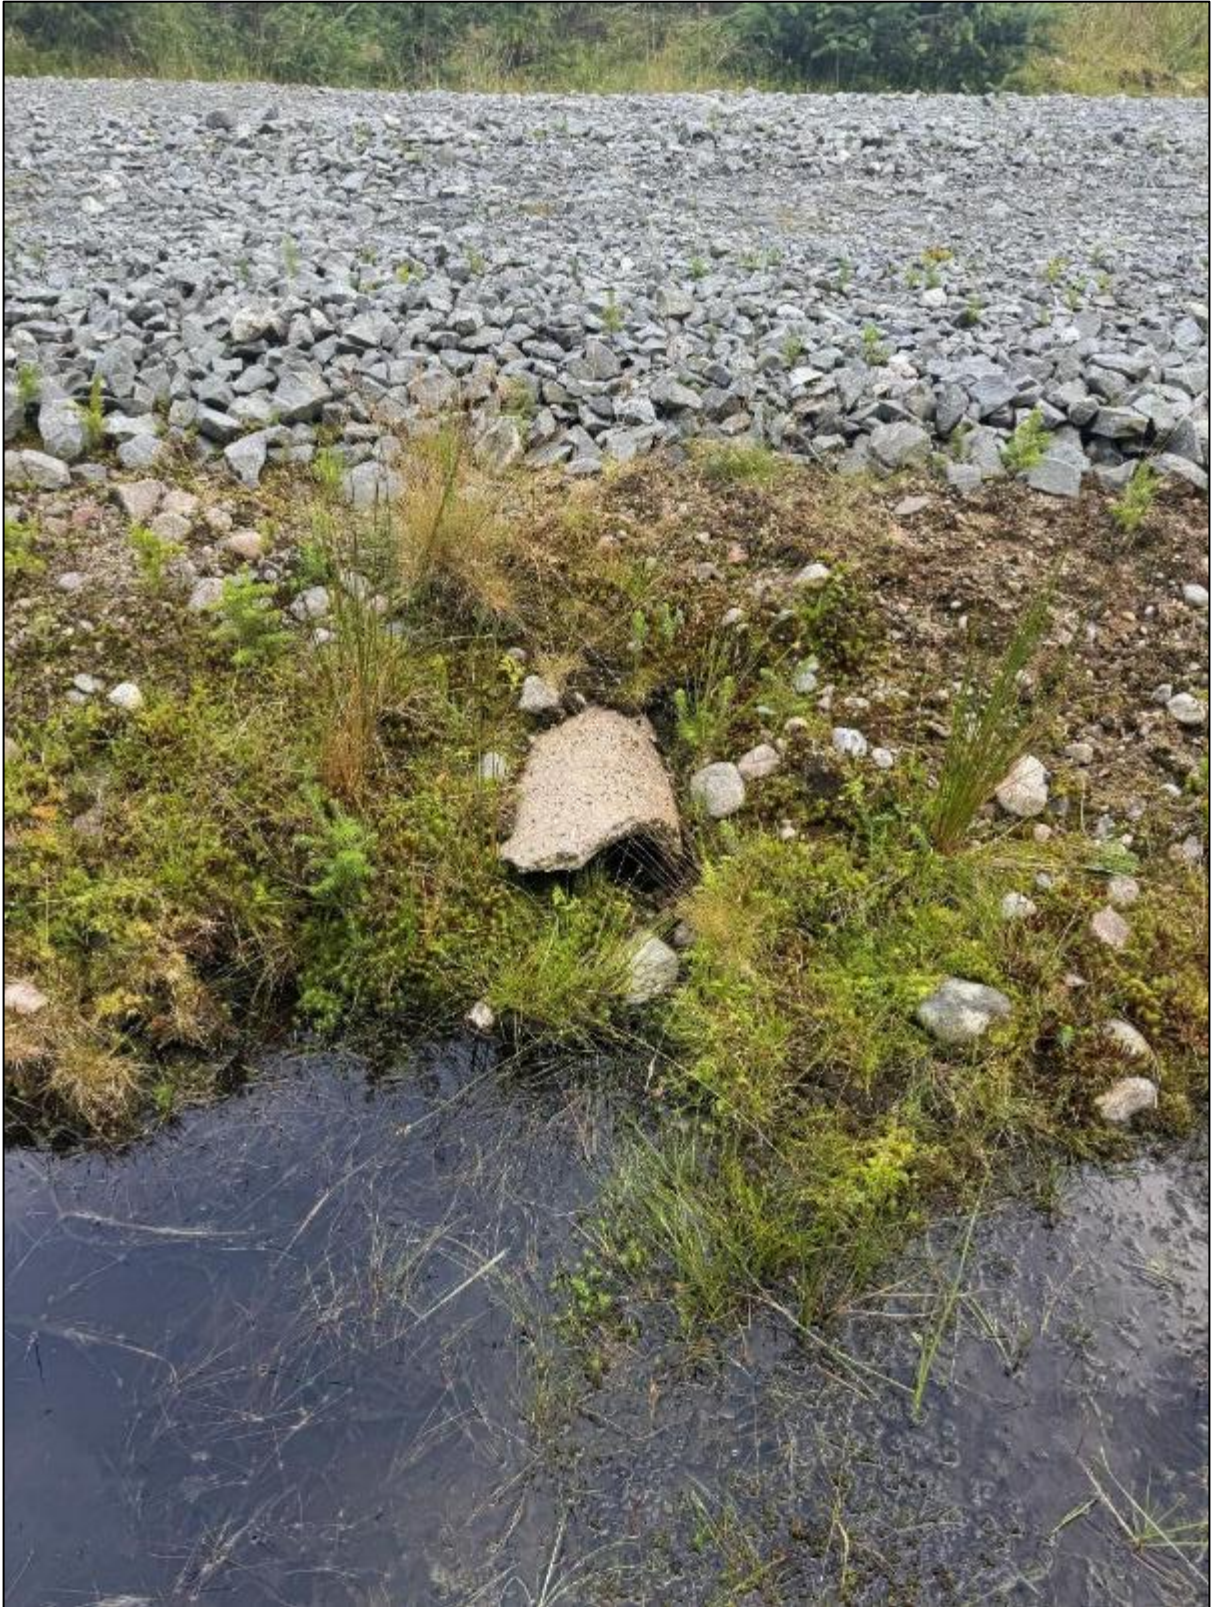
| Crossing No. | OS NGR | CA (km <sup>2</sup> ) | Figure No.* | Notes |
|---|---|---|---|---|
| 39 | NH 09437 00035 | <0.5 | A39 | Small track ditch with little sediment transport/ storage. Concrete pipe culvert (~300mm). |

**Figure A39.** Photograph of stream crossing 39. Culvert entrance.

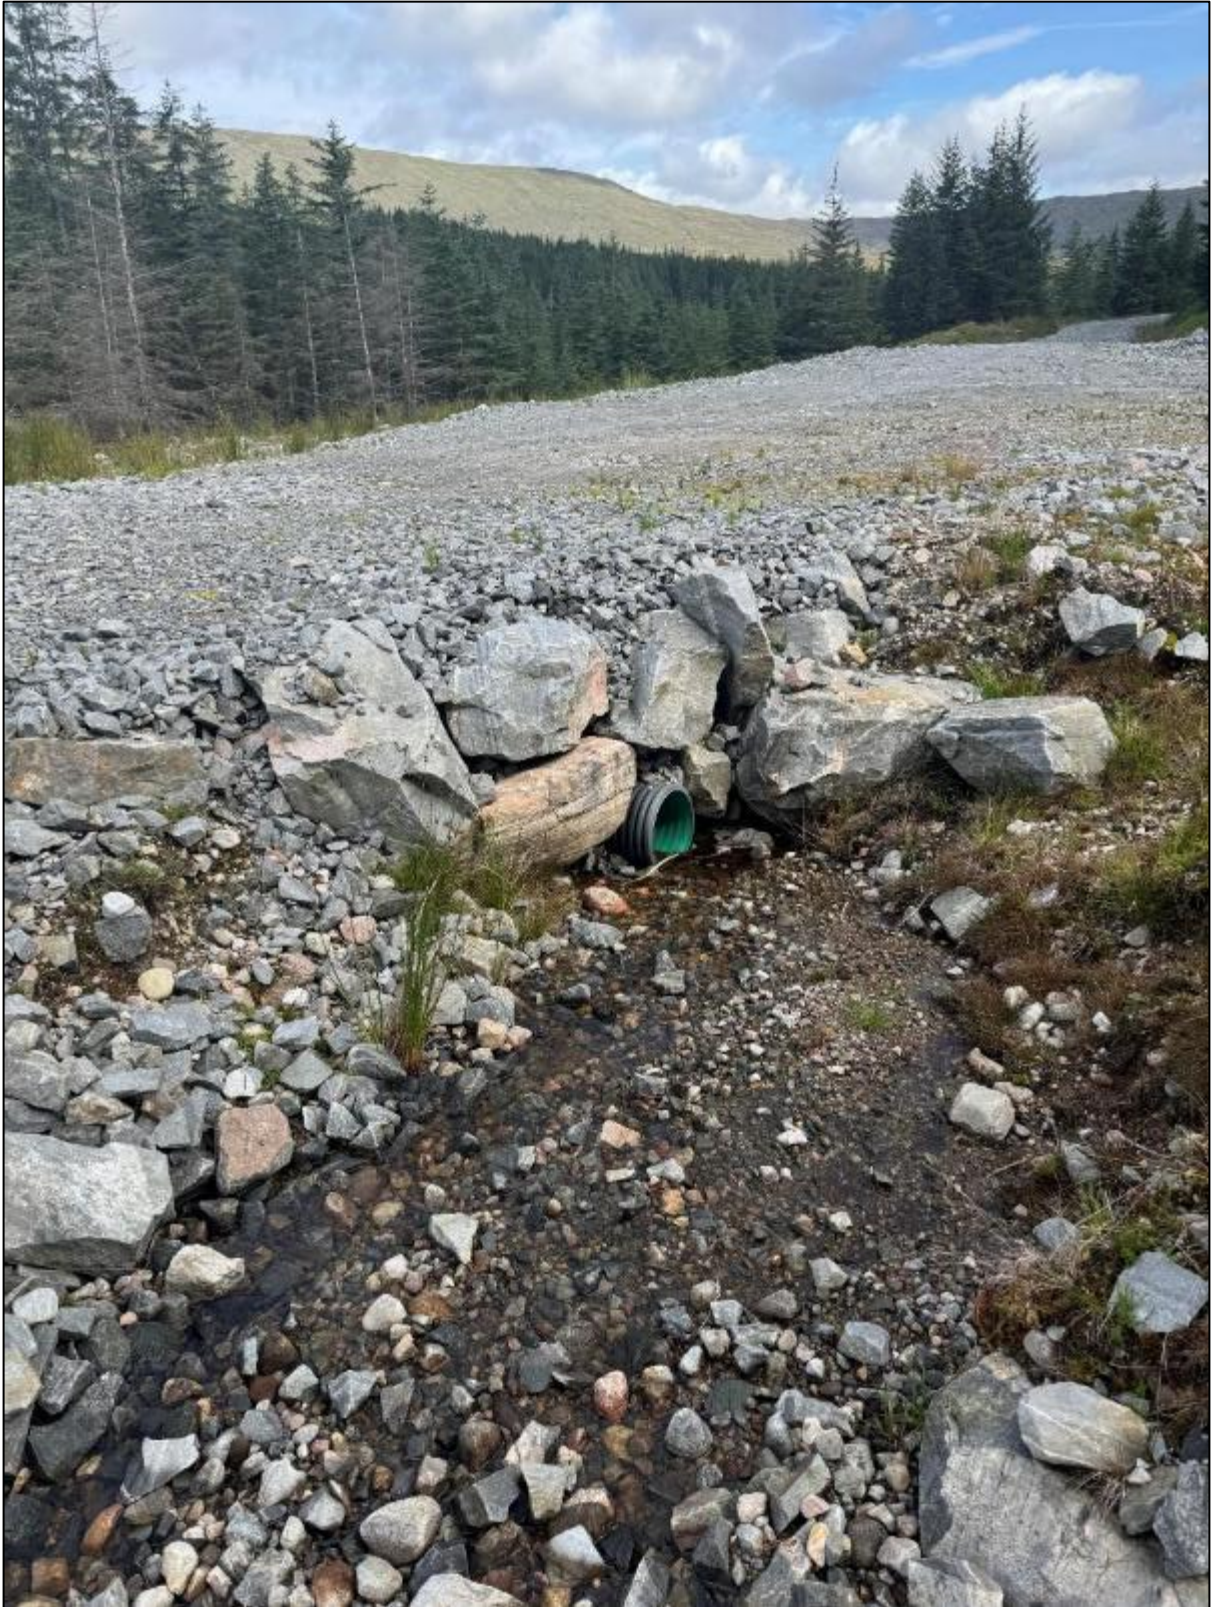
| Crossing No. | OS NGR | CA (km <sup>2</sup> ) | Figure No.* | Notes |
|---|---|---|---|---|
| 40 | NN 09163 99871 | <0.5 | A40 | Small stream but reasonable sediment transport/ storage. Pipe culvert (~300mm), perched downstream - too small given sediment supply. |

**Figure A40.** Photograph of stream crossing 40. Culvert entrance.

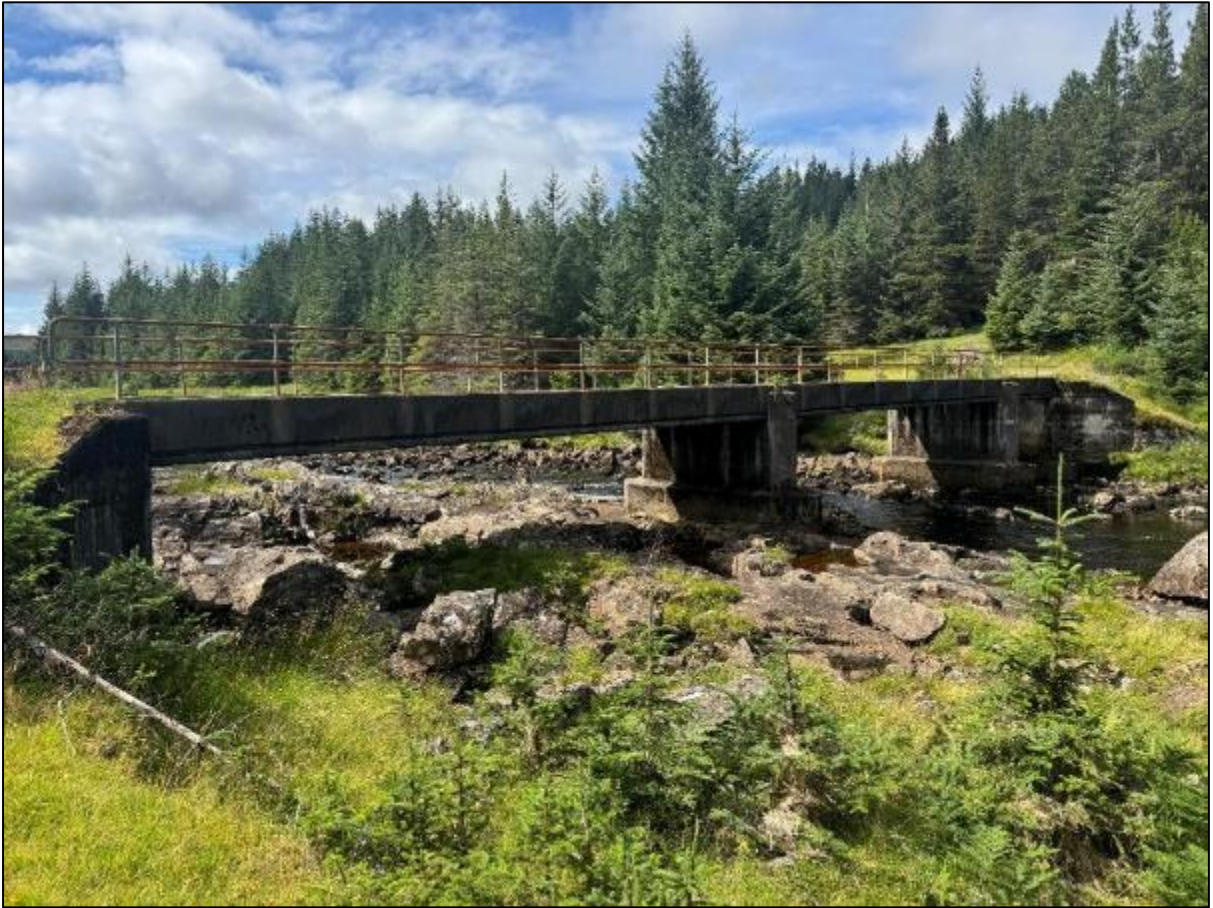
| Crossing No. | OS NGR | CA (km <sup>2</sup> ) | Figure No.* | Notes |
|---|---|---|---|---|
| 41 | NN 09045 99811 | 58.8 | A41 | River Kingie . Bedrock channel - very little evidence of sediment transport/ storage. Bridge soffit likely too low for extreme floods. Also two piers within channel - not ideal. |

**Figure A41.** Photograph of stream crossing 41. River Kingie, looking upstream.

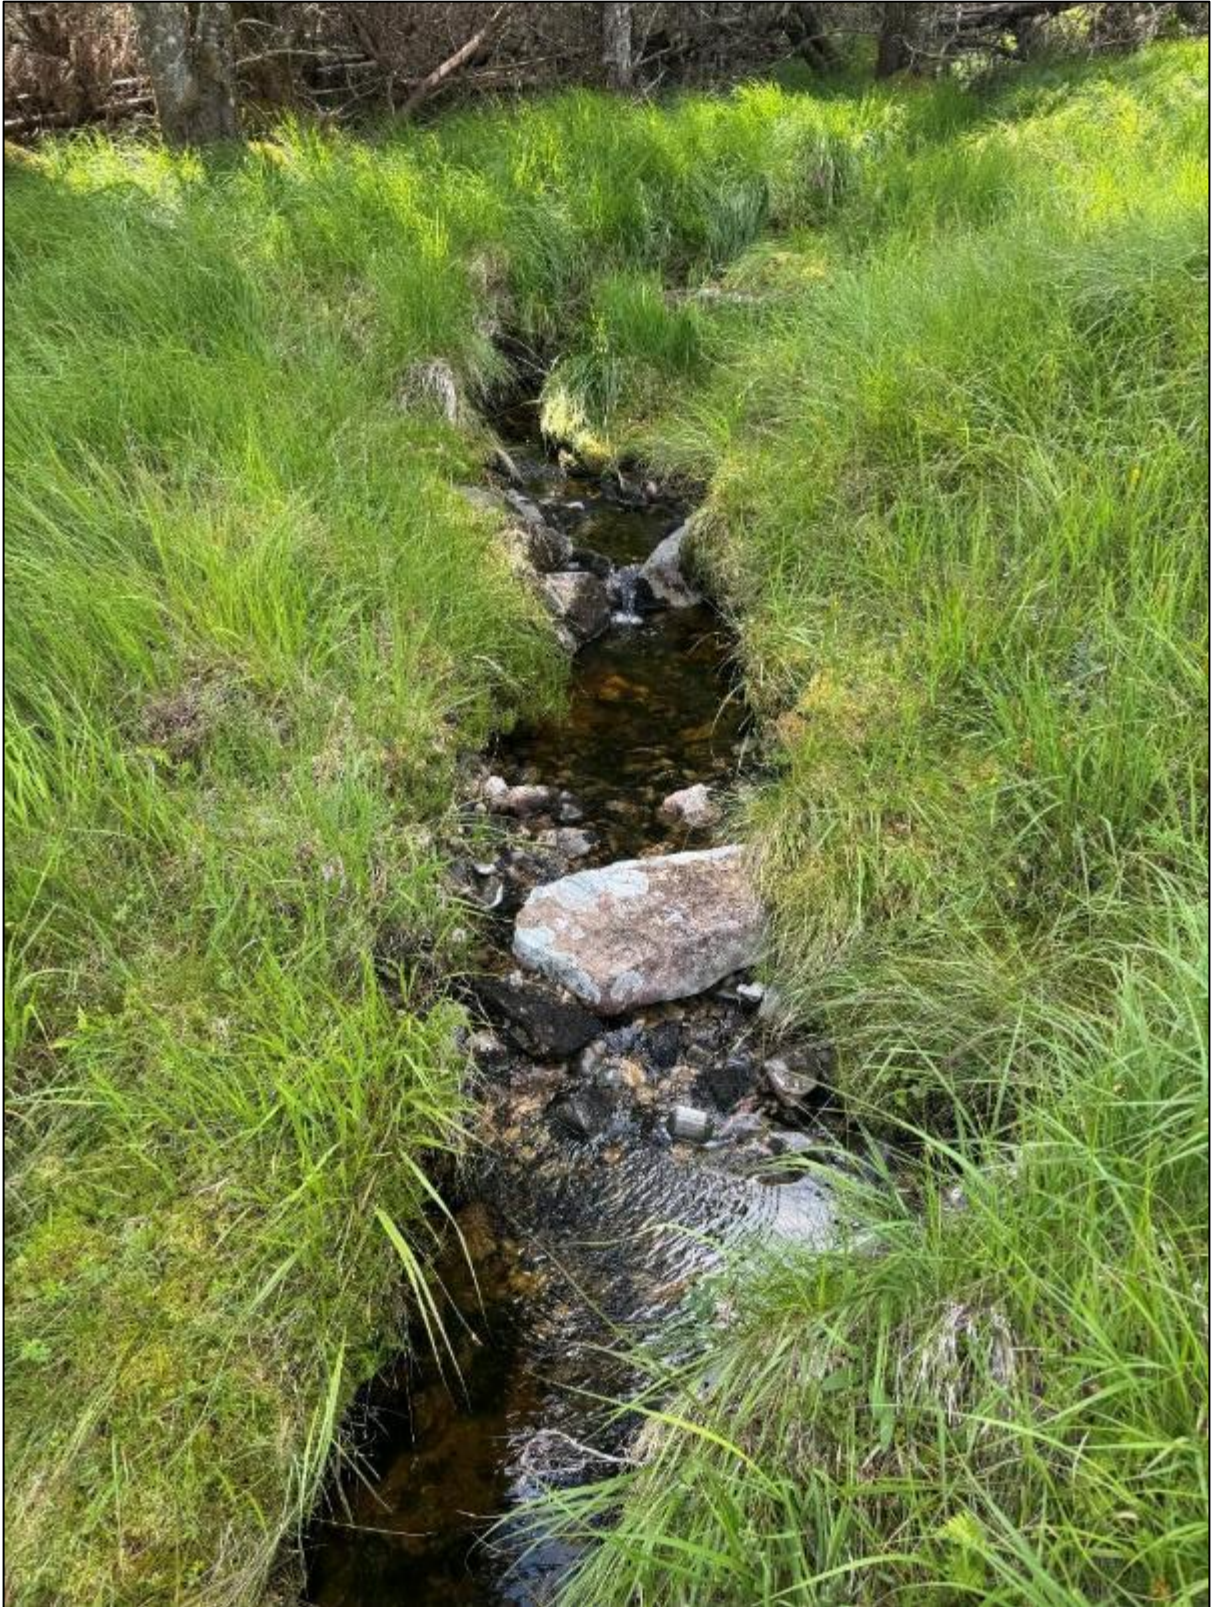
| Crossing No. | OS NGR | CA (km <sup>2</sup> ) | Figure No.* | Notes |
|---|---|---|---|---|
| 42 | NH 08934 01376 | <0.5 | A42 | Small, incised stream with some evidence of sediment transport/ storage. Possible partial avulsion upstream causing overland flow into peat (causing erosion). |

**Figure A42.** Photograph of proposed stream crossing 42 (no culvert at present). Looking upstream.

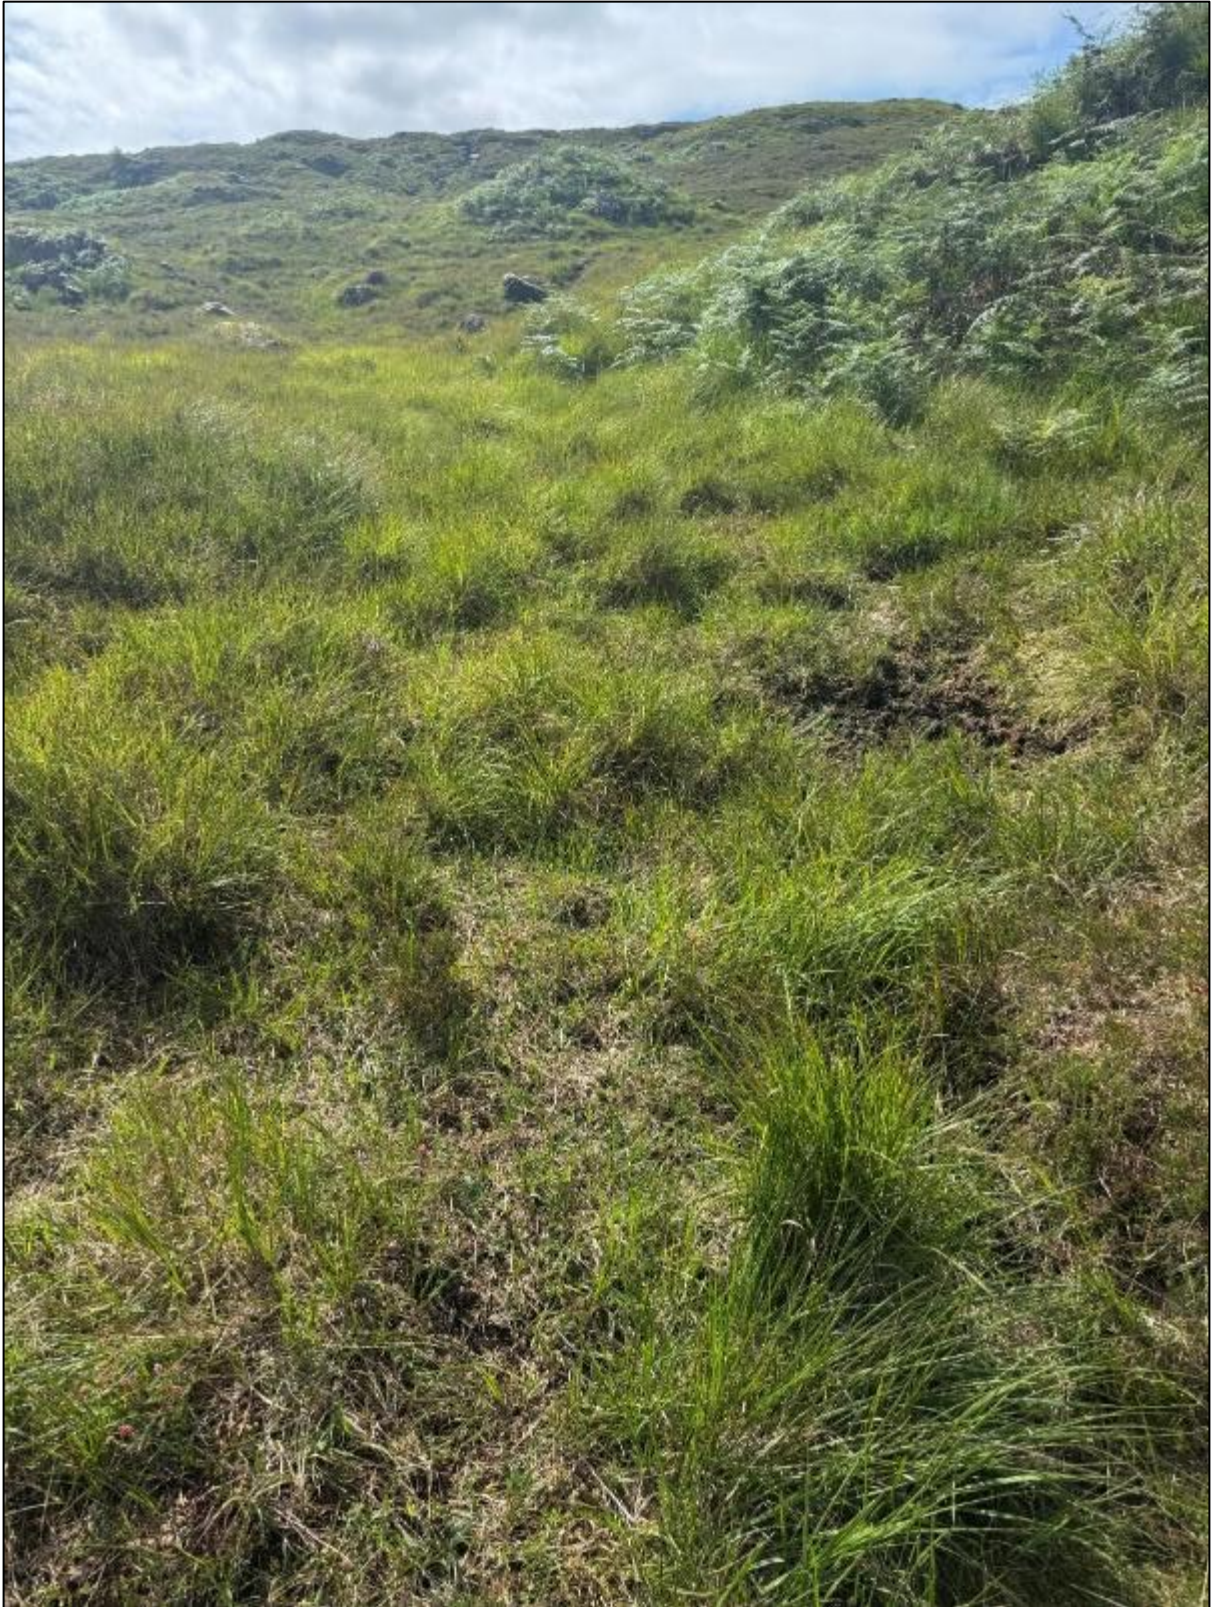
| Crossing No. | OS NGR | CA (km <sup>2</sup> ) | Figure No.* | Notes |
|---|---|---|---|---|
| 43 | NH 08819 01444 | <0.5 | A43 | Very small channel with no flow and limited sediment transport/ storage. |

**Figure A43.** Photograph of proposed stream crossing 43 (no culvert at present). Looking upstream.
