## **Fearna Pumped Storage Hydro Scheme - EIA Report**

### **Appendix D – Geomorphology Report Southern Access Route (SAR)**

# **Fearna Pumped Storage Hydro Scheme Geomorphology Report:**

## **A. Southern Access Route**

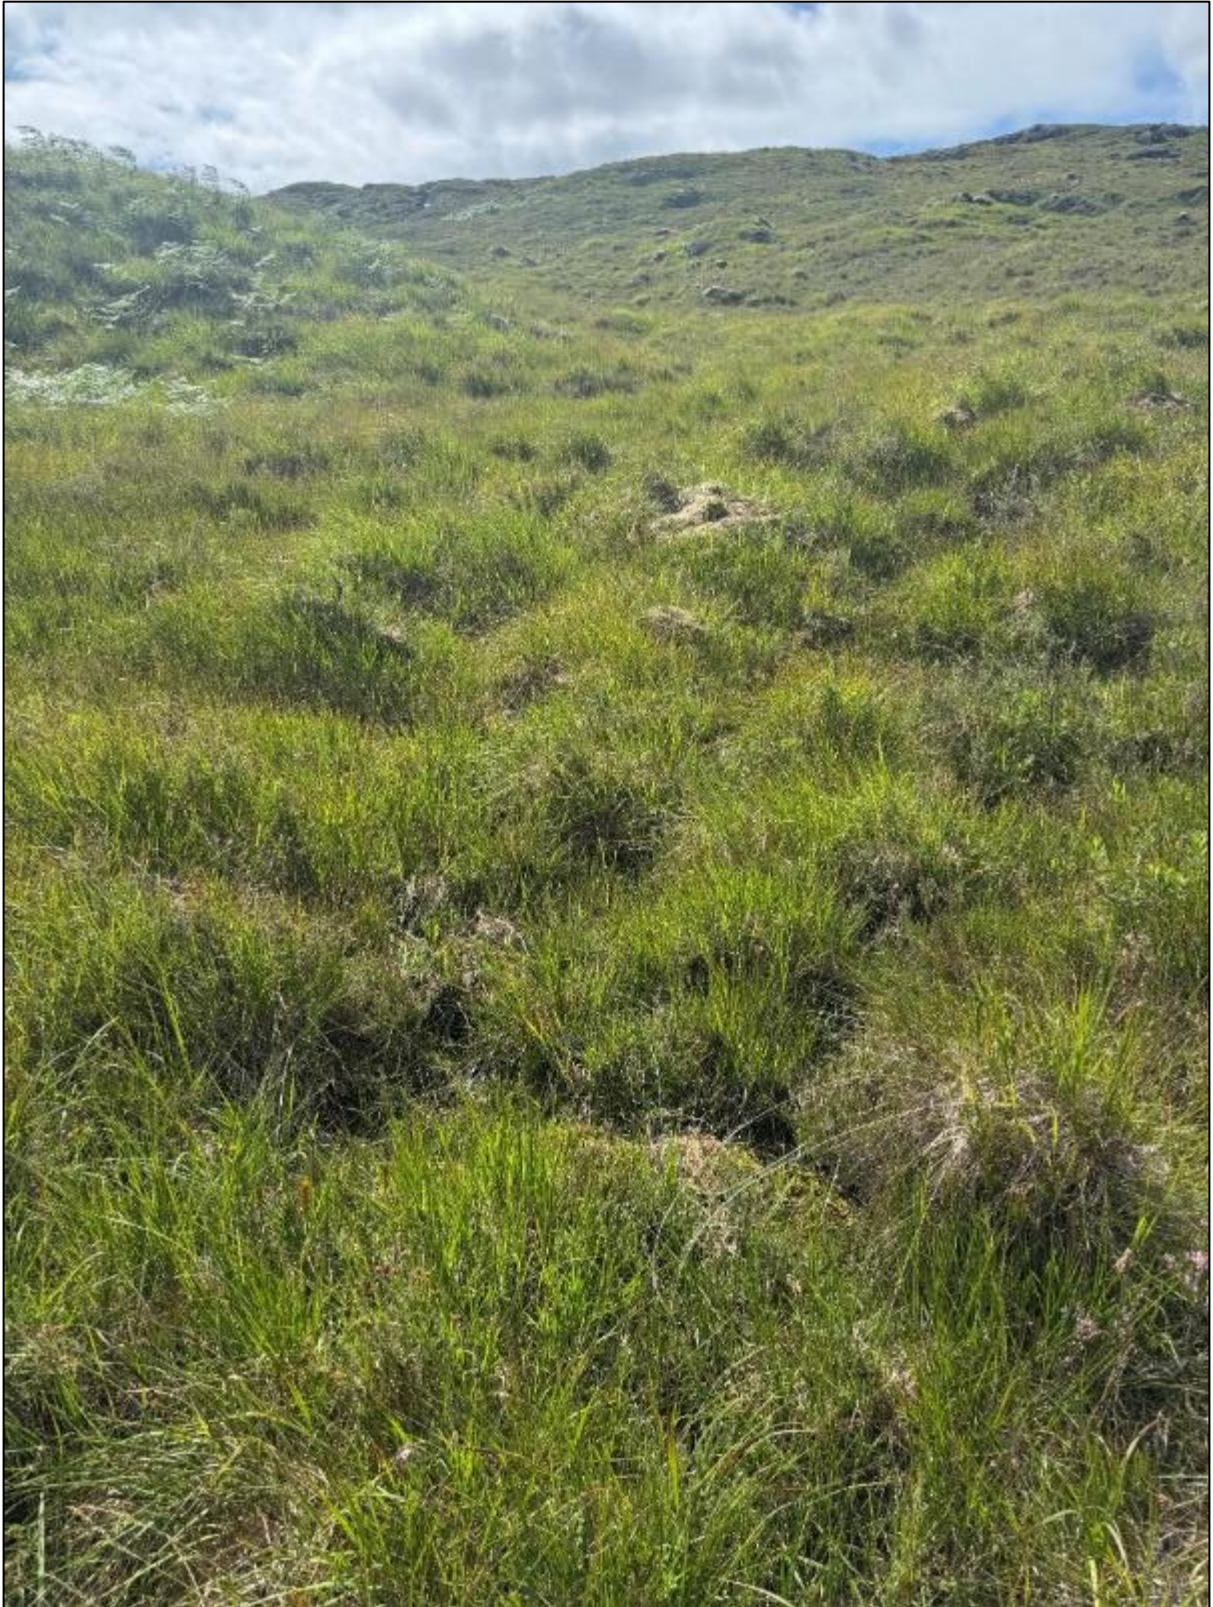
| Crossing No. | OS NGR | CA (km <sup>2</sup> ) | Figure No.* | Notes |
|---|---|---|---|---|
| 44 | NH 08754 01499 | <0.5 | A44 | Very small channel with no flow and limited sediment transport/ storage. |

**Figure A44.** Photograph of proposed stream crossing 44 (no culvert at present). Looking upstream.

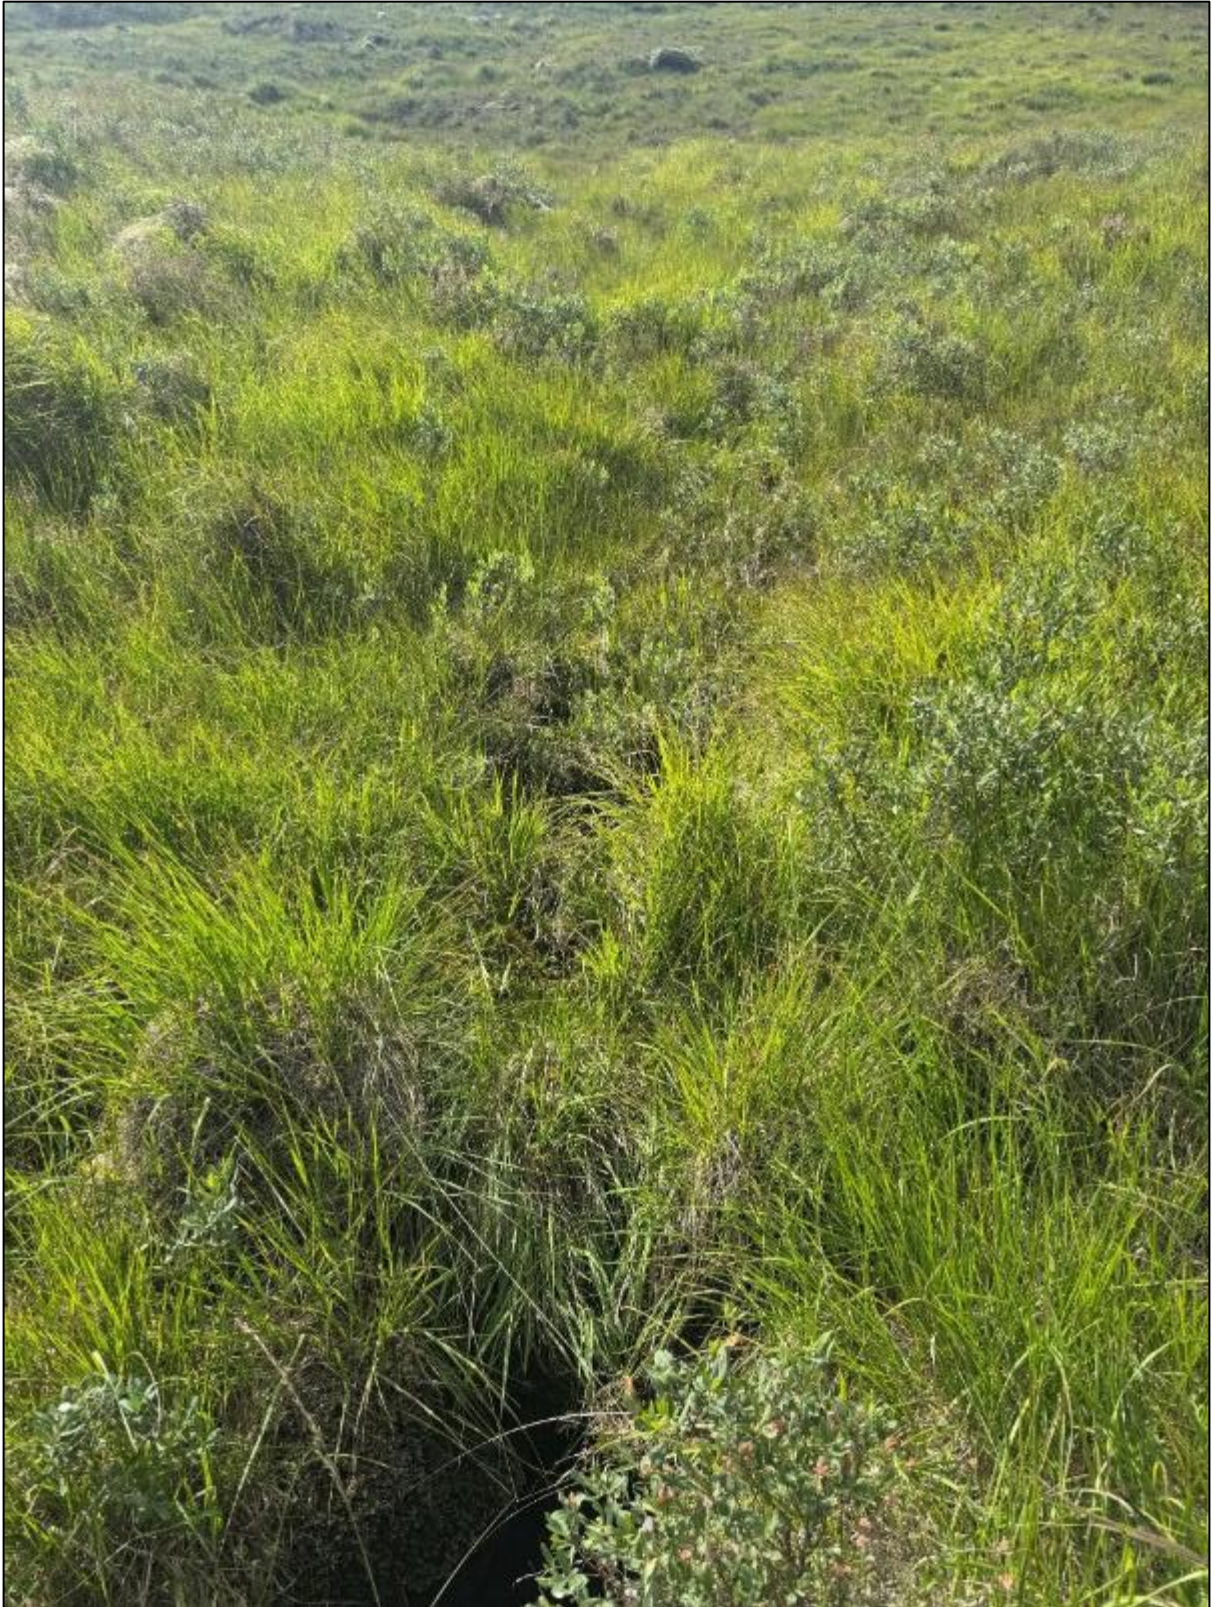
| Crossing No. | OS NGR | CA (km <sup>2</sup> ) | Figure No.* | Notes |
|---|---|---|---|---|
| 45 | NH 08726 01516 | <0.5 | A45 | Small, entrenched stream. Limited sediment transport/ storage. |

**Figure A45.** Photograph of proposed stream crossing 45 (no culvert at present). Looking upstream.

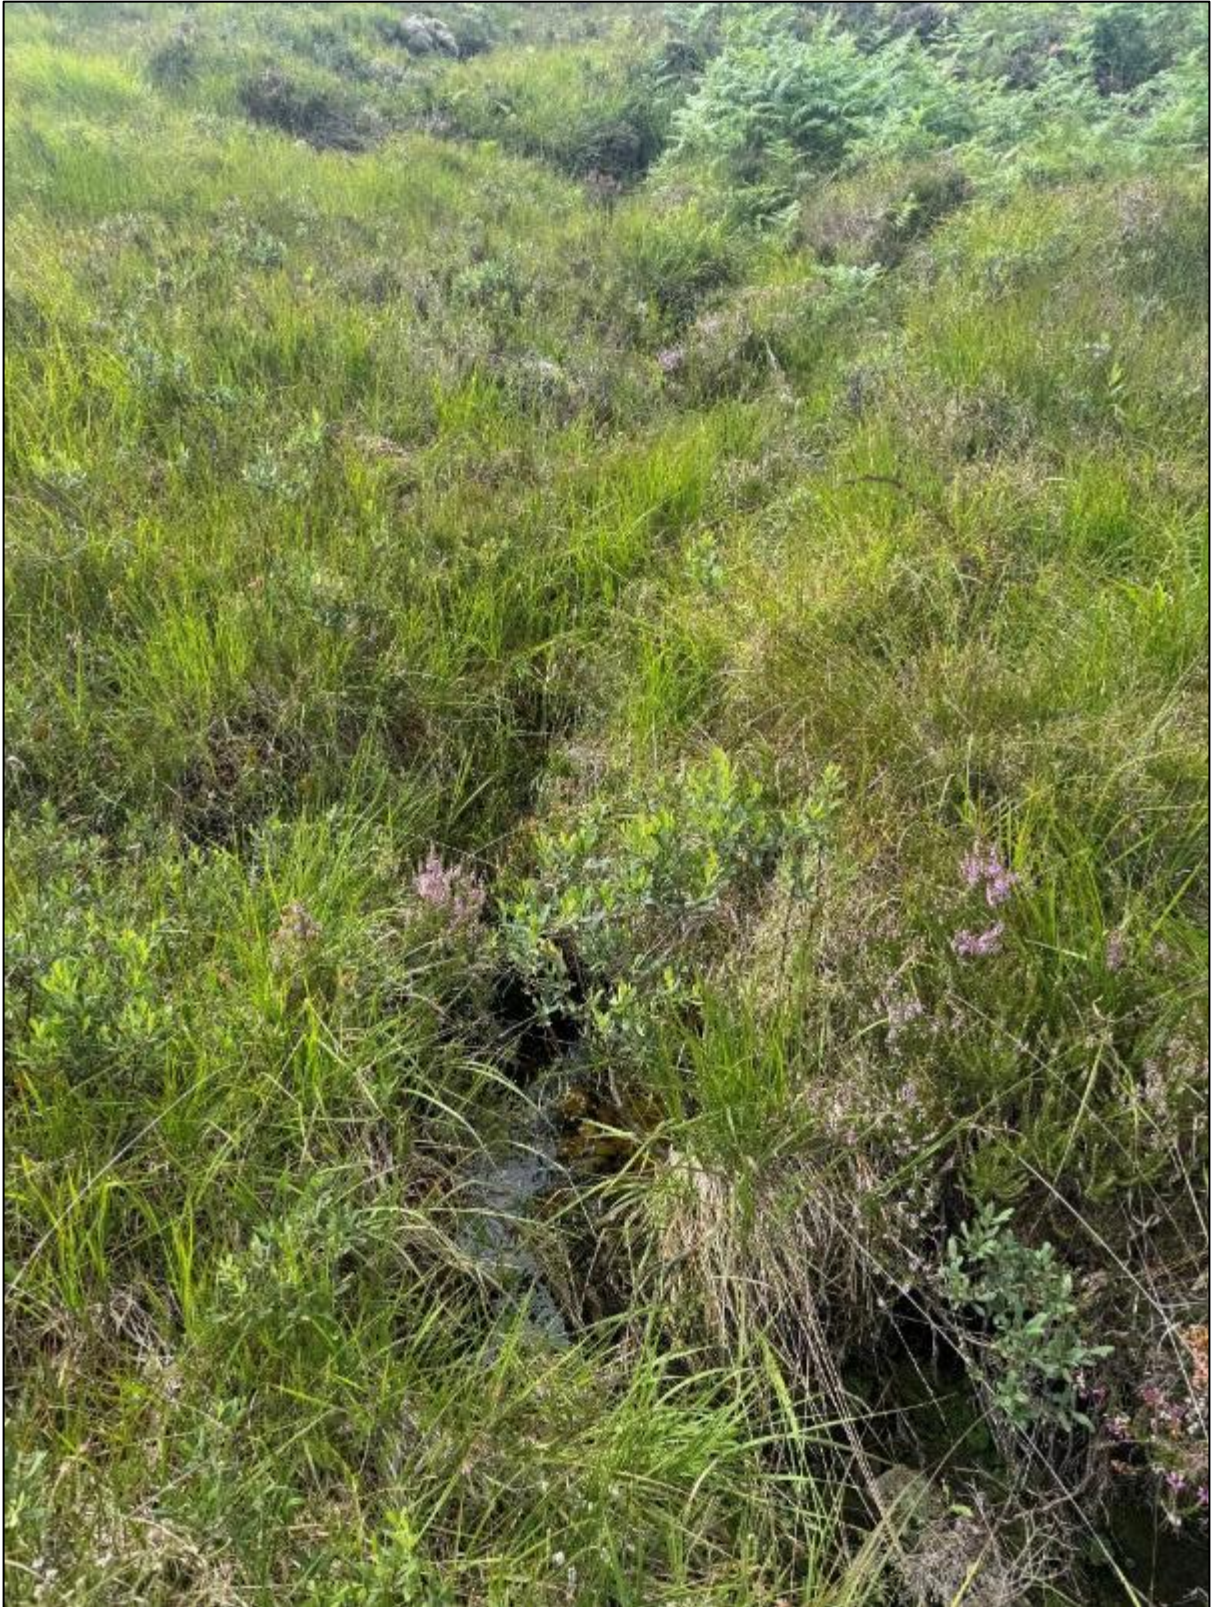
| Crossing No. | OS NGR | CA (km <sup>2</sup> ) | Figure No.* | Notes |
|---|---|---|---|---|
| 46 | NH 08656 01559 | <0.5 | A46 | Small, entrenched stream. Limited sediment transport/ storage. |

**Figure A46.** Photograph of proposed stream crossing 46 (no culvert at present). Looking upstream.

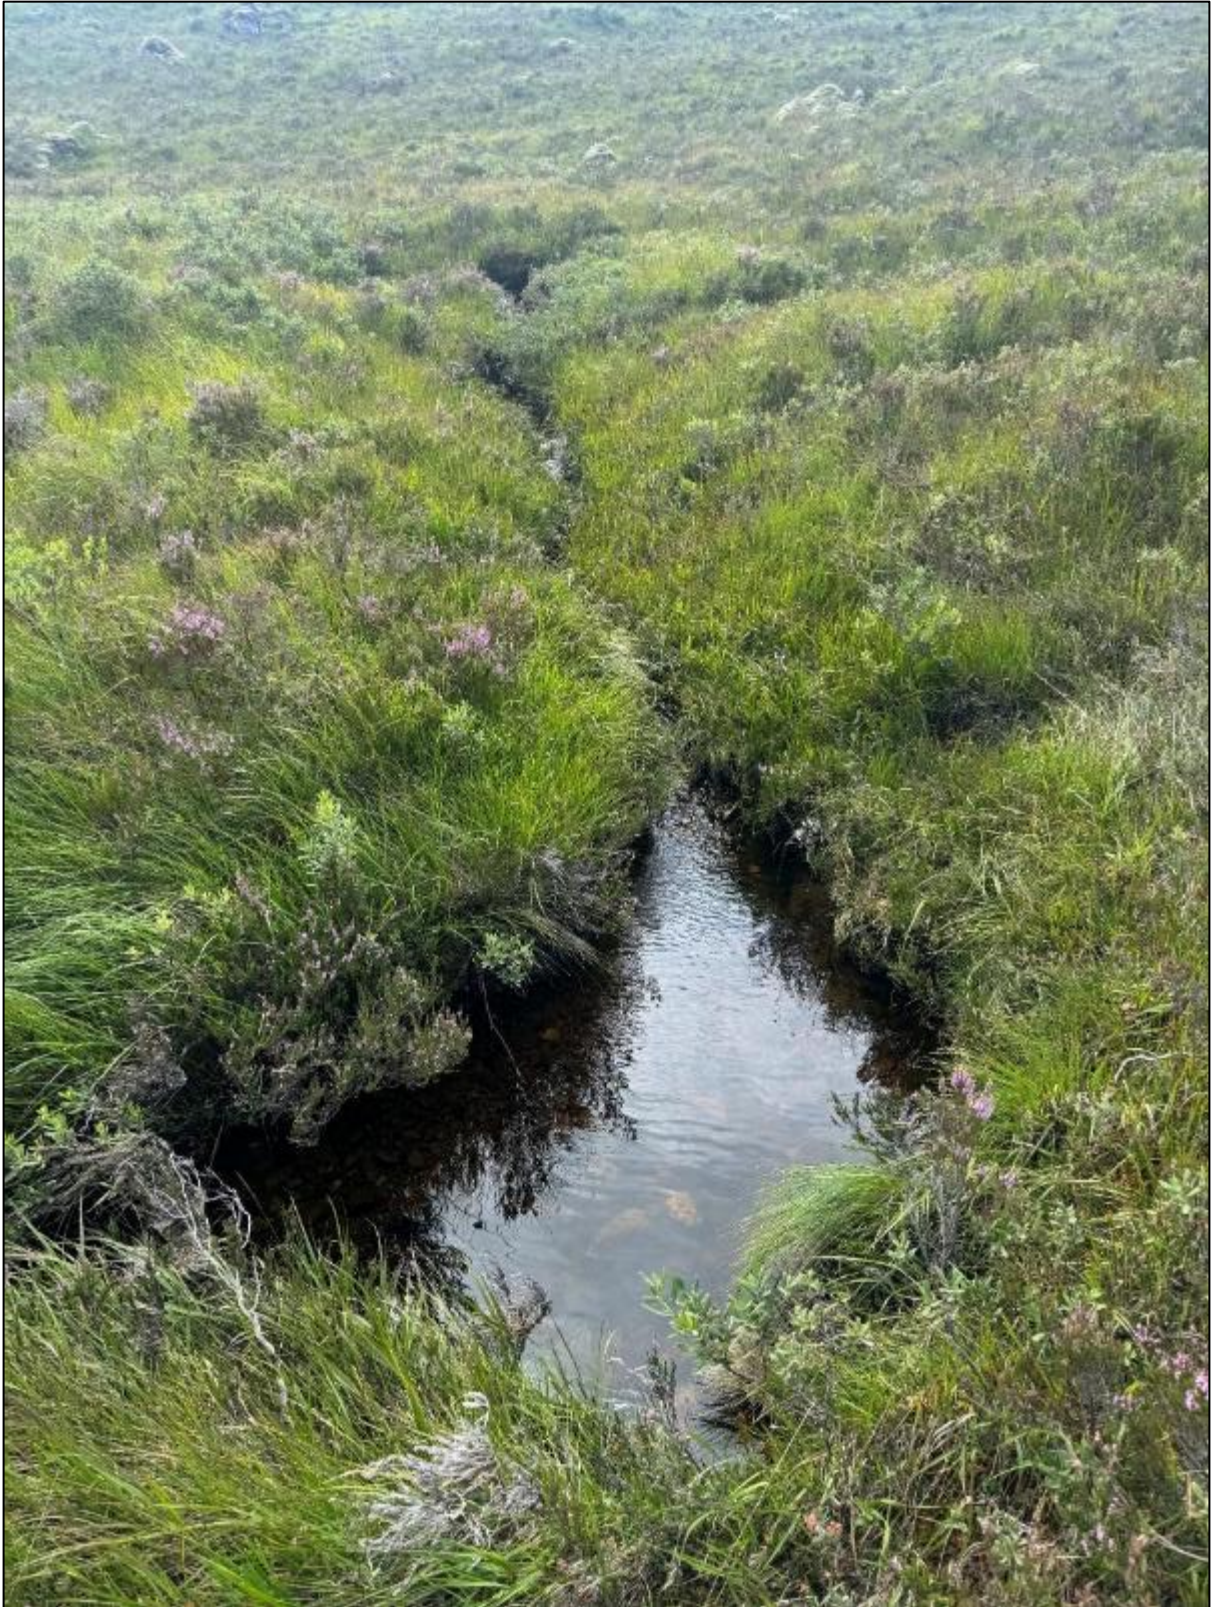
| Crossing No. | OS NGR | CA (km <sup>2</sup> ) | Figure No.* | Notes |
|---|---|---|---|---|
| 47 | NH 08502 01734 | <0.5 | A47 | Small, entrenched stream. Limited sediment transport/ storage. |

**Figure A47.** Photograph of proposed stream crossing 47 (no culvert at present). Looking upstream.

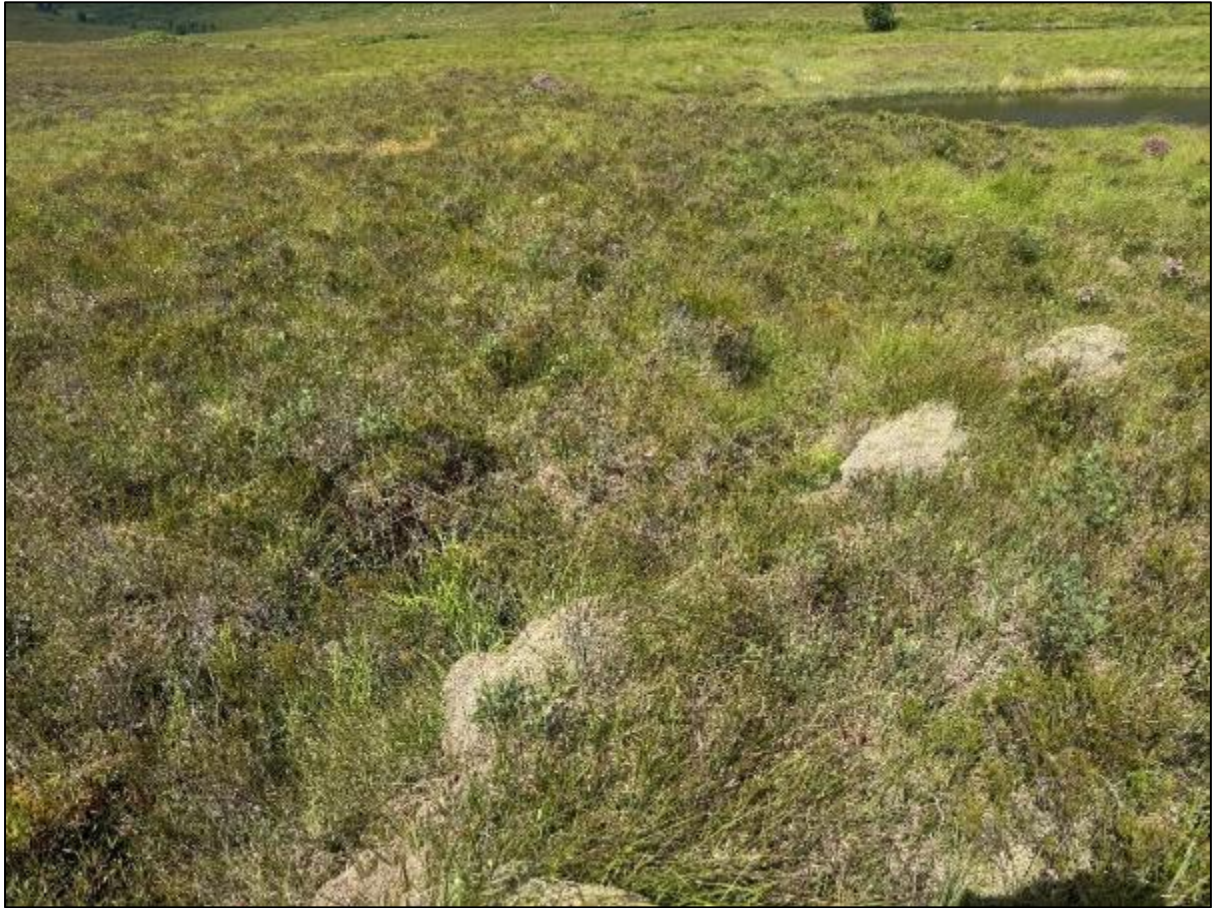
| Crossing No. | OS NGR | CA (km <sup>2</sup> ) | Figure No.* | Notes |
|---|---|---|---|---|
| 48 | NH 08259 01823 | <0.5 | A48 | Very small seep - no sediment issues. |

**Figure A48.** Photograph of proposed stream crossing 48 (no culvert at present). Looking downstream.

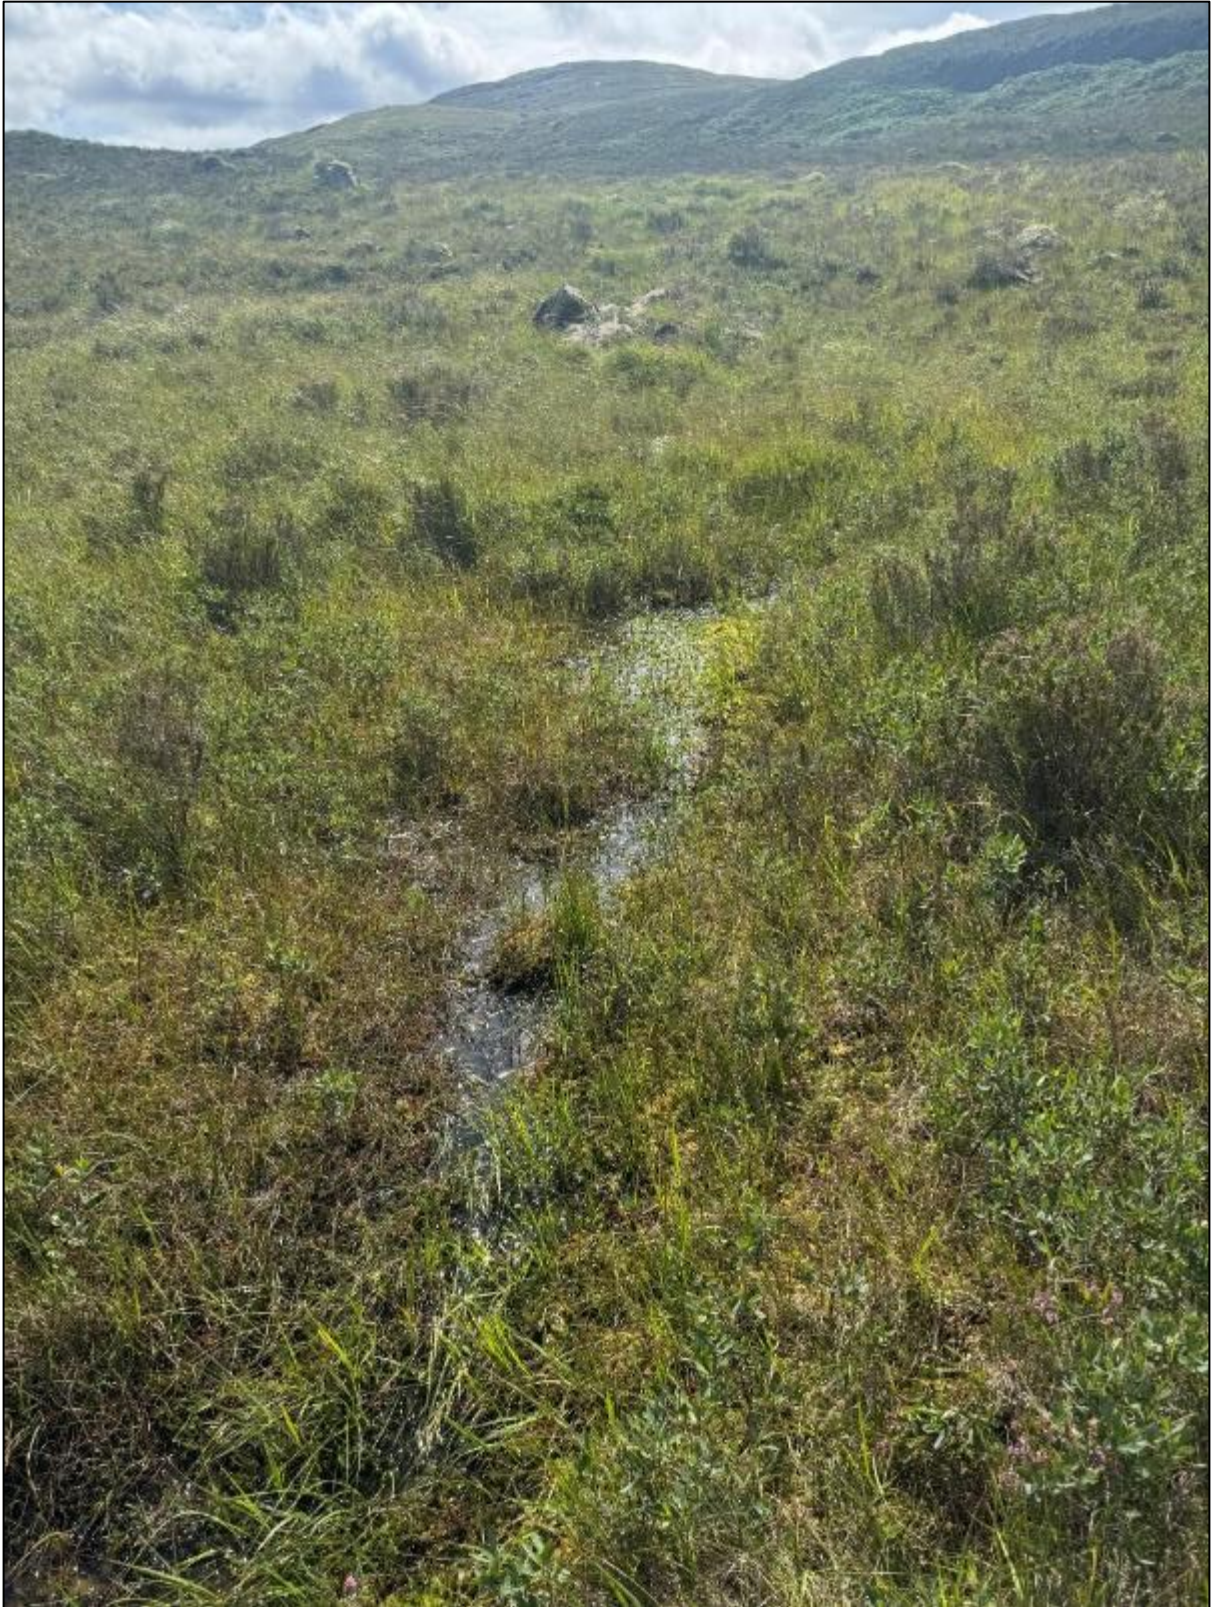
| Crossing No. | OS NGR | CA (km <sup>2</sup> ) | Figure No.* | Notes |
|---|---|---|---|---|
| 49 | NH 08218 01853 | <0.5 | A49 | Very small seep - no sediment issues. |

**Figure A49.** Photograph of proposed stream crossing 49 (no culvert at present). Looking upstream.

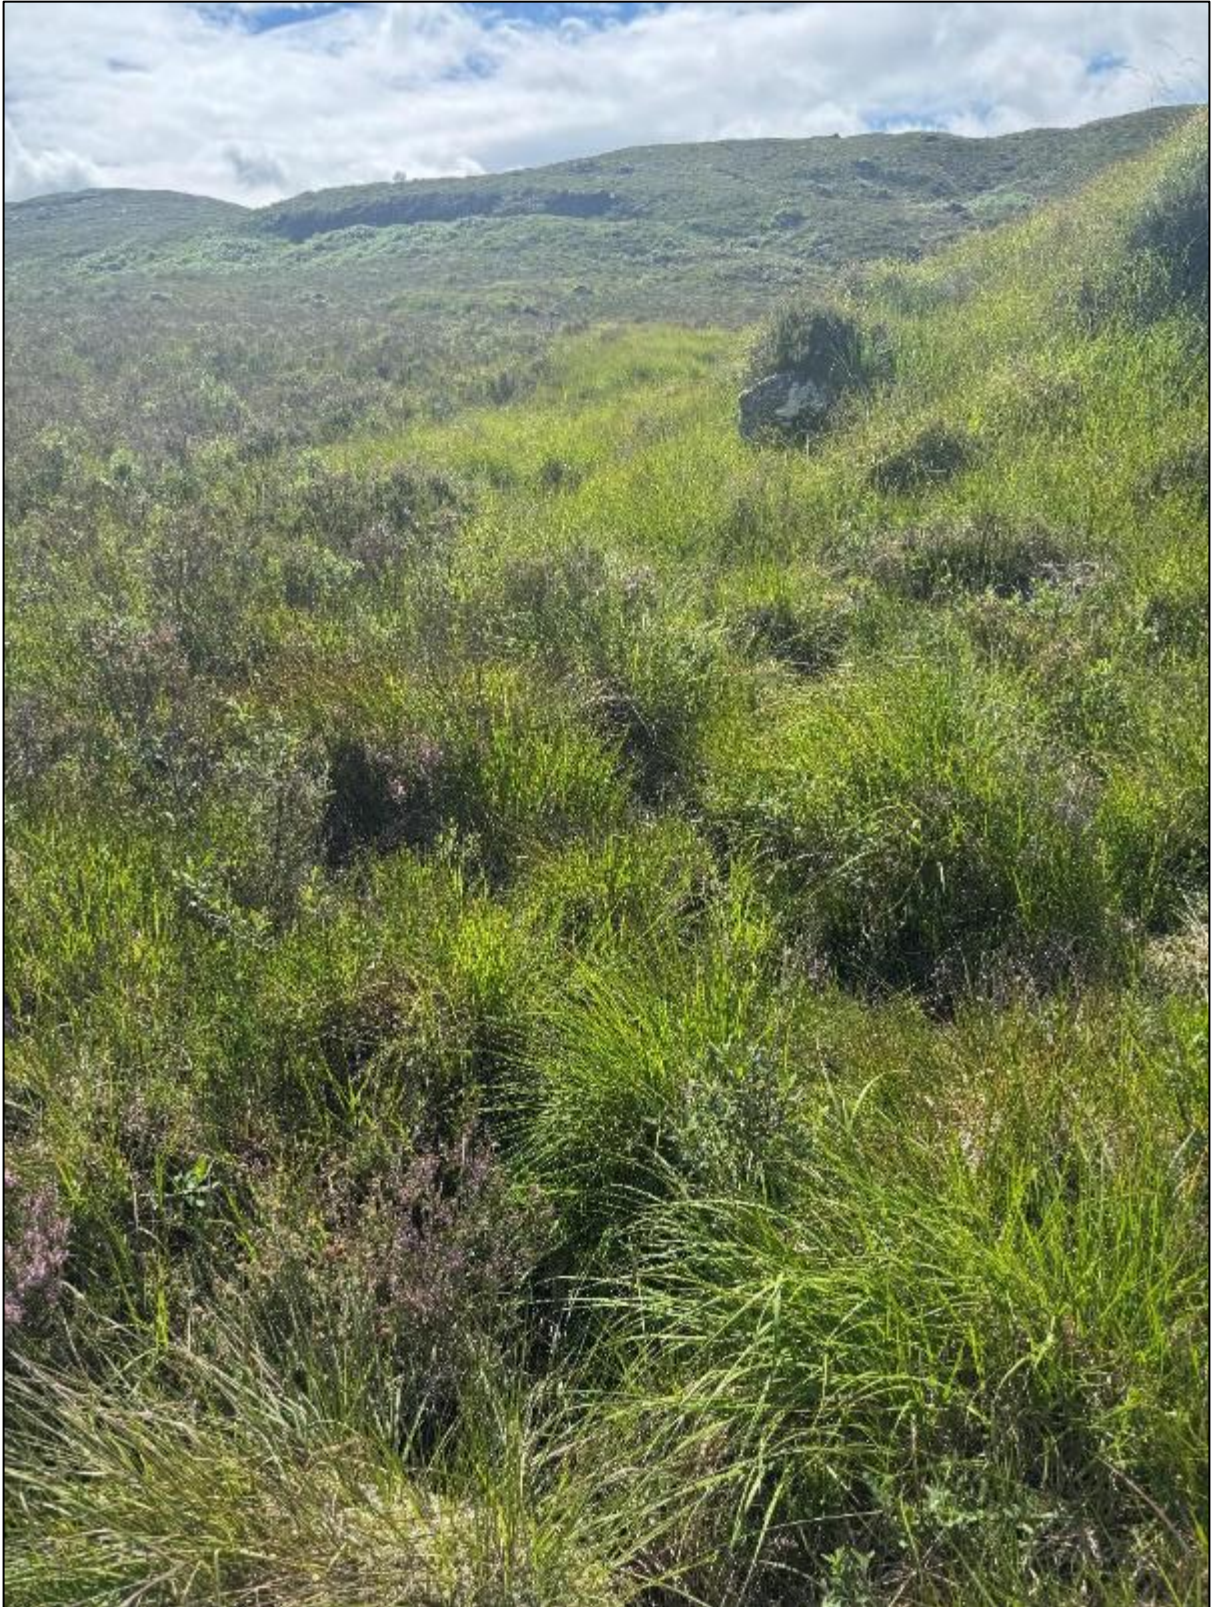
| Crossing No. | OS NGR | CA (km <sup>2</sup> ) | Figure No.* | Notes |
|---|---|---|---|---|
| 50 | NH 08179 01860 | <0.5 | A50 | Very small stream - no sediment issues. |

**Figure A50.** Photograph of proposed stream crossing 50 (no culvert at present). Looking upstream.

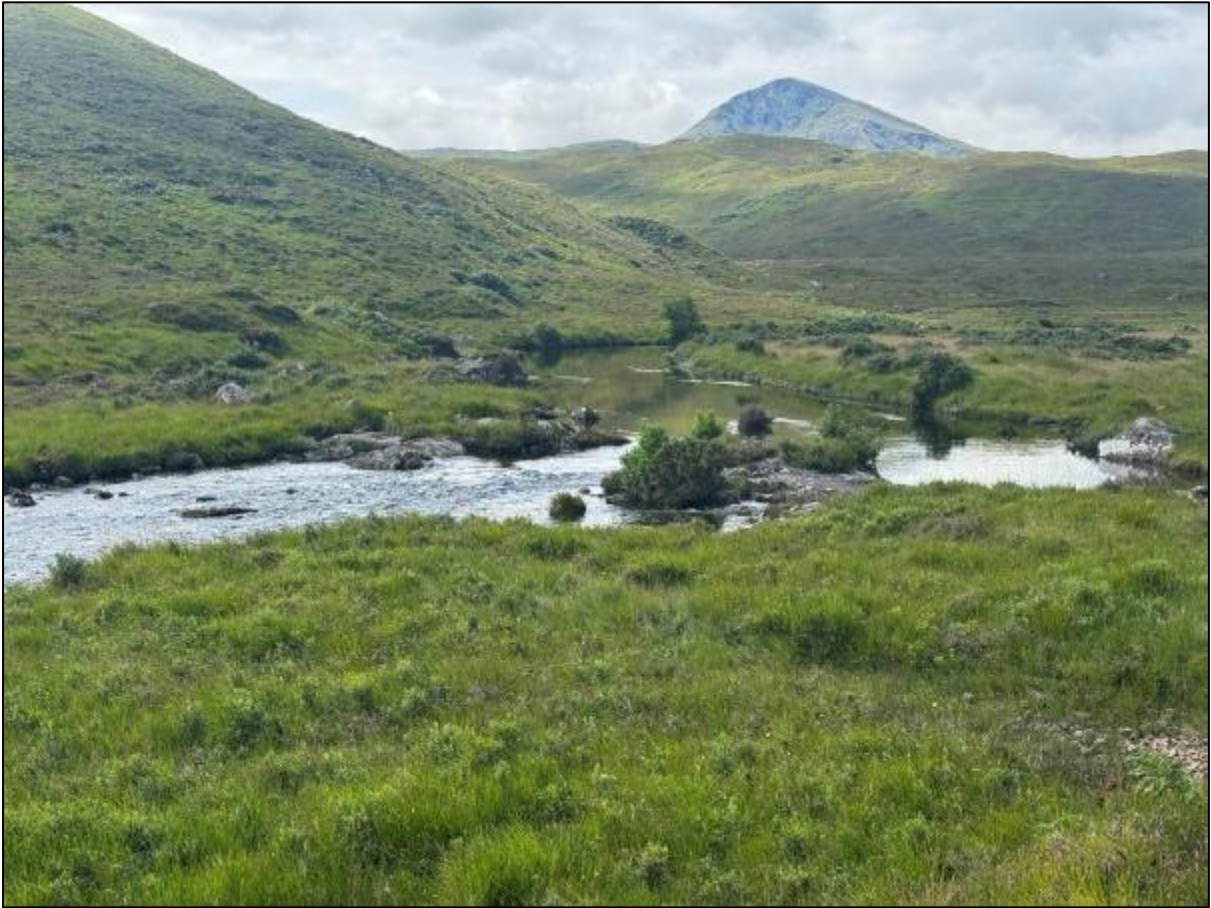
| Crossing No. | OS NGR | CA (km <sup>2</sup> ) | Figure No.* | Notes |
|---|---|---|---|---|
| 51 | NH 08144 01961 | 134.2 | A51 | Approx location of proposed SAR crossing of Gearr Garry. Bedrock control, little sediment accumulation and undynamic channel. |

**Figure A51.** Photograph of proposed stream crossing 51 (Gearr Garry, no culvert at present). Looking upstream.
